Home Inspection Report

Report Number: 101
For The Property Located On:
1000 Detail St
Accuracynville, North Carolina 27513

Date of Inspection: Thursday, April 23, 2015

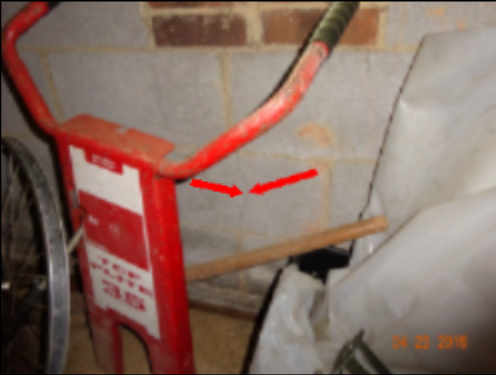
(A1 - 1.1) Main House

A closed crack was noted in the foundation of the home under the master bedroom at the center of the rear wall. Cracks in the foundation indicate a deficiency in the foundation, footing, or supporting soil that can change and worsen if it progresses over the life of the home. A general contractor should be consulted to determine the significance /cause of the cracks and outline any necessary repairs. The contractor should begin his investigation around the large tree located close the to foundation.

<p>A closed crack was noted in the foundation of the home under the master bedroom at the center of the rear wall. Cracks in the foundation indicate a deficiency in the foundation, footing, or supporting soil that can change and worsen if it progresses over the life of the home. A general contractor should be consulted to determine the significance /cause of the cracks and outline any necessary repairs. The contractor should begin his investigation around the large tree located close the to foundation.</p>

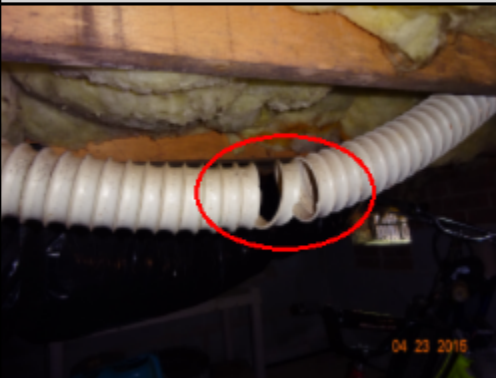
(A1 - 1.2) Main House

The bathroom vent ductwork is broken exiting conditioned air into the crawl space. A licensed general contractor or general repair specialist should be consulted for further evaluation to make sure the duct is proper installed and to make necessary repairs.

<p>The bathroom vent ductwork is broken exiting conditioned air into the crawl space. A licensed general contractor or general repair specialist should be consulted for further evaluation to make sure the duct is proper installed and to make necessary repairs.</p>
---	--

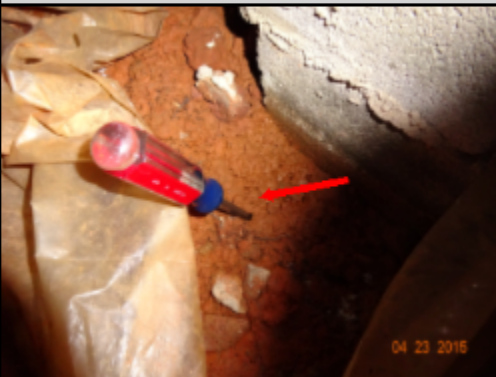
(A1 - 1.3) Main House

In the crawl space, the foundation walls were wet and the soil adjacent to the foundation was muddy from direct water penetration in the area. Direct water penetration damages the foundation, the wood structure, and creates an undesirable environment in the crawl space areas that encourages insect, fungal growth such as mold/mildew. Water in the crawl space indicates an absent or damaged waterproofing and foundation drain system. Repairs are needed to prevent water penetration. A general contractor should be consulted for further evaluation to determine the source of the moisture and to make necessary repairs.

<p>In the crawl space, the foundation walls were wet and the soil adjacent to the foundation was muddy from direct water penetration in the area. Direct water penetration damages the foundation, the wood structure, and creates an undesirable environment in the crawl space areas that encourages insect, fungal growth such as mold/mildew. Water in the crawl space indicates an absent or damaged waterproofing and foundation drain system. Repairs are needed to prevent water penetration. A general contractor should be consulted for further evaluation to determine the source of the moisture and to make necessary repairs.</p>
---	--

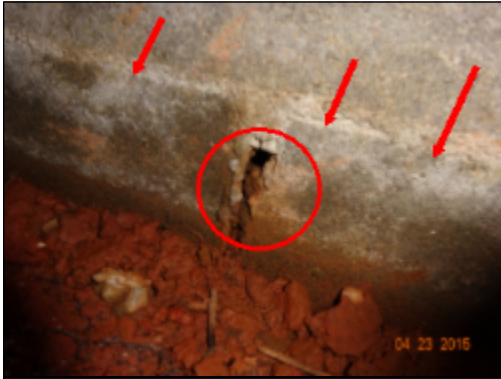
(A1 - 1.4) Main House

Additional Photograph: This a photograph of the moist areas that border the majority of the crawl space with the highest concentration by the deck. The white efflorescence on the brick wall is an indication of reoccurring moisture. This is evidenced throughout. The whole circled in the picture did not show evidence of deterioration. This most likely happened during construction and there is not a whole on the other side.

<p>Additional Photograph: This a photograph of the moist areas that border the majority of the crawl space with the highest concentration by the deck. The white efflorescence on the brick wall is an indication of reoccurring moisture. This is evidenced throughout. The whole circled in the picture did not show evidence of deterioration. This most likely happened during construction and there is not a whole on the other side.</p>
---	---

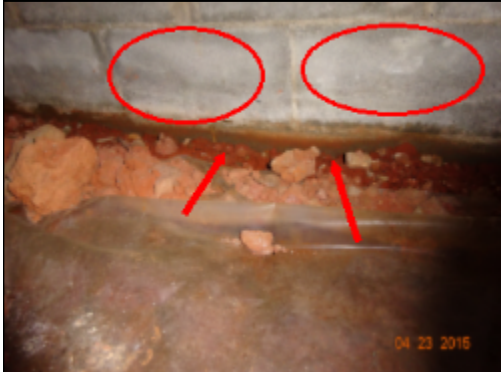
(A1 - 1.5) Main House

Additional Photograph: The efflorescence is circled and the mud has arrows. This a photograph of the moist areas that border the majority of the crawl space with the highest concentration by the deck. The white efflorescence on the brick wall is an indication of reoccurring moisture. This is evidenced throughout. The whole circled in the picture did not show evidence of deterioration. This most likely happened during construction and there is not a whole on the other side.

<p>Additional Photograph: The efflorescence is circled and the mud has arrows. This a photograph of the moist areas that border the majority of the crawl space with the highest concentration by the deck. The white efflorescence on the brick wall is an indication of reoccurring moisture. This is evidenced throughout. The whole circled in the picture did not show evidence of deterioration. This most likely happened during construction and there is not a whole on the other side.</p>
--	--

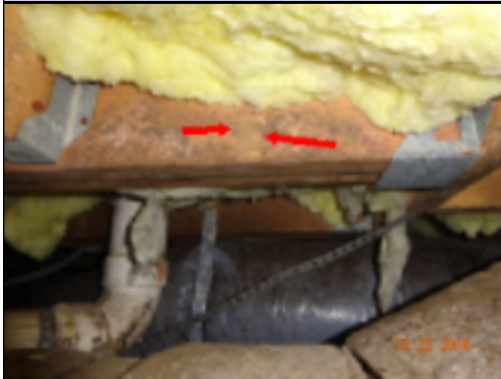
(A1 - 1.6) Main House

Water lines and stains were noted on storage in the crawl space area. This evidence indicates a history of direct water penetration. Direct water penetration damages the foundation and creates an undesirable environment in the living areas that encourages insect, fungal growth such as mold/mildew. Damp foundation walls can indicate absent or damaged waterproofing and foundation drain system. Repairs are needed to prevent water penetration. A general contractor should be consulted for further evaluation to determine the source of the moisture and necessary repairs. This is a picture of surface mold on a beam just above the main air handler ductwork. This mold is in multiple locations and is an indication of high levels of moisture. The arrow points to where I rubbed it off with my finger which means that this is not a wood destroying fungus.

<p>Water lines and stains were noted on storage in the crawl space area. This evidence indicates a history of direct water penetration. Direct water penetration damages the foundation and creates an undesirable environment in the living areas that encourages insect, fungal growth such as mold/mildew. Damp foundation walls can indicate absent or damaged waterproofing and foundation drain system. Repairs are needed to prevent water penetration. A general contractor should be consulted for further evaluation to determine the source of the moisture and necessary repairs. This is a picture of surface mold on a beam just above the main air handler ductwork. This mold is in multiple locations and is an indication of high levels of moisture. The arrow points to where I rubbed it off with my finger which means that this is not a wood destroying fungus.</p>
---	---

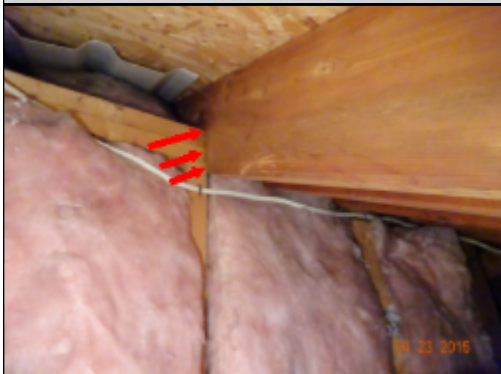
(A6 - 2.1) Main House Single Story Section off the upstairs bedroom

From the attic, the rafter located on the adjoining wall to the bedroom was notched beyond what would be typically expected. Rafters are key components of the roof system and need to be repaired to prevent framing movement and further damage. An engineer should be consulted for further evaluation to determine the significance and cause of the concern and outline necessary repairs to ensure the stability of the structure.

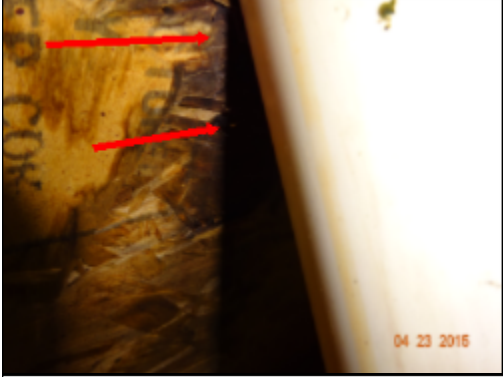
(A6 - 3.1) Main House Single Story Section over the master bedroom

Additional Photograph: This is a photograph of decayed sheathing around other vent.

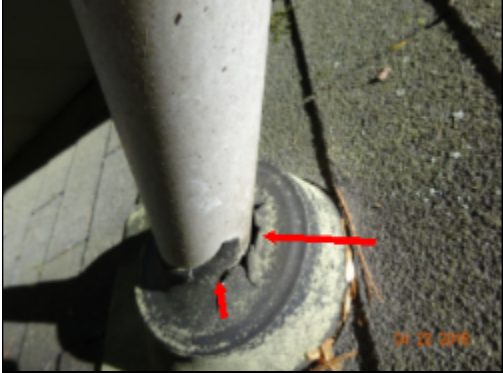
(A6 - 3.2) Main House Single Story Section over the master bedroom

The two of vent boots located over the master bedroom that acts as a flashing to prevent water penetration around the plumbing vent pipe are split, cracked and leaking. A licensed roofing contractor should be consulted for evaluation and repair to ensure the weather-tightness of the roof covering system.

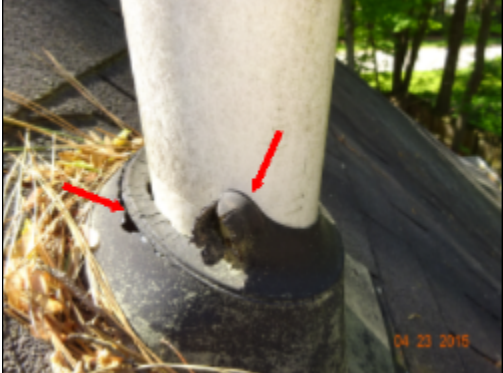
(A6 - 3.3) Main House Single Story Section over the master bedroom

Additional photo of the other cracked boot over the master bedroom.

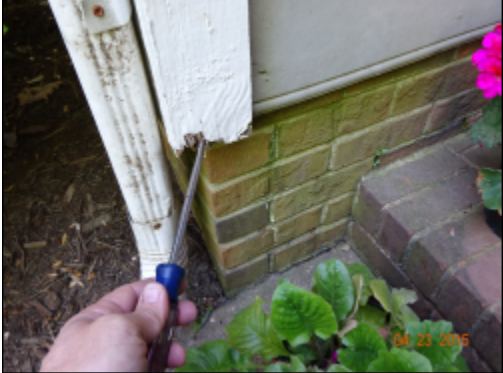
(B1 - 1.1) Main House

A siding installation company or general contractor should be consulted to evaluate and repair the trim to ensure the integrity of the cladding system. This is located by the front step.

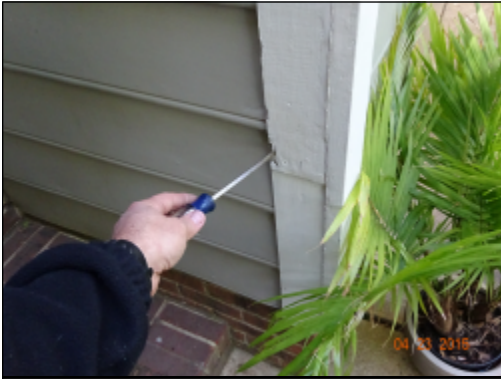
(B1 - 1.2) Main House

A siding installation company or general contractor should be consulted to evaluate and repair the trim to ensure the integrity of the cladding system. This is also by the front door.

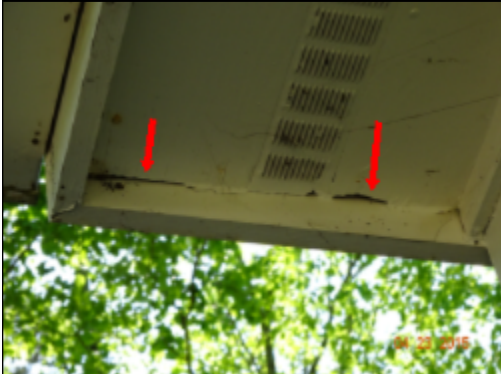
(B1 - 1.3) Main House

The boxing and trim areas were found to have areas of damage/decay related to problems with the gutters and roof drainage. Water is flowing behind gutter trays and leaking from the gutter seams. Repairs are needed to the boxing and gutter system. A licensed general contractor should be consulted for a complete evaluation the exterior of the home to determine the extent of the damage to the boxing, trim, and underlying components to ensure the weathertightness of the system. This section over the garage has gaps.

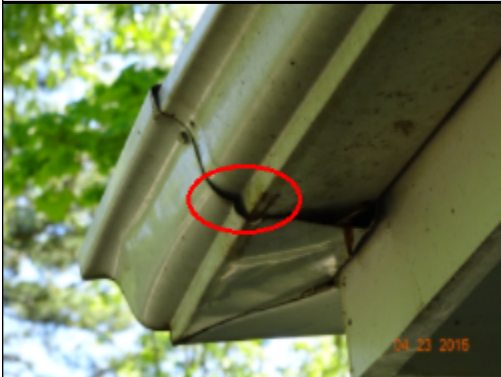
(B1 - 1.4) Main House

The gutter is bent and not sealed. Rain water leaks out onto the cement entry area. A licensed contractor should be contacted for repair.

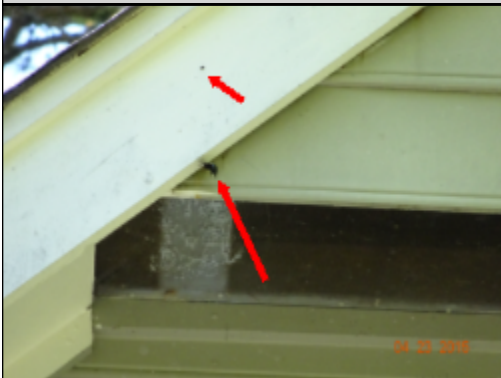
(B1 - 1.5) Main House

The round holes typical of boring / carpenter bees were noted in the siding/trim/boxing. Boring Bees damage wood by boring deep tunnels. Repairs are needed. A pest control specialist should be consulted. A licensed general contractor should be consulted for a complete evaluation the exterior of the home to determine the extent of the damage to the siding, boxing, trim, and underlying components to ensure the weathertightness of the system. Areas affected were noted above the highest peak and to the left and right of the chimney. Notice the picture is actually pointing to a bee making its way behind the face plate.

<p>The round holes typical of boring / carpenter bees were noted in the siding/trim/boxing. Boring Bees damage wood by boring deep tunnels. Repairs are needed. A pest control specialist should be consulted. A licensed general contractor should be consulted for a complete evaluation the exterior of the home to determine the extent of the damage to the siding, boxing, trim, and underlying components to ensure the weathertightness of the system. Areas affected were noted above the highest peak and to the left and right of the chimney. Notice the picture is actually pointing to a bee making its way behind the face plate.</p>
---	--

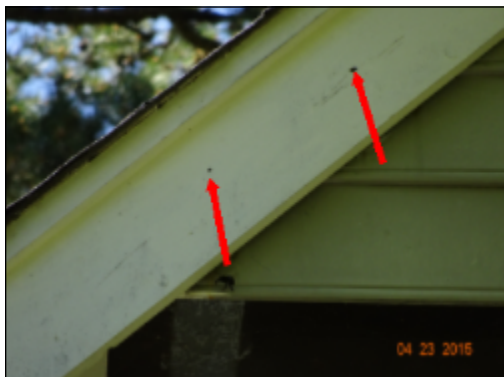
(B1 - 1.6) Main House

Additional Photograph: This a photograph of bee holes in face plate.

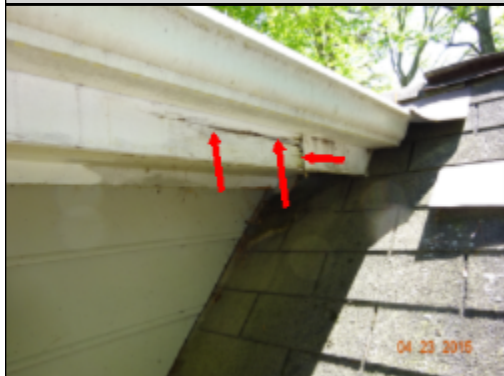
(B1 - 1.7) Main House

Additional Photograph: This a photograph of rotted face plate. This area is located over the master bedroom.

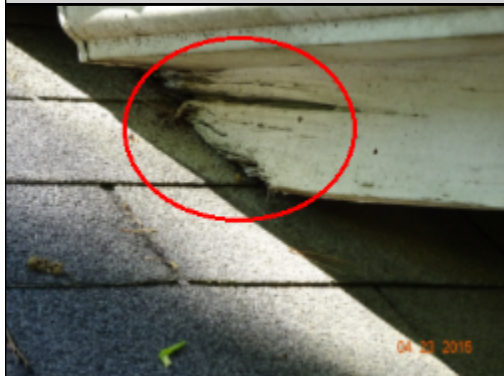
(B1 - 1.8) Main House

Additional Photograph: This a photograph of the face plate over the garage and entry way.

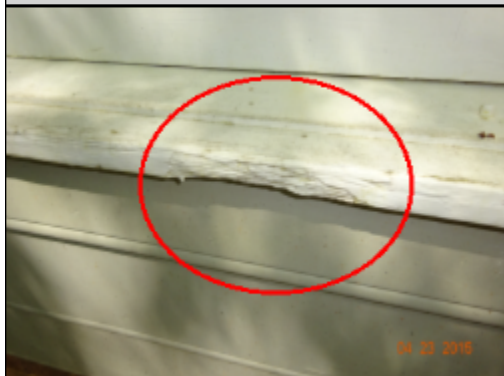
(B2 - 1.1) All Windows; Location: Main House

The dining room window(s) has/ have soft and decayed wood in the sill area. Decay in the windows can result in leaking and water penetration and should be repaired as soon as possible. All windows should be inspected for similar damage as repairs are made. A licensed general contractor should be consulted to evaluate the extent of the damage and make necessary repairs.

<p>The dining room window(s) has/ have soft and decayed wood in the sill area. Decay in the windows can result in leaking and water penetration and should be repaired as soon as possible. All windows should be inspected for similar damage as repairs are made. A licensed general contractor should be consulted to evaluate the extent of the damage and make necessary repairs.</p>
---	--

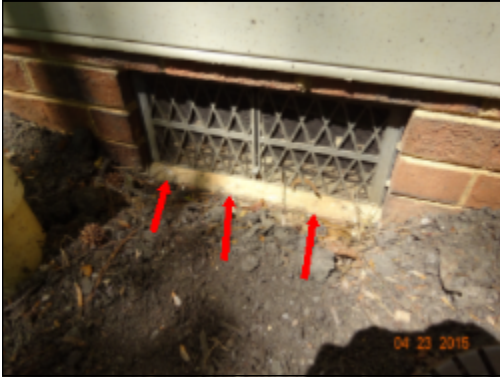
(B5 - 1.1) Grading; Location: Main House Left

The grading around the foundation of the home is too high. Incorrect clearance can result in water penetration, drainage, and conditions inducive of insects and decay. A licensed general contractor should be consulted to evaluate and correct the grading as needed for proper clearance and drainage.

The grading around the foundation of the home is too high. Incorrect clearance can result in water penetration, drainage, and conditions conducive of insects and decay. A licensed general contractor should be consulted to evaluate and correct the grading as needed for proper clearance and drainage.
---	---

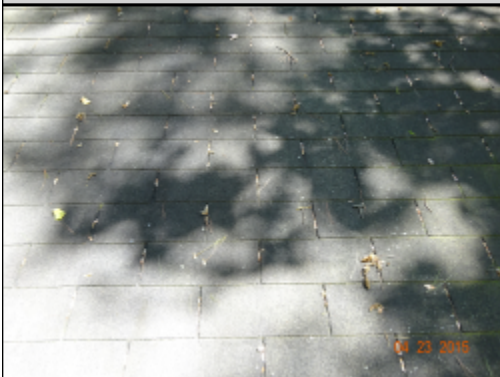
(C1 - 1.1) All Accessible Areas

The roof covering system is original to the home which was built in 1990. The overall condition of the shingles is good but the homeowner should begin to budget for replacement simply due the the age of the shingle.

The roof covering system is original to the home which was built in 1990. The overall condition of the shingles is good but the homeowner should begin to budget for replacement simply due to the age of the shingle.
---	--

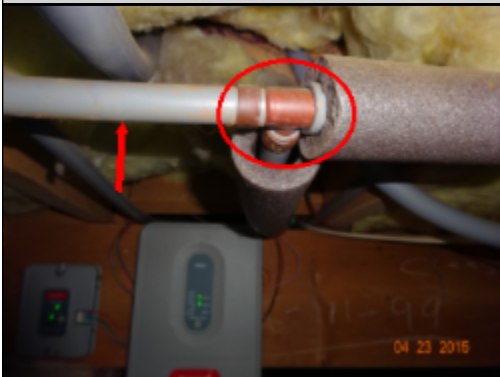
(D1 - 1.1) Crawl Space

Polybutylene plumbing supply lines (PB) are installed in this house. PB was used as water distribution piping in many homes built from the mid 1980's until the mid-1990's. The piping and associated fittings have had a failure rate and subsequent leakage sufficient to have been the subject of several nationwide class action lawsuits. Copper and brass fittings used in later years seem to have reduced the failure rate, but the piping may still fail due to problems with poor installation, improper handling, or chemical reaction with the water supply. The piping in this house has Copper fittings. A licensed plumbing contractor should be consulted for complete evaluation of the water supply and distribution systems to determine the general condition of the system and to make necessary repairs. The copper fitting which is better than plastic is circled.

<p>Polybutylene plumbing supply lines (PB) are installed in this house. PB was used as water distribution piping in many homes built from the mid 1980's until the mid-1990's. The piping and associated fittings have had a failure rate and subsequent leakage sufficient to have been the subject of several nationwide class action lawsuits. Copper and brass fittings used in later years seem to have reduced the failure rate, but the piping may still fail due to problems with poor installation, improper handling, or chemical reaction with the water supply. The piping in this house has Copper fittings. A licensed plumbing contractor should be consulted for complete evaluation of the water supply and distribution systems to determine the general condition of the system and to make necessary repairs. The copper fitting which is better than plastic is circled.</p>
---	---

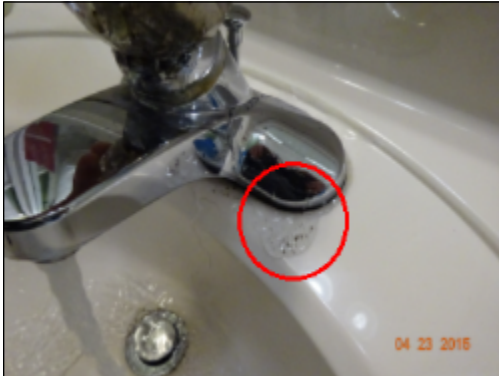
(D1 - 3.1) Master bath

The plumbing system is in need of further evaluation and repair; the following concerns were noted at the time of the inspection: the faucet leaked from the handle when fully turned on. A licensed plumbing contractor should be consulted for complete evaluation and of the waste line systems to determine the general condition of the system and to make necessary repairs to ensure proper drainage and sanitary conditions. Plumbing issues should be corrected prior to purchasing the home to prevent leaking or future problems and ensure sanitary conditions.

<p>The plumbing system is in need of further evaluation and repair; the following concerns were noted at the time of the inspection: the faucet leaked from the handle when fully turned on. A licensed plumbing contractor should be consulted for complete evaluation and of the waste line systems to determine the general condition of the system and to make necessary repairs to ensure proper drainage and sanitary conditions. Plumbing issues should be corrected prior to purchasing the home to prevent leaking or future problems and ensure sanitary conditions.</p>
--	--

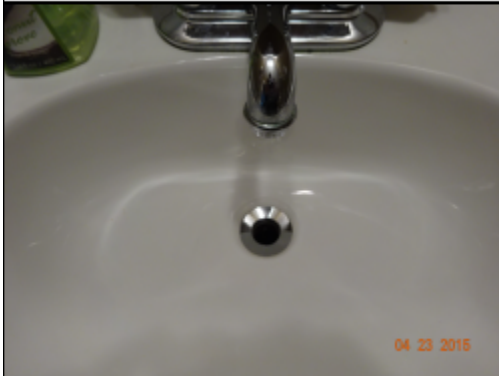
(D2 - 1.1) Bathroom - 1/2 bath

The plumbing system is in need of further evaluation and repair; the following concerns were noted at the time of the inspection: the stopper for the sink drain is missing. A licensed plumbing contractor should be consulted for complete evaluation and of the waste line systems to determine the general condition of the system and to make necessary repairs to ensure proper drainage and sanitary conditions.

<p>The plumbing system is in need of further evaluation and repair; the following concerns were noted at the time of the inspection: the stopper for the sink drain is missing. A licensed plumbing contractor should be consulted for complete evaluation and of the waste line systems to determine the general condition of the system and to make necessary repairs to ensure proper drainage and sanitary conditions.</p>
---	--

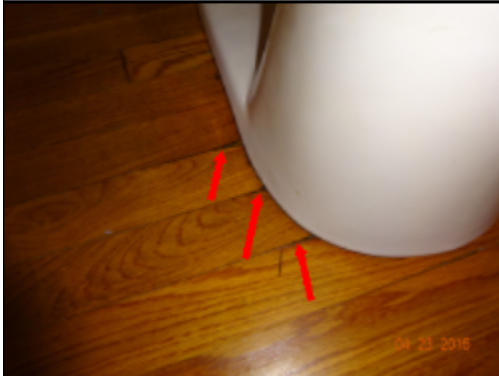
(D2 - 1.2) Bathroom - 1/2 bath

The toilet is leaking. The wax ring needs to be repaired to secure the toilet and ensure sanitary conditions. Notice the discolored lines in the wood flooring. The sub floor in the crawl space was not rotted on the underside. A licensed plumbing contractor should be consulted for complete evaluation and of the waste line systems to determine the general condition of the system and to make necessary repairs.

<p>The toilet is leaking. The wax ring needs to be repaired to secure the toilet and ensure sanitary conditions. Notice the discolored lines in the wood flooring. The sub floor in the crawl space was not rotted on the underside. A licensed plumbing contractor should be consulted for complete evaluation and of the waste line systems to determine the general condition of the system and to make necessary repairs.</p>
---	---

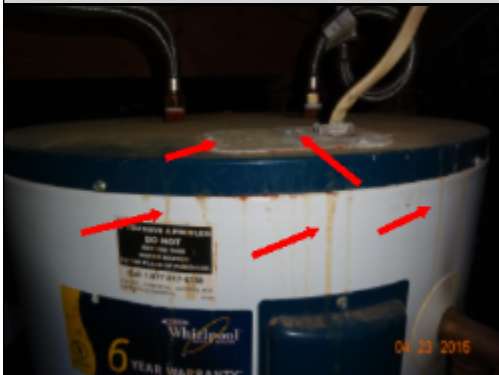
(D3 - 1.1) Unit #1 ; Location: Crawl Space

The water heating unit for this home is over ten years old and was found to be in poor condition. The unit has heavy corrosion of the casing and supply line connections. A licensed plumbing contractor should be consulted to evaluate the system and repair/ replace as needed to ensure safe and reliable hot water supply. The leak was not present at the time of inspection. Owner disclosure is suggested regarding any repairs.

The water heating unit for this home is over ten years old and was found to be in poor condition. The unit has heavy corrosion of the casing and supply line connections. A licensed plumbing contractor should be consulted to evaluate the system and repair/replace as needed to ensure safe and reliable hot water supply. The leak was not present at the time of inspection. Owner disclosure is suggested regarding any repairs.	
(D3 - 1.2) Unit #1

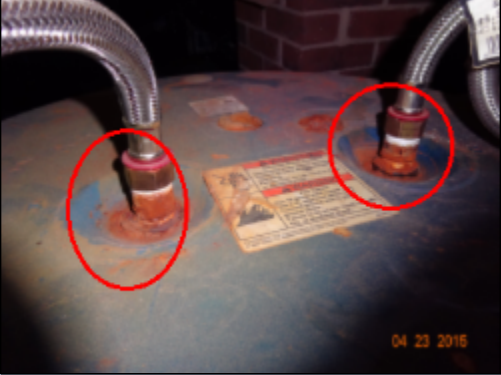
(D3 - 1.2) Unit #1 ; Location: Crawl Space

Additional Photograph: This is a photograph of the corrosion on the water heater.

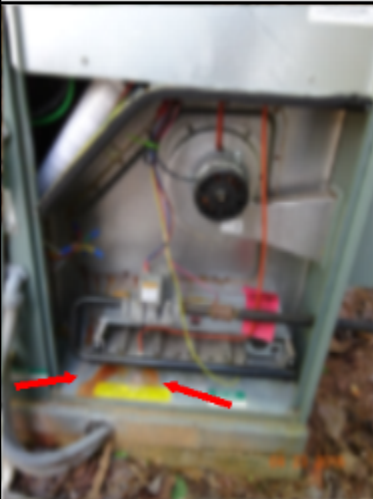
(F1 - 1.1) Heating Unit - Heat pack; Location: Exterior: Package Unit (Heating and Cooling)

The area surrounding the gas furnace combustion/draft fan is rusted and deteriorated. Damage to the fan can result in improper operation of the combustion and or exhaust system. A HVAC contractor should be consulted for a complete evaluation and to make necessary repairs to ensure safe, reliable, and proper operation of the HVAC system. The arrows on the bottom show the rusty stains that flow from the bottom of the heat exchanger.

The area surrounding the gas furnace combustion/draft fan is rusted and deteriorated. Damage to the fan can result in improper operation of the combustion and or exhaust system. A HVAC contractor should be consulted for a complete evaluation and to make necessary repairs to ensure safe, reliable, and proper operation of the HVAC system. The arrows on the bottom show the rusty stains that flow from the bottom of the heat exchanger.		
(F1 - 1.2) Heating Unit - Heat pack

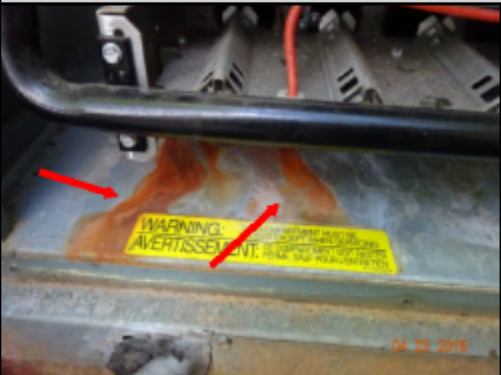
(F1 - 1.2) Heating Unit - Heat pack; Location: Exterior: Package Unit (Heating and Cooling)

Additional Photograph. This photograph represents a closer look at the rust stain from the heat exchanger.

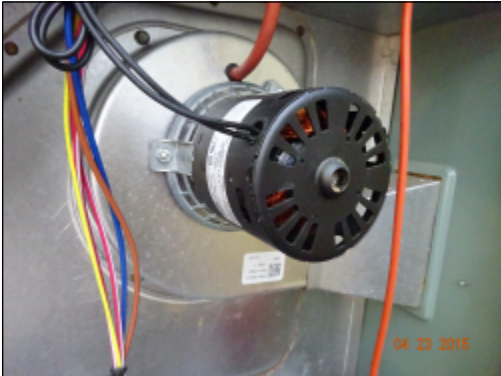
(F1 - 1.3) Heating Unit - Heat pack; Location: Exterior: Package Unit (Heating and Cooling)

The fan has been replaced recently. The buyer should ask for owner disclosure regarding the work that was done on the furnace.

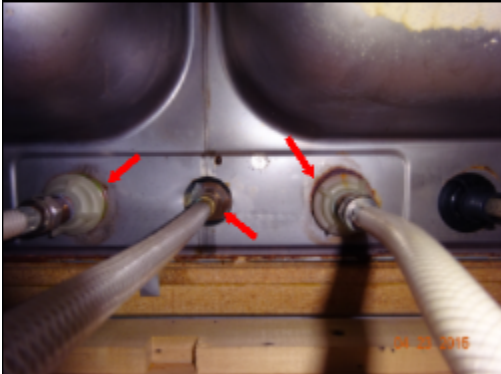
(H2 - 1.1) Kitchen

The sink faucet is deteriorated and corroded where it is attached to the sink. The faucet was noted to be in poor condition. Repair or replacement is needed. A licensed plumbing contractor should be consulted for evaluation and repair to ensure proper service. The leak is visible when the sink is turned on.

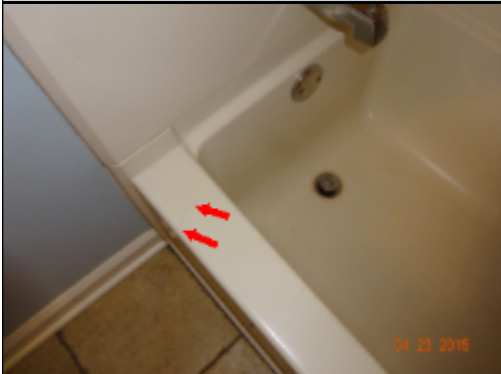
(H3 - 3.1) Bathroom #3

The fiberglass/acrylic tub has a crack in the surface. The chip could allow water to penetrate under the surface and possibility result in leaks. A specialist should be consulted to determine if the tub surface can be repaired.

The fiberglass/acrylic tub has a crack in the surface. The chip could allow water to penetrate under the surface and possibility result in leaks. A specialist should be consulted to determine if the tub surface can be repaired.
(H3 - 3.2) Bathroom #3

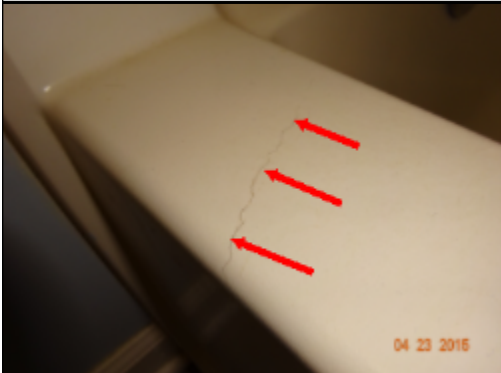
(H3 - 3.2) Bathroom #3

Additional photo of the crack in the tub

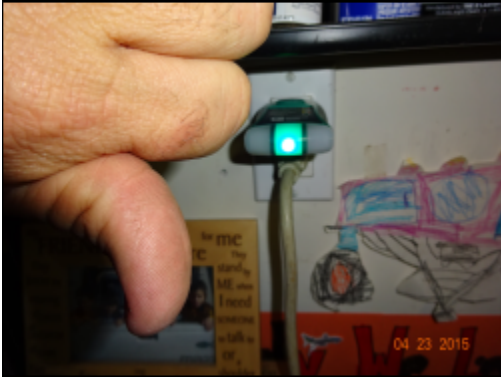
(H4 - 1.1) Garage

The GFCI in the garage did not trip when tested. This is a safety concern due to the potential exposure to water in the garage. A licensed electrician should be hired to fix the issue.

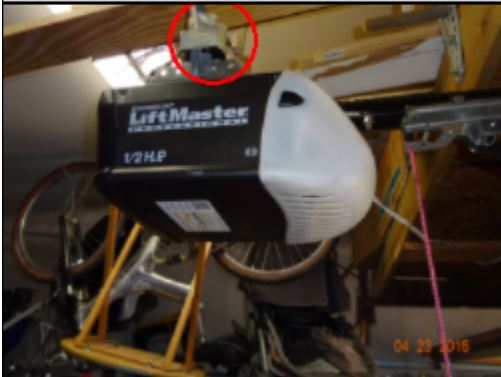
(H4 - 1.2) Garage

The garage door needs adjustment and repair. The electronic eyes are set too high to function properly because they have been mounted on top of the door opener. A garage door installation company or a licensed general contractor should be consulted for evaluation and repair to ensure that the door operates safely and properly.

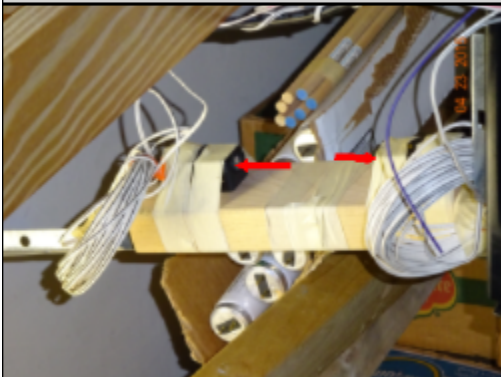
(H4 - 1.3) Garage

Additional picture of the garage door electric eyes.
