ELDREDGE HOME INSPECTION

FULL HOME TEMP - NON IRB

1234 Main Street
Cary, NC 27513

01/24/2026 9:00AM

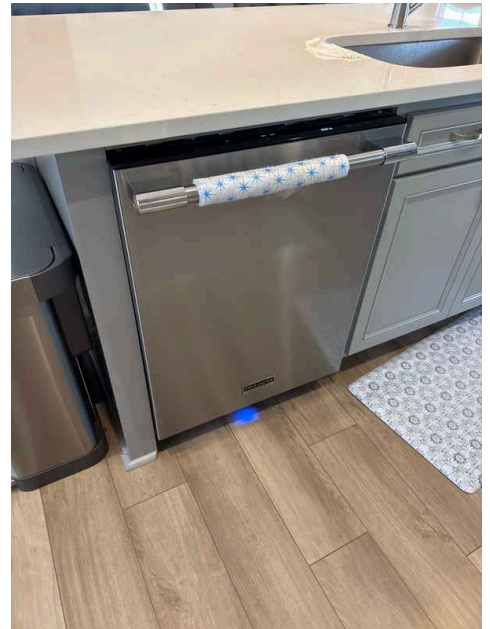
2.1.1 Dishwasher

APPLIANCE CONTRACTOR IS NEEDED FOR REPAIR

See description for this finding. The client stated that the dishwasher shows an E 20 error when the sanitizer is installed..

An appliance contractor should be consulted for the evaluation and repair of this appliance.

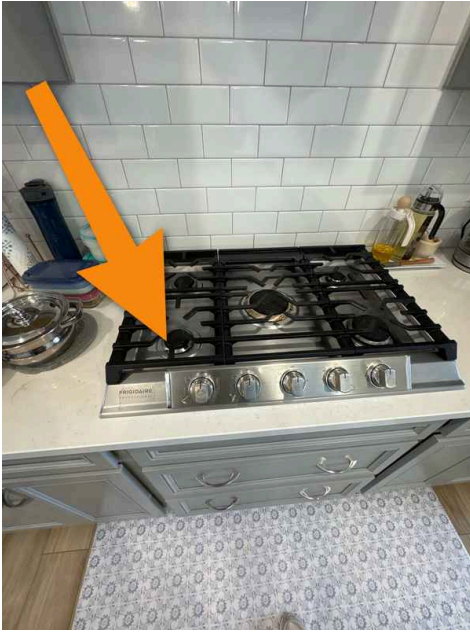
2.5.1 Range top (counter)

APPLIANCE CONTRACTOR IS NEEDED FOR REPAIR

This burner does not light consistently.

An appliance contractor should be consulted for the evaluation and repair of this appliance.

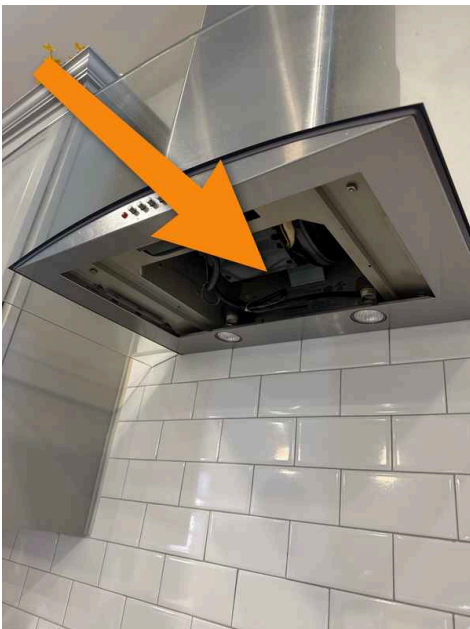
2.6.1 Hood Vent for Range

APPLIANCE REPAIR TECHNICIAN IS NEEDED

Oil from cooking is dripping from the hood vent onto the pan below. This is not typical. Further investigation needed to determine the cause of this unique concern and to conduct repairs.

This appliance should be evaluated for installation according to the manufactures instructions.

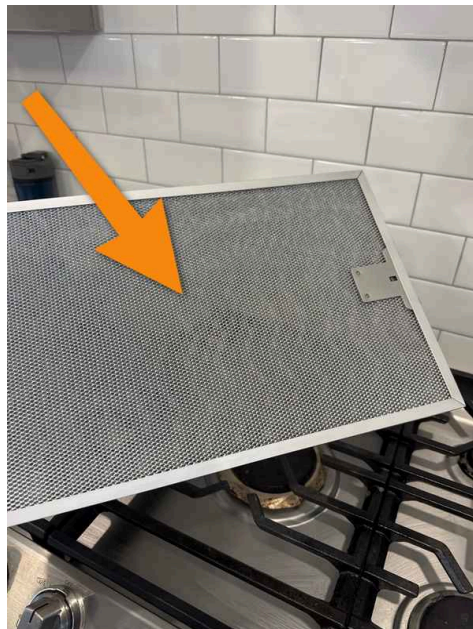
Please note that the filter was very clean during the inspection. This means routine maintenance is being performed properly.

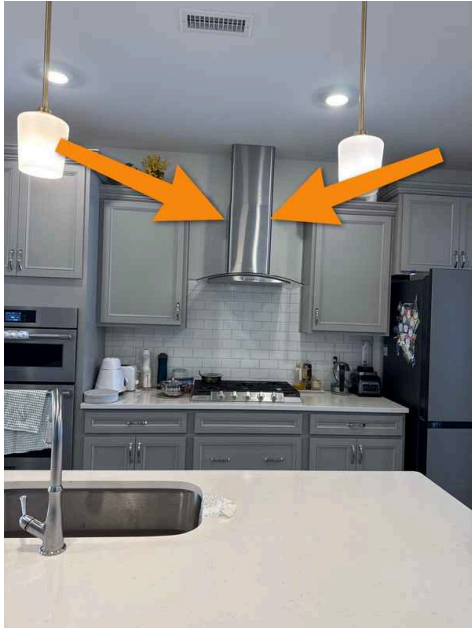
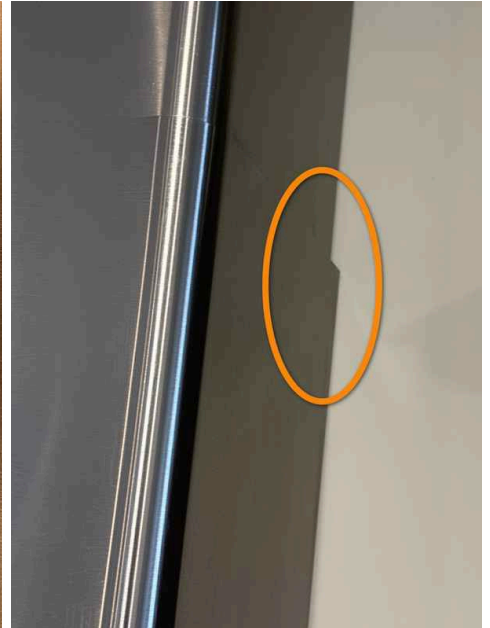
2.6.2 Hood Vent for Range

COVER FOR THE DUCT IS MISALIGNED/NOT INSTALLED

The cover for the duct is misaligned/not installed. Repairs should be made to straighten the duct cover by an appliance contractor.

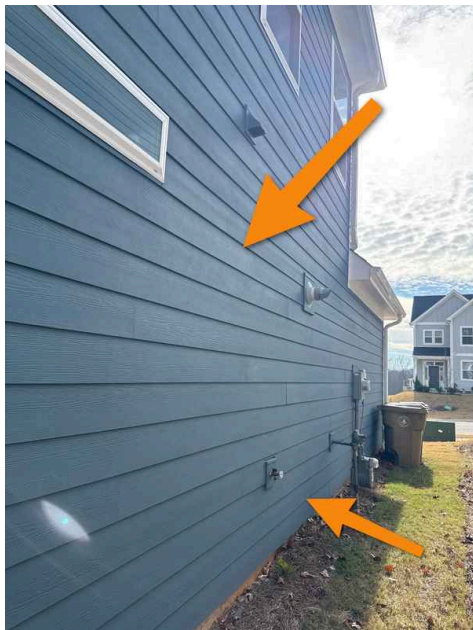
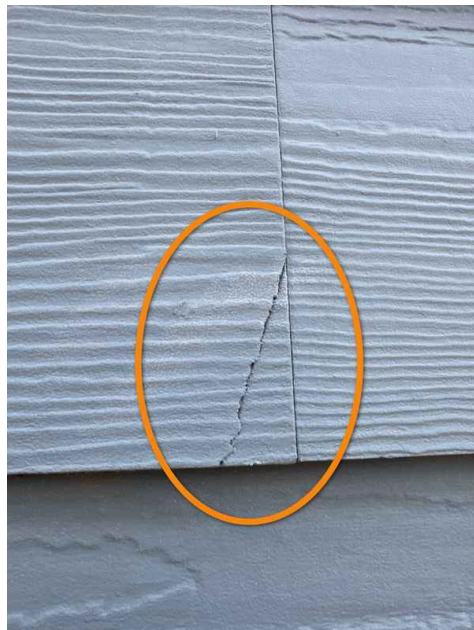
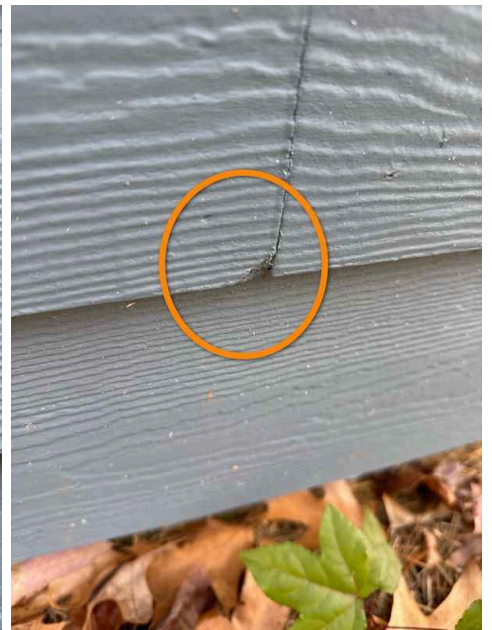
A GENERAL REPAIR IS NEEDED FOR THE SIDING.

Additional photo of this finding showing the damaged siding.

Similar findings were found here.

All repairs should be completed by a siding installation company or a licensed general contractor.

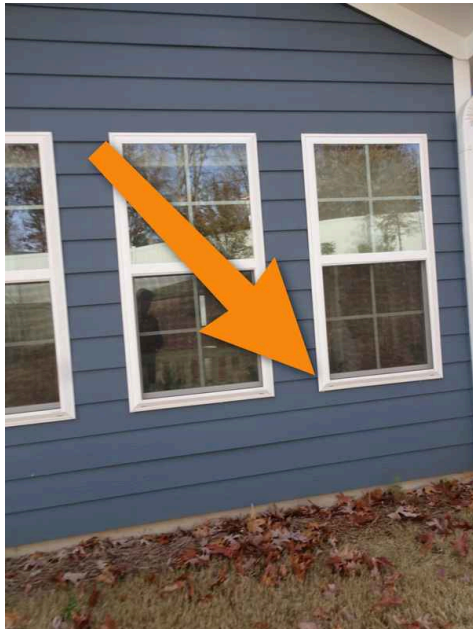
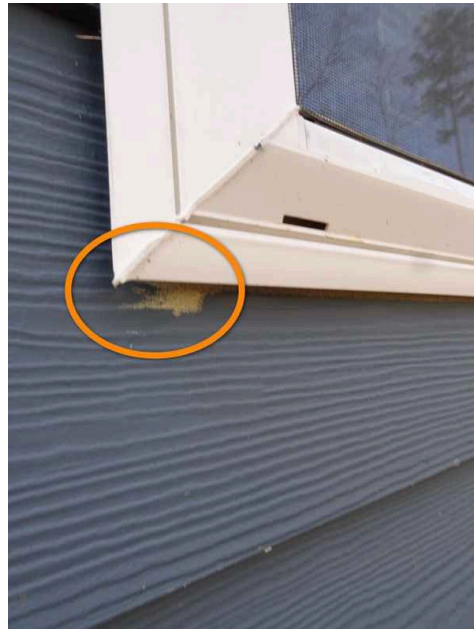
Additional photo of this finding showing missing paint.

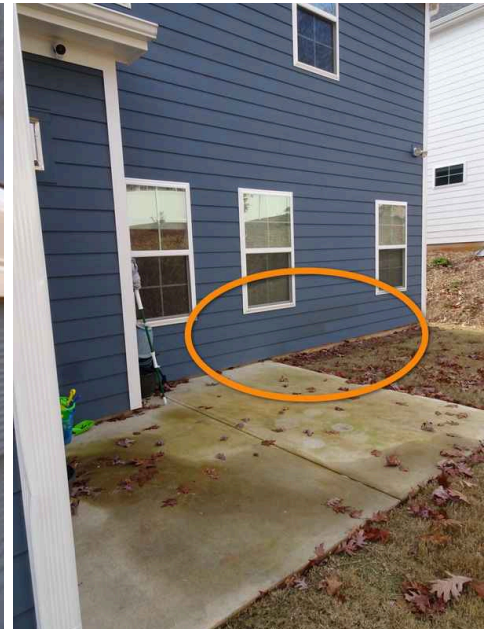
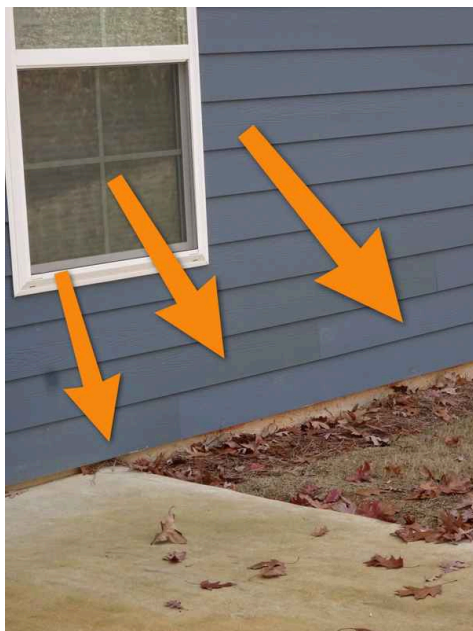
The siding is two different colors in this area.

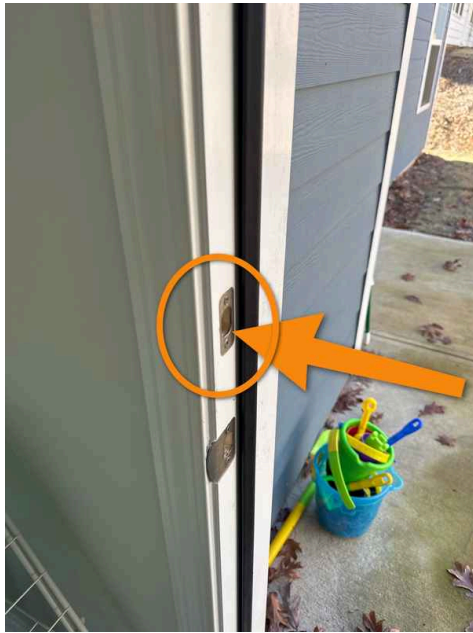
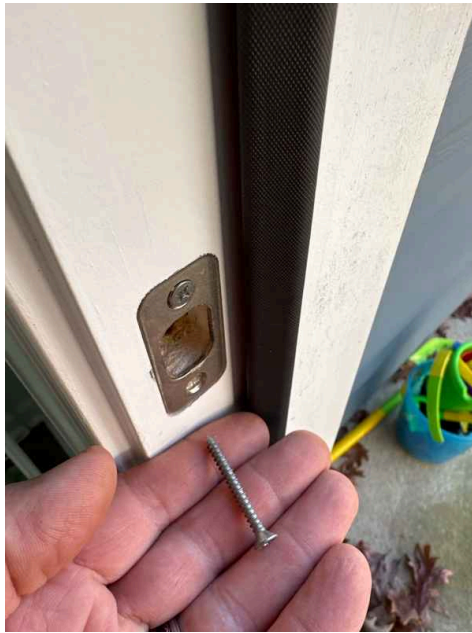
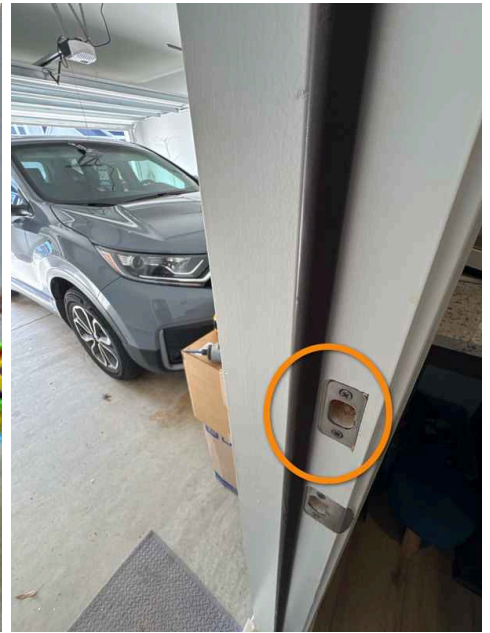
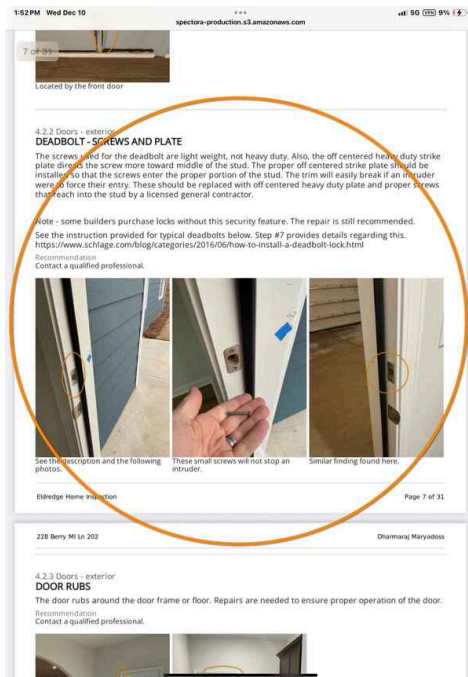
4.2.1 Doors - exterior

The screws used for the deadbolt are light weight, not heavy duty. Also, the off centered heavy duty strike plate directs the screw more toward middle of the stud. The proper off centered strike plate should be installed so that the screws enter the proper portion of the stud. The trim will easily break if an intruder were to force their entry. These should be replaced with off centered heavy duty plate and proper screws that reach into the stud by a licensed general contractor.

These light duty screws are half the length and half the diameter of the proper screws.

Similar findings were found here.

This finding was described in a previous report. Repairs have not been made.

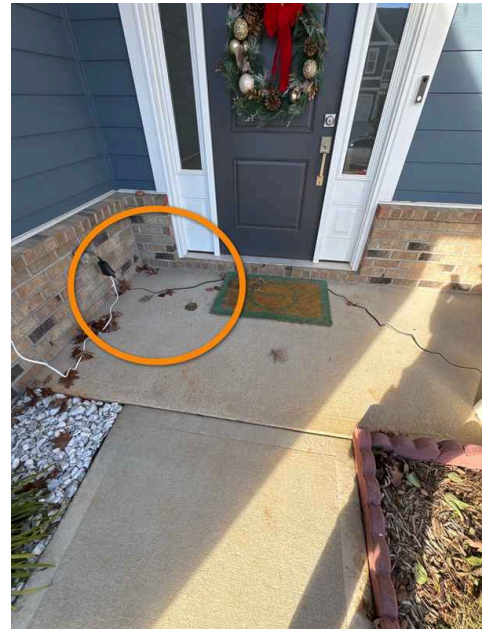
4.3.1 Driveways, Walkways, & Patios

The concrete pad has been improperly graded, resulting in the slope directing water runoff toward the structure instead of away from it, which may lead to potential drainage and structural issues. A licensed general contractor should be consulted to evaluate this area and make repairs.

See description for this finding. Water collects in the circled area when wind driven rain hits the porch.

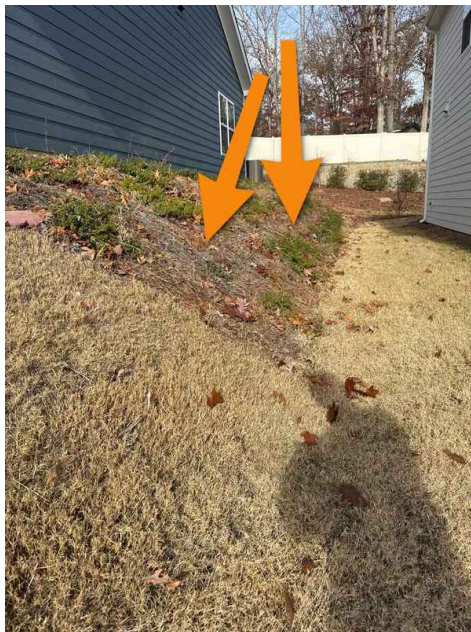
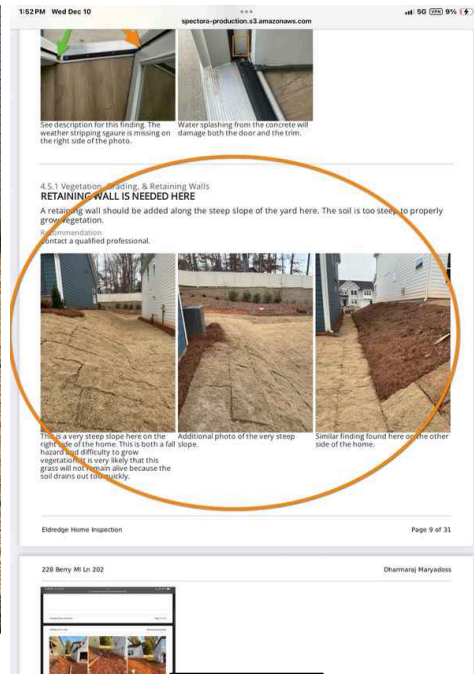
4.5.1 Vegetation, Grading, & Retaining Walls

See description for this finding, the steep slope is a fall hazard.

This finding was described in a previous report. Repairs have not been made.

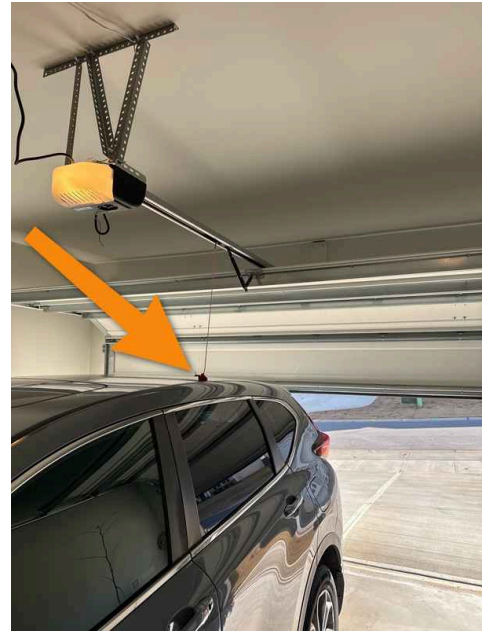
DOOR LUBE, ADJUSTMENT, AND POSSIBLE REPAIR

The garage door tracks for the door and for the motor need lubrication and/or repair. The door is loud when raised and lowered. A garage door contractor should be consulted for the repair of the door.

The door falls downward/closed when the emergency release is pulled. The spring you should assist the door more and also keep the door in the open position. This will enable a person to pull the car out in the event of an emergency.

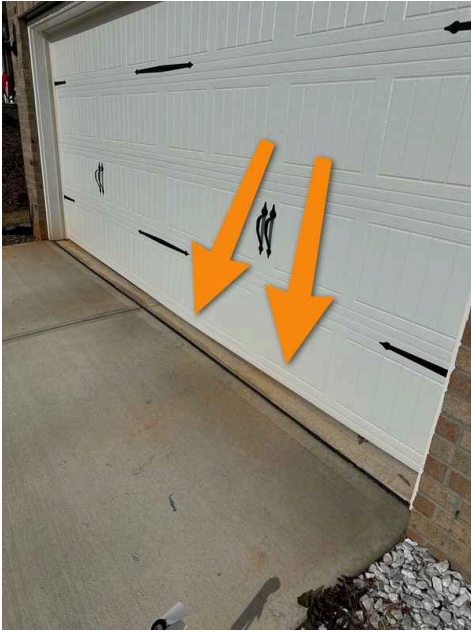
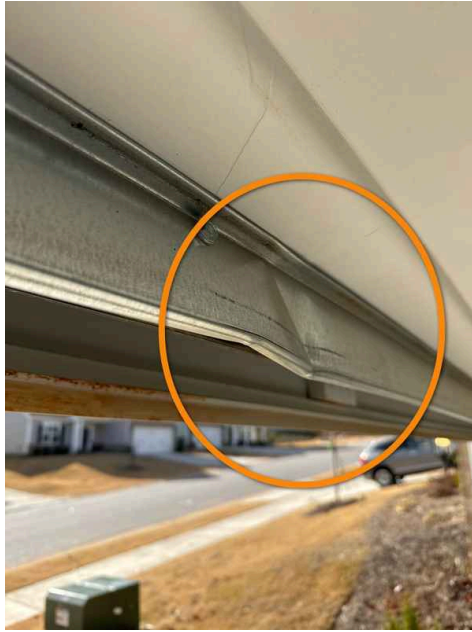
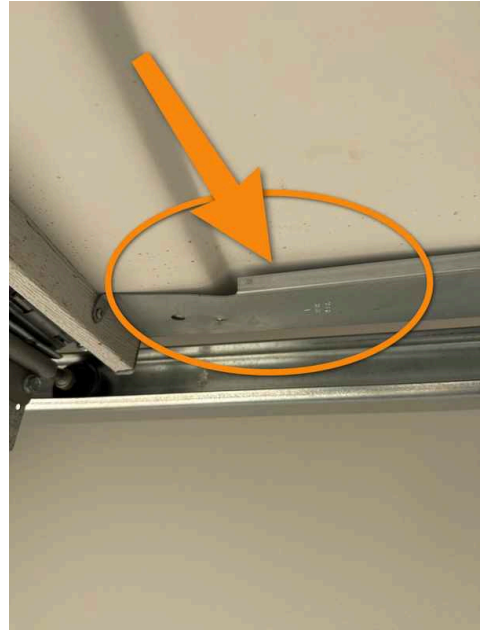
6.2.2 Garage Door & Opener

DOOR PANEL IS DAMAGED

The garage door needs adjustment and repair. The panel is bent/damaged. A garage door installation company or a licensed general contractor should be consulted for evaluation and repair to ensure that the door operates safely and properly.

Note: even a slightly damaged door can develop metal fatigue over time and result in failure of the garage door.

See description for this finding, the panel curves out here.

Additional photo of this finding found on the first panel from the bottom.

Additional photo of this finding found on the second panel from the bottom.

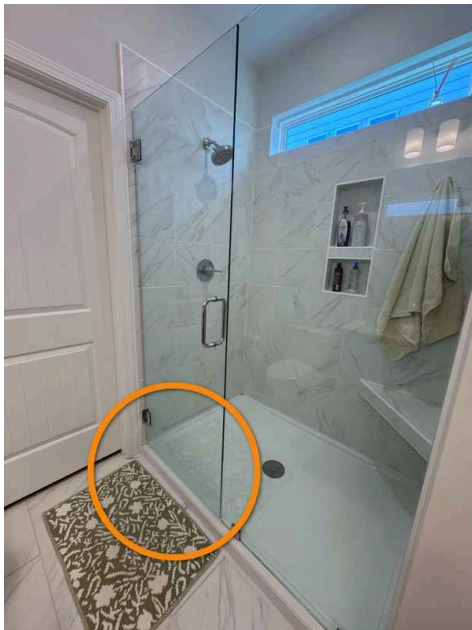
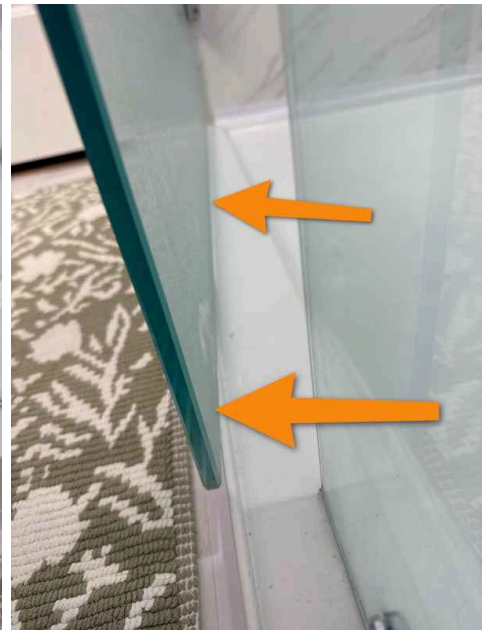
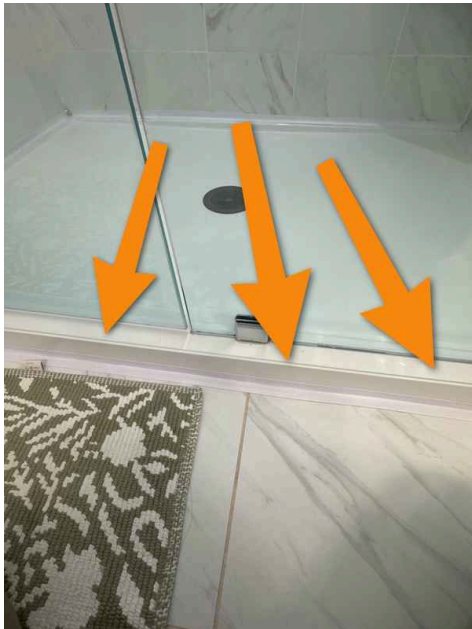
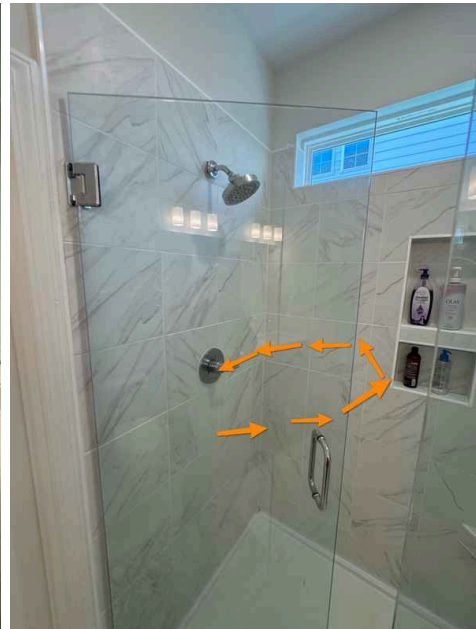
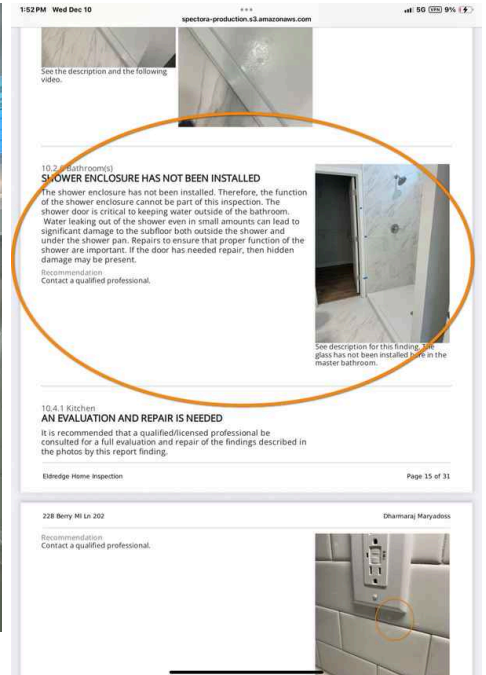
Evidence shows that the enclosure is not functioning properly. The shower door is critical to keeping water outside of the bathroom. If water begins leaking out of the shower even in small amounts, this can lead to significant damage to the subfloor both outside the shower and under the shower pan/tub. Repairs to ensure that proper function of the shower are important.

See description and following photos regarding the shower in the master.

The door is hinged to swing both ways which means the door should swing in both directions. The door cannot swing out because the door hits the threshold.

Also the plastic diverter that directs water in toward the shower pan is missing. See following photos.

This means that excessive amount of water spill out just outside the shower here.

This also means you have to reach around the door in order to turn on the shower. The original building specs/plans should be followed.

Please note that the shower enclosure was not installed during the first inspection.

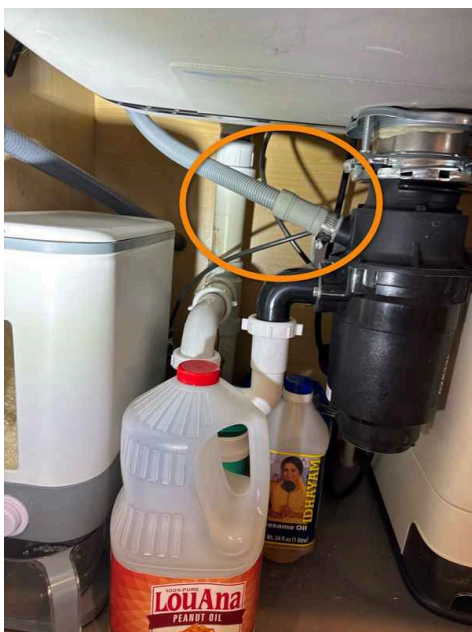
10.3.1 Kitchen

The plumbing lines for sink rattle when the water is turned on and off. The skin cause leaks.

It is recommended that a qualified/licensed professional be consulted for a full evaluation and repair of the findings described in the photos by this report finding.

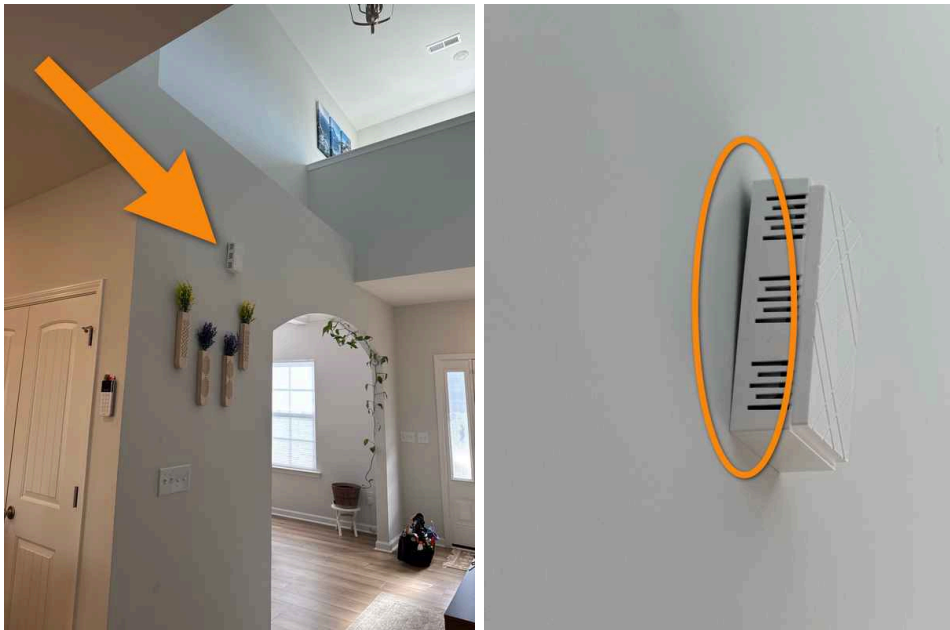
10.5.1 Living areas

Additional photo of this finding showing that the doorbell is pulling off of the wall.

It is recommended that a qualified/licensed professional be consulted for a full evaluation and repair of the findings described in the photos by this report finding.

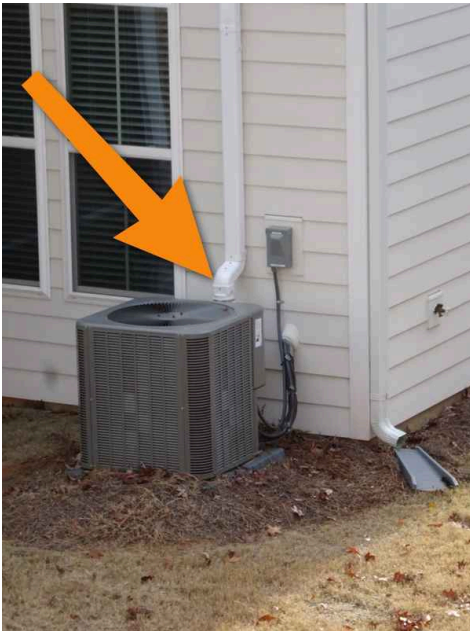
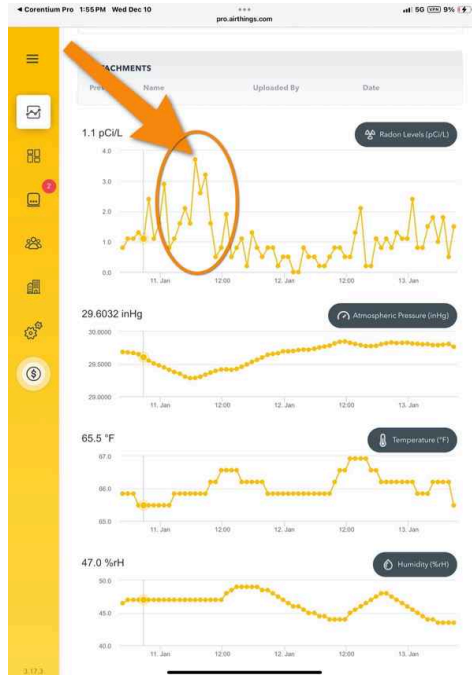
RADON TEST IS RECOMMENDED

A nearby home was noted to have a radon mitigation system installed. For this reason, it is recommended that a radon test be conducted for this home. Radon gas is odorless and colorless. This gas is the second leading cause of lung cancer so it is always recommended to be tested.

Additional photo of this finding the spike in Radon levels. Periodic testing is recommended.

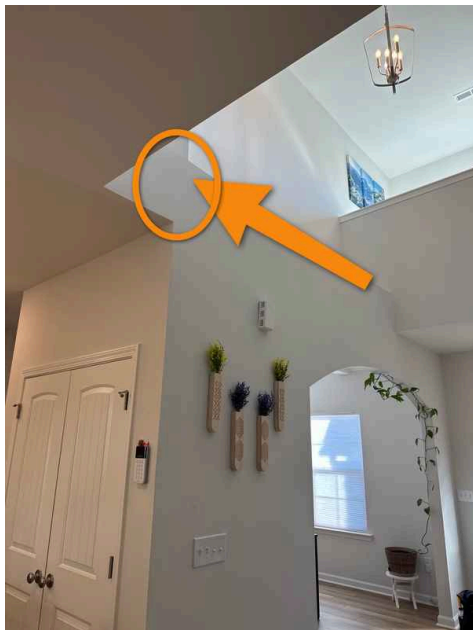
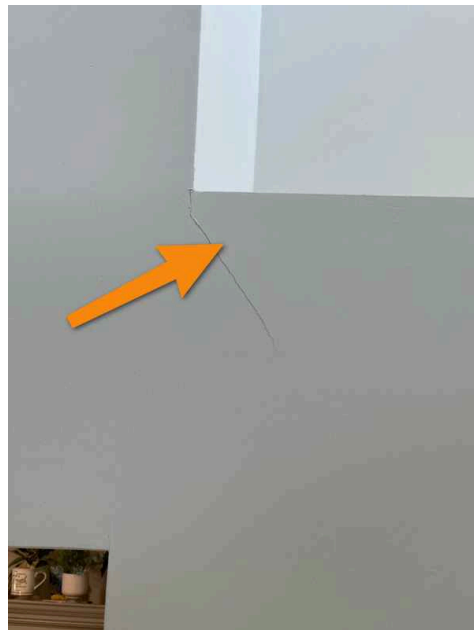
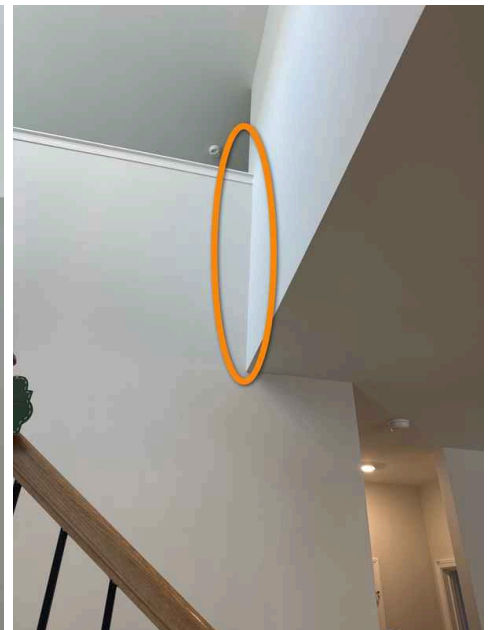
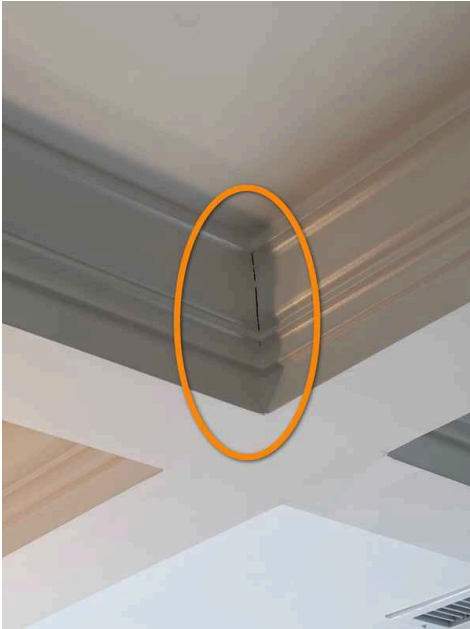
CRACKS AND GAPS WERE FOUND IN THE HOME (NEWER HOME)

Cracks in the walls and trim are common in a new or an 11 month old home. These cracks should be repaired. Cracks can often be caused by loose trim. More nails may need to be added along with caulking and painting. It is recommended that the homeowner go through the home marking all areas with blue tape to assist the painters in finding these areas for repair.

Similar findings were found here.

Similar findings were found here. All areas of the home should be assessed for the same finding.

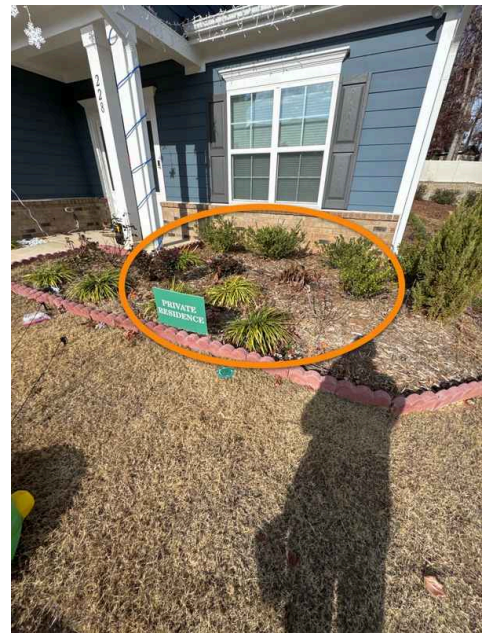
CLEAN OUT NOT FOUND

The service cleanout for the main waste line was not located. It is important to know the location of the cleanout so that the drain line can be evaluated. It is recommended a qualified professional locate the cleanout for proper system assessment.

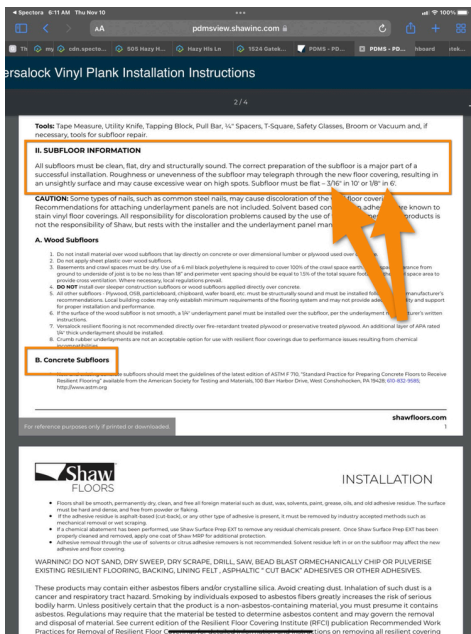
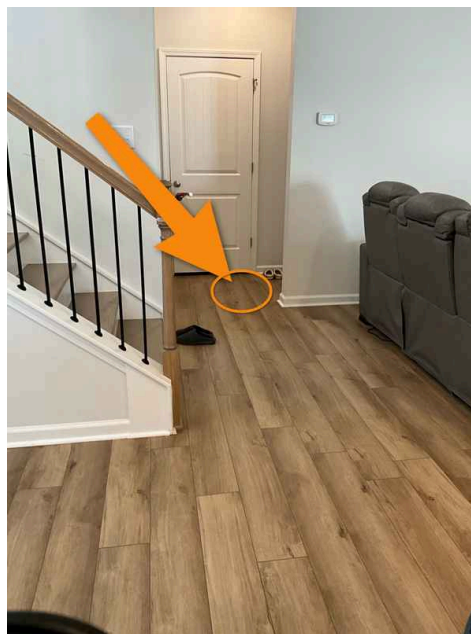
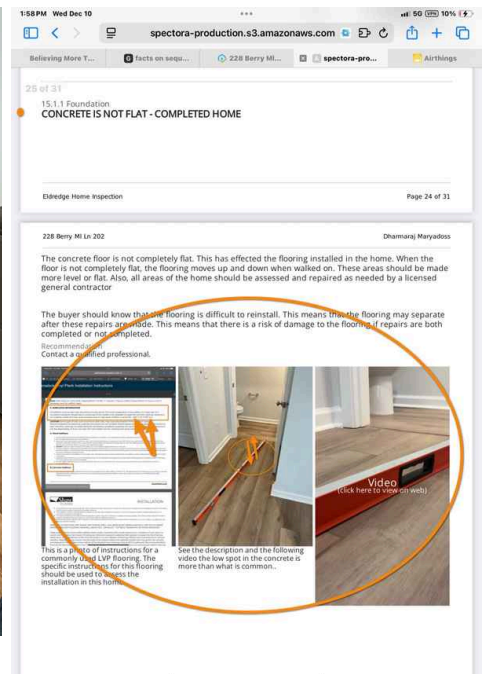
15.1.1 Foundation

The concrete floor is not completely flat. This has effected the flooring installed in the home. When the floor is not completely flat, the flooring moves up and down when walked on. These areas should be made more level or flat. Also, all areas of the home should be assessed and repaired as needed by a licensed general contractor

The buyer should know that the flooring is difficult to reinstall. This means that the flooring may separate after these repairs are made. This means that there is a risk of damage to the flooring if repairs are both completed or not completed.

This finding was described in a previous report. Repairs have not been made near the bedroom.

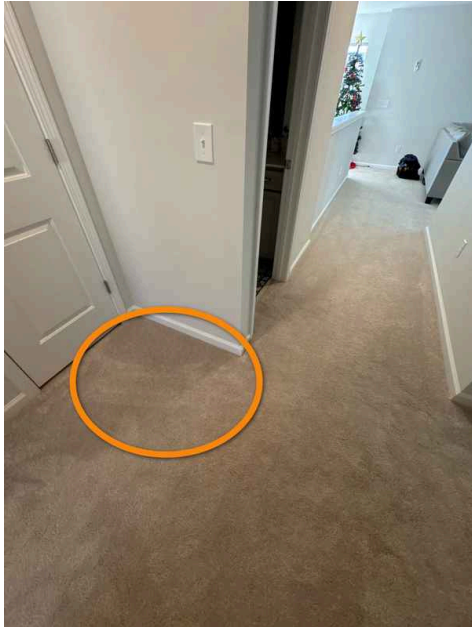
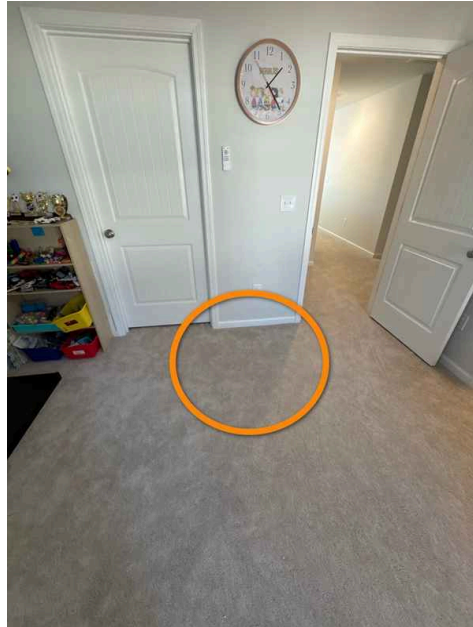
15.3.1 Floor Structure

There is a creak in the floor. The sheathing that attaches to the floor joist is not tight enough. A licensed general contractor should be consulted for the repair to the floor.

See description for this finding just outside the hallway bathroom on the second floor.

Also, an intermittent creaking sound was noted here.

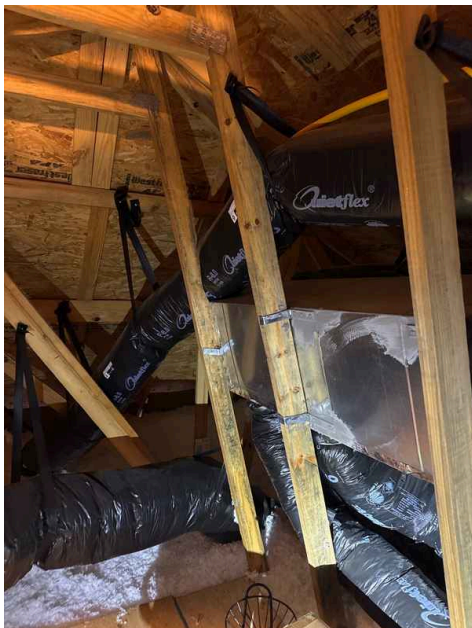
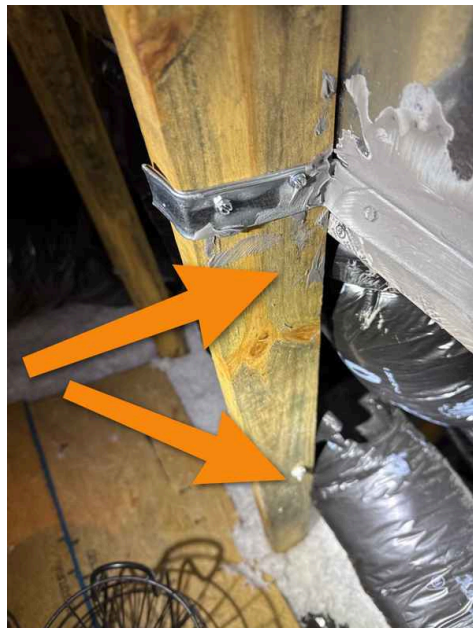
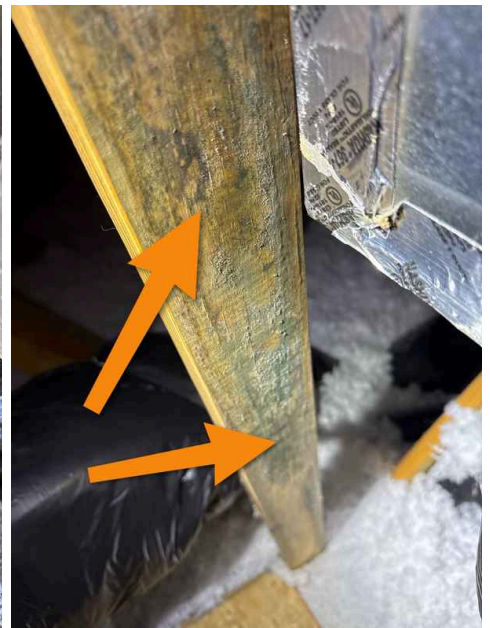
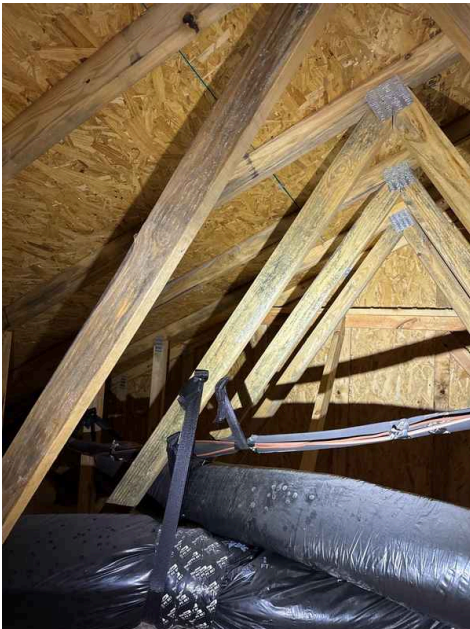
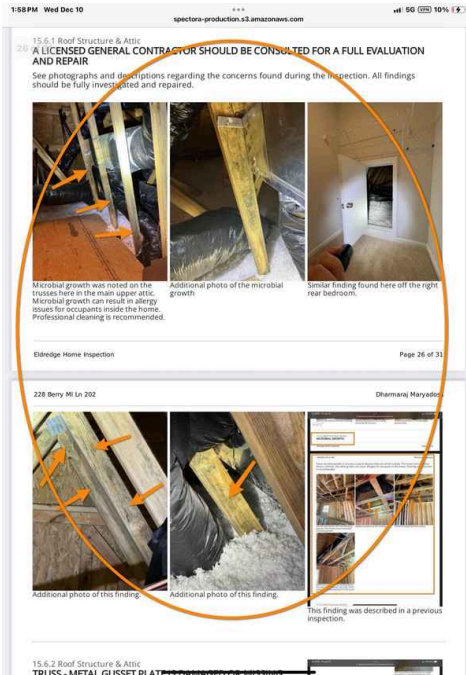
MICROBIAL GROWTH IS PRESENT IN HIGHER LEVELS THAN WHAT IS COMMON

The wood structure has evidence of high levels of moisture which is microbial growth. It is recommended that the attic structure be professionally cleaned by a mold removal specialist.

Microbial growth was also found in the small attic space off the right rear bedroom.

This finding was described in a previous report. Repairs have not been made.

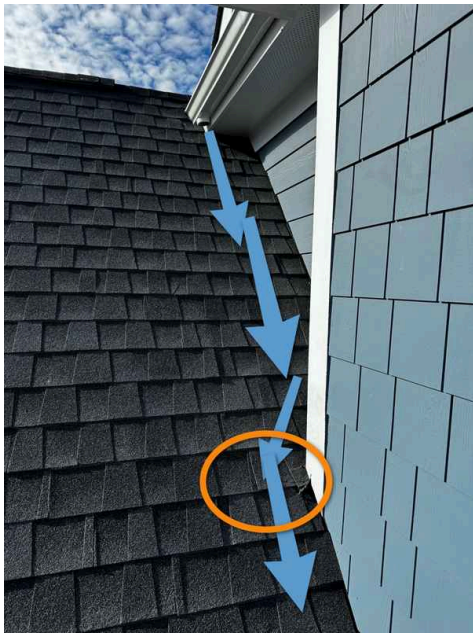
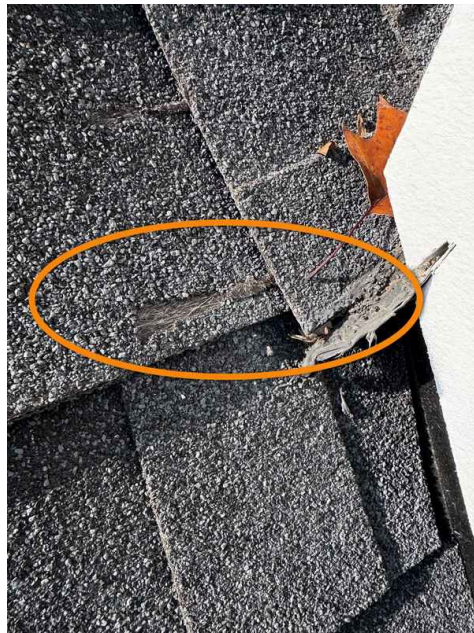
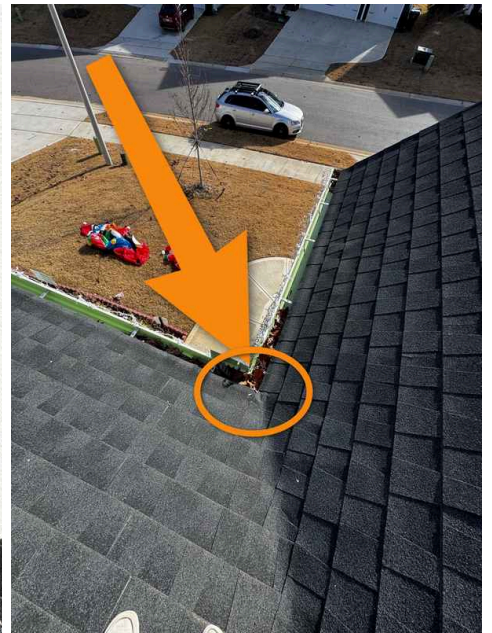
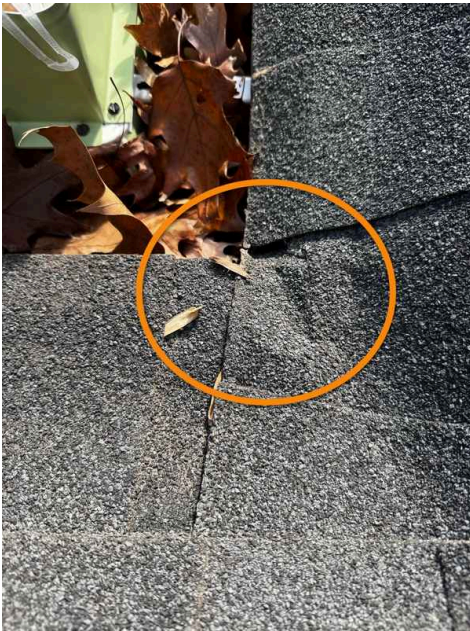
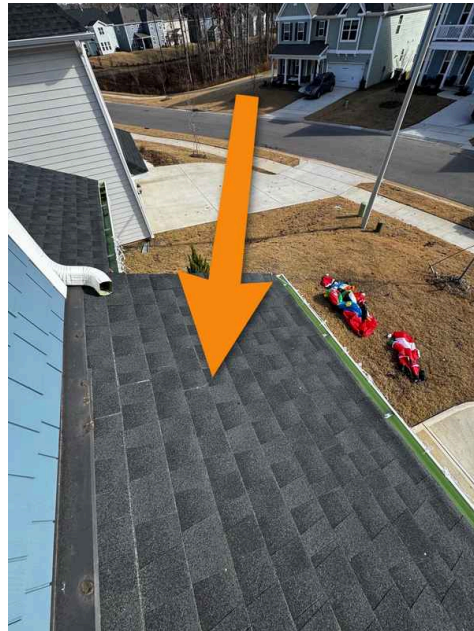
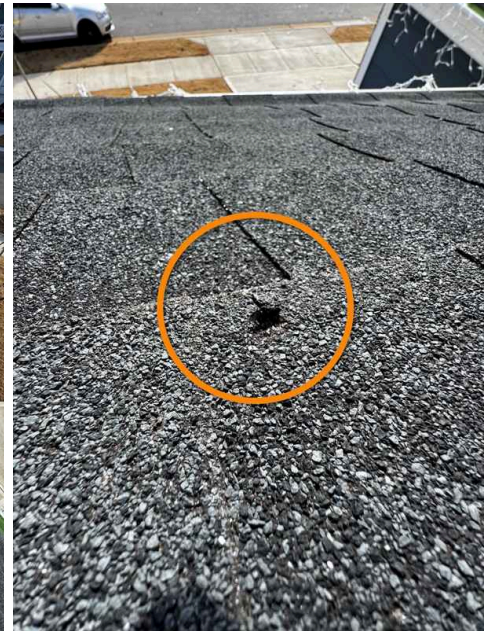
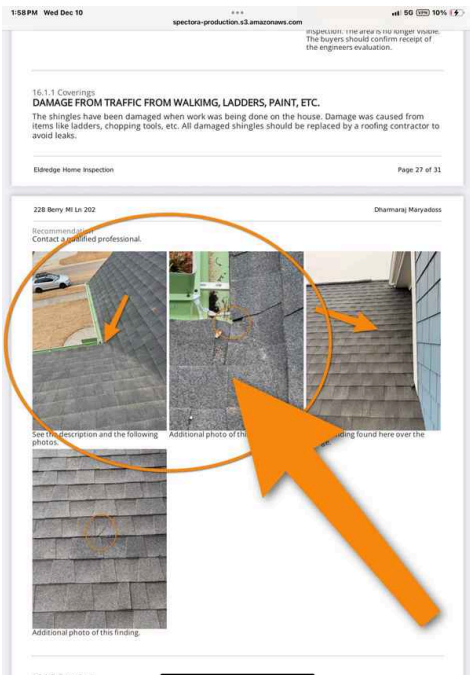
DAMAGE FROM TRAFFIC FROM WALKING, LADDERS, PAINT, ETC.

The shingles have been damaged when work was being done on the house. Damage was caused from items like ladders, chopping tools, etc. All damaged shingles should be replaced by a roofing contractor to avoid leaks.

See description and following photos regarding the circled area. A larger amount of water flows past here.

This shingle is completely damaged. Replacement is needed.

Additional photo of this finding showing that the shingle is creased and damaged.

Additional photo showing that a raised nail has punctured the shingle.

This finding was described in a previous report. Repairs have not been made.

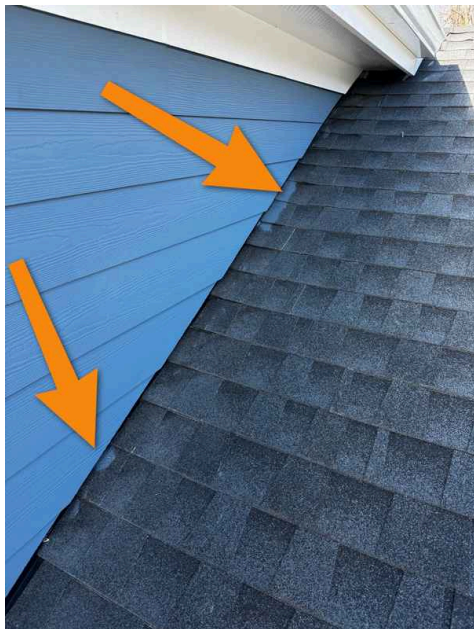
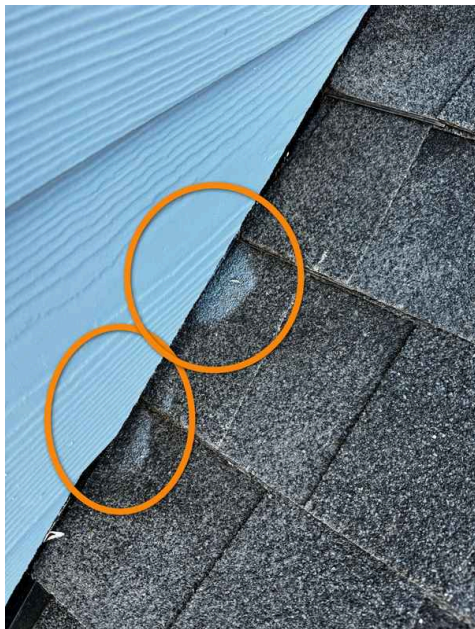
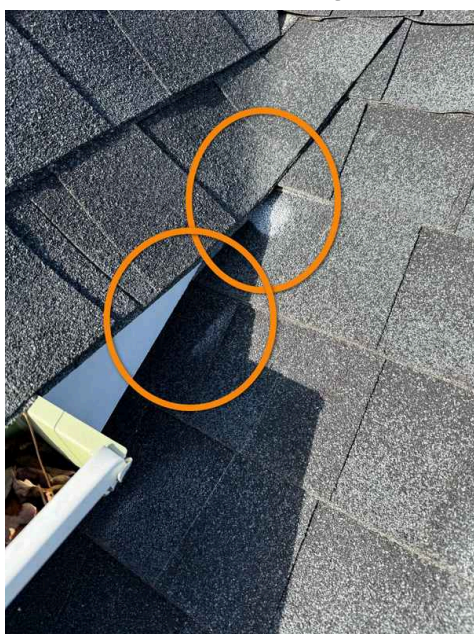
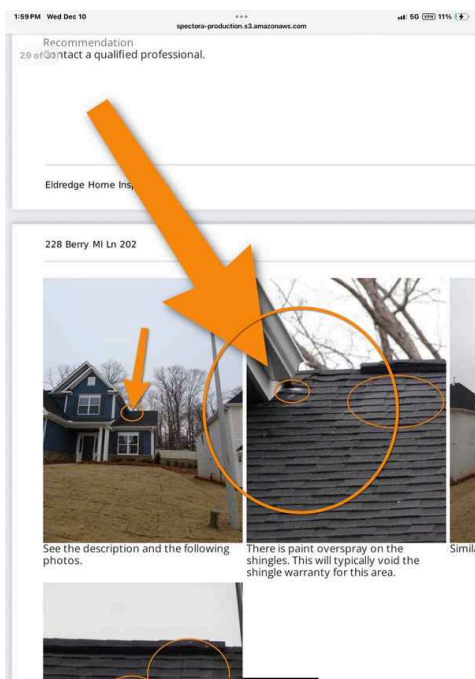
16.1.2 Coverings

See description and following photos. Paint was found on the shingles.

This finding was described in a previous report. Repairs have not been made in this area.

A roofing contractor should be consulted for a complete evaluation of the roof covering and flashings system to make necessary repairs to ensure the weathertightness of the roof covering system.

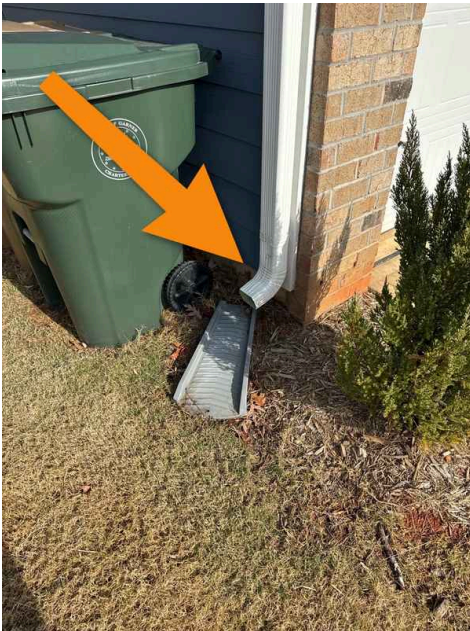
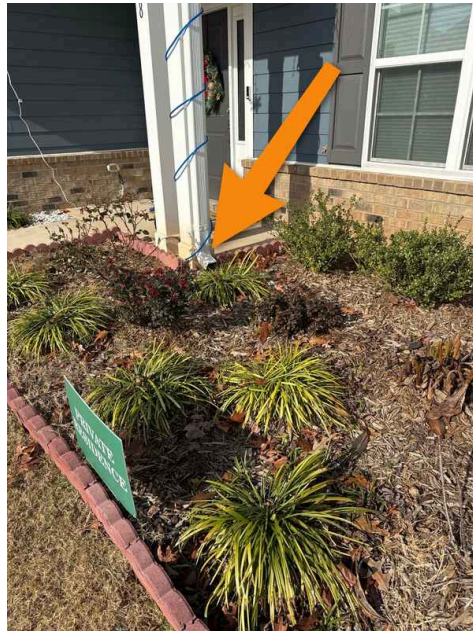
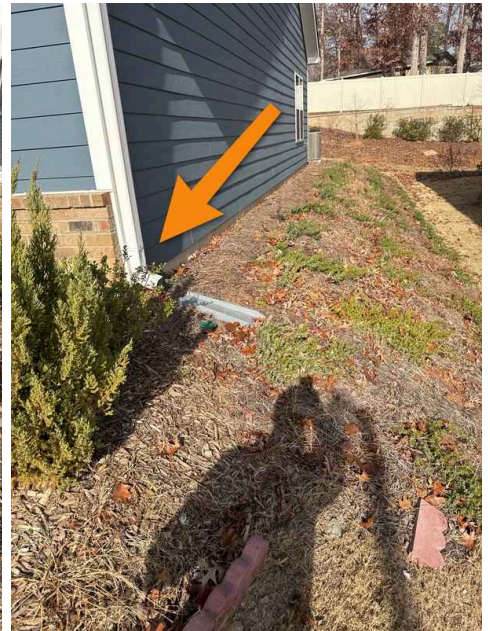
16.2.1 Roof Drainage Systems

The gutter downspouts are not all effectively extended or piped away from the foundation. Direct drainage from the gutter system can result in direct water penetration into the foundation.

This downspout is causing erosion to the hill because there is no retaining wall.

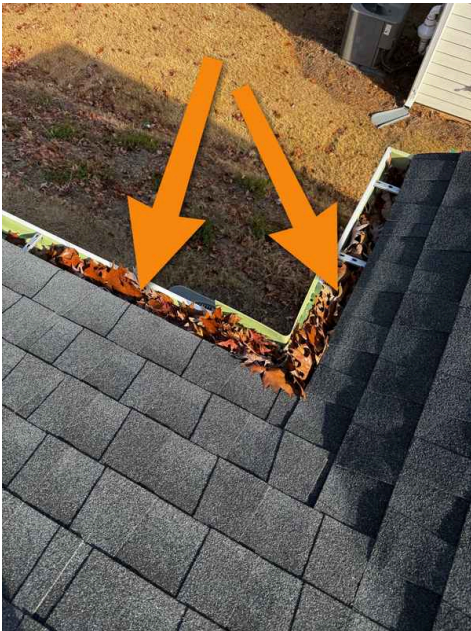
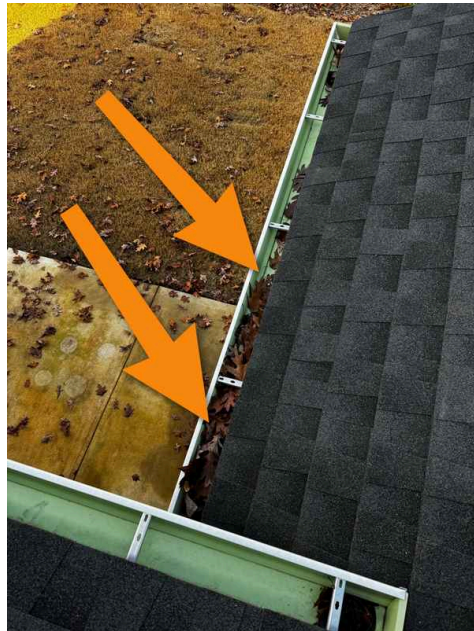
The gutters are full of debris and need to be cleaned. The gutters play an important role in keeping the foundation dry. A licensed general contractor should be consulted to clean the gutters and to make any necessary repairs.

All areas of the home should be assessed for the same finding.
