ELDREDGE HOME INSPECTION

FULL HOME TEMP - NON IRB

1234 Main Street
Cary, NC 27513

01/24/2026 9:00AM

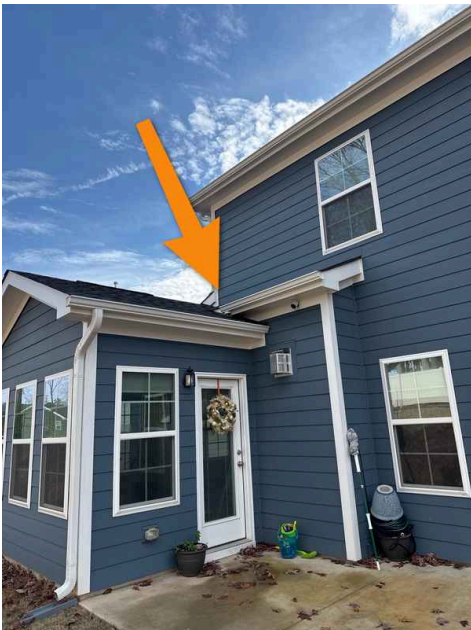
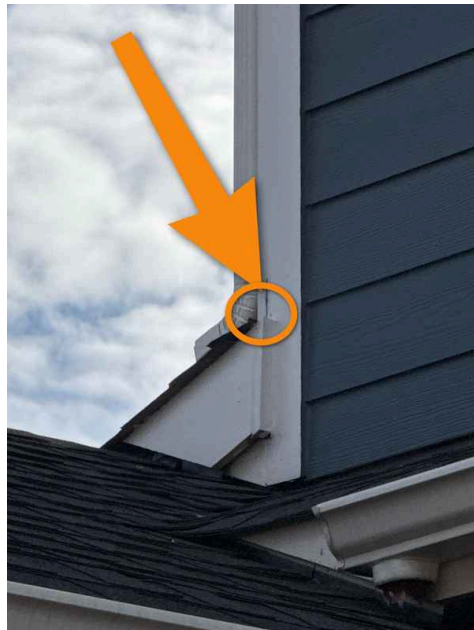
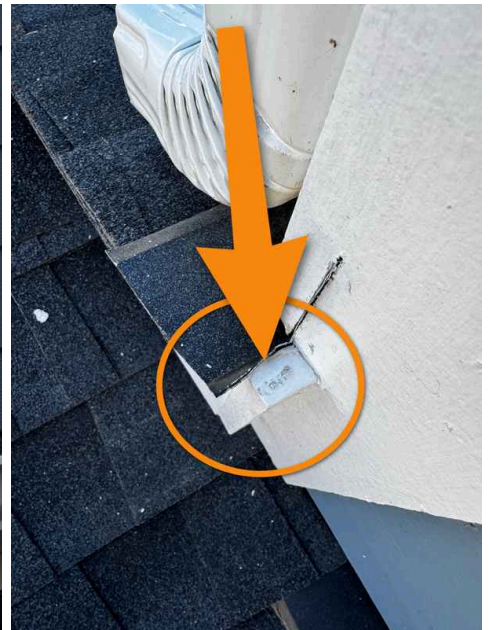
FLASHING BENT / LOOSE / MISSING

The flashing is loose/bent/missing up which will or has caused leaks within the roof. A roofing contractor should be consulted for a complete evaluation of the flashings system to make necessary repairs to ensure the weathertightness of the roof covering system.
