ELDREDGE HOME INSPECTION

(919) 830-3588

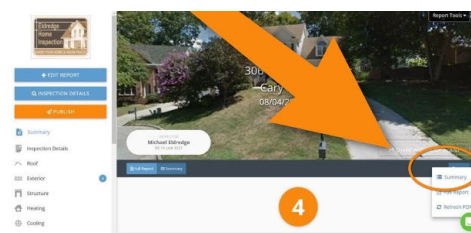
Click on the PDF summary for the best way to view the report

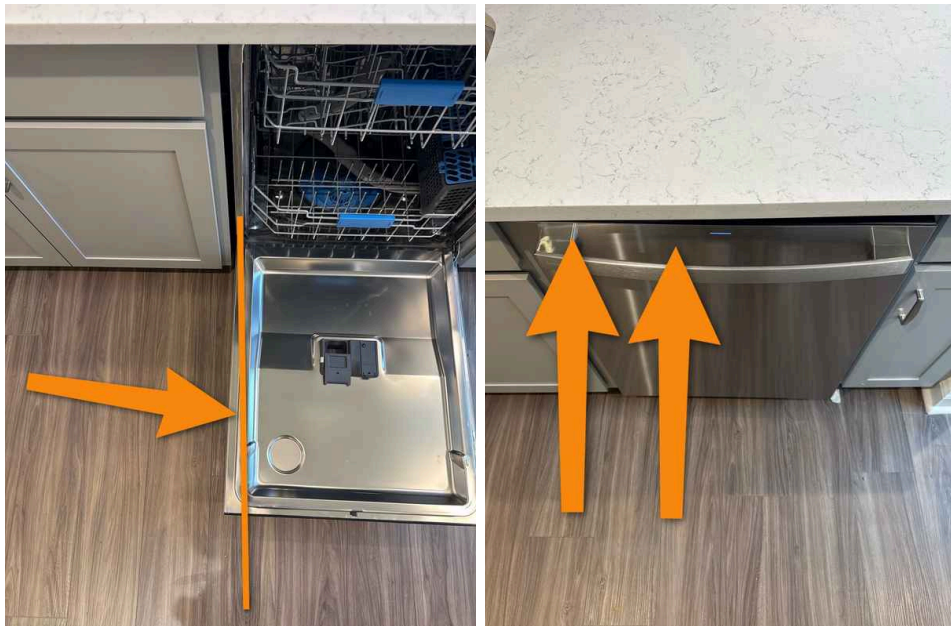
See description and following photos.

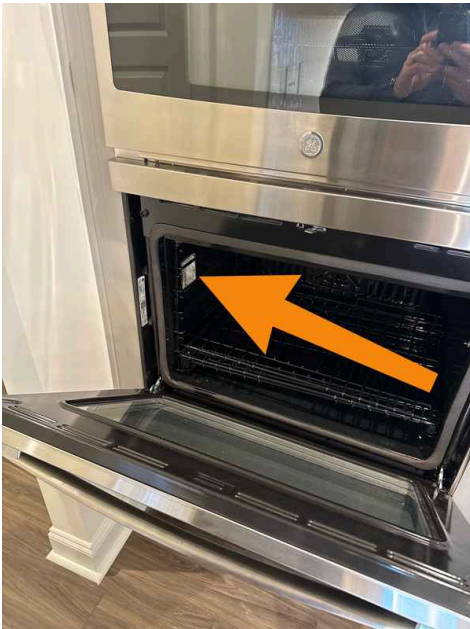
See description for this finding regarding the light.

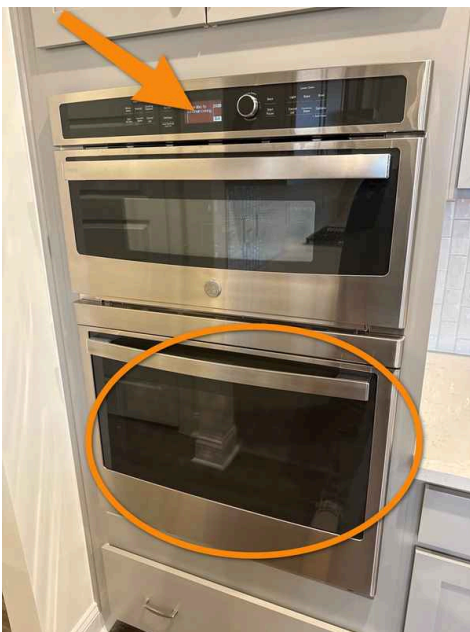
See description and following photos.

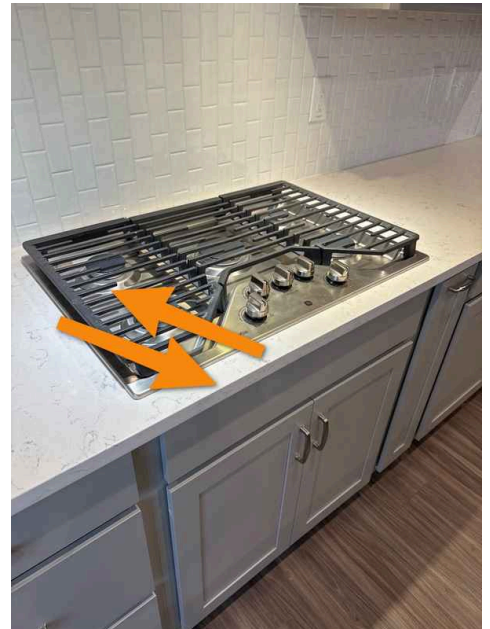
See description for this finding.

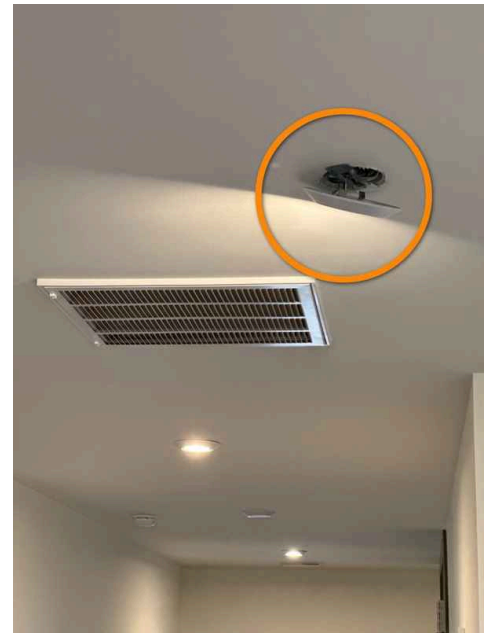
See description for this finding located in the living room.

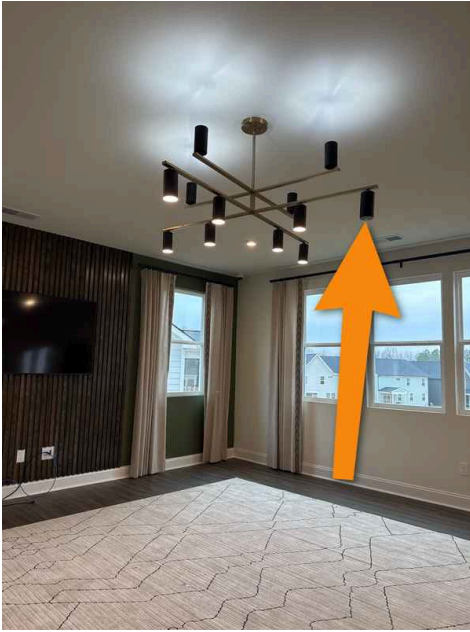
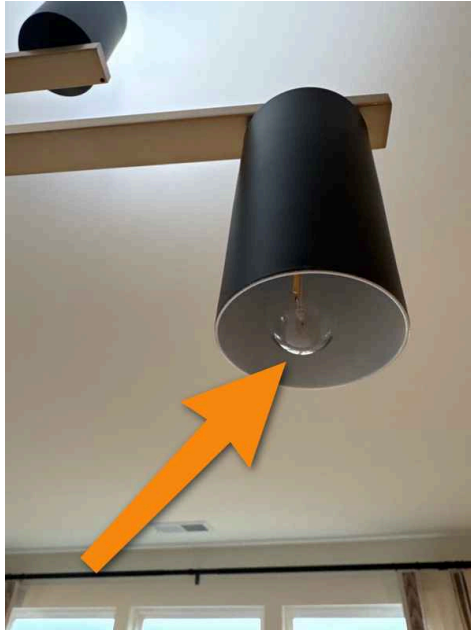
See description and following photos.

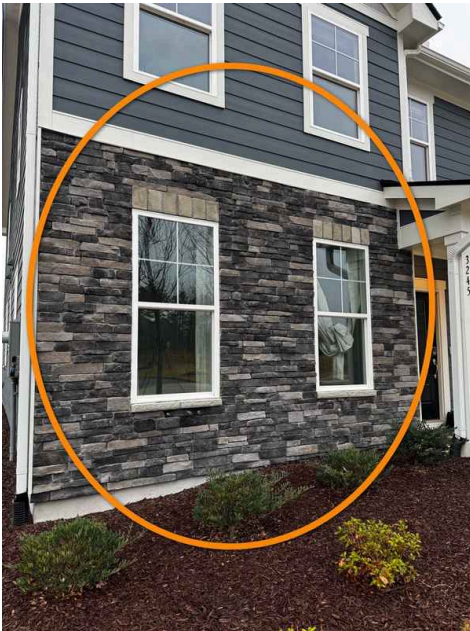
See description and following photos.

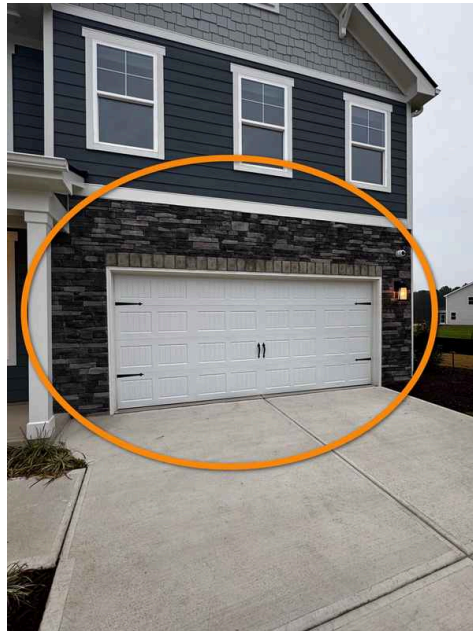
Similar findings were found here.

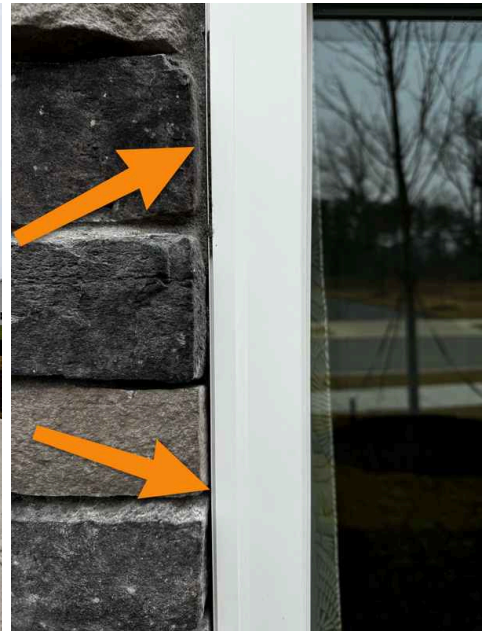
There is no transition strip between materials.

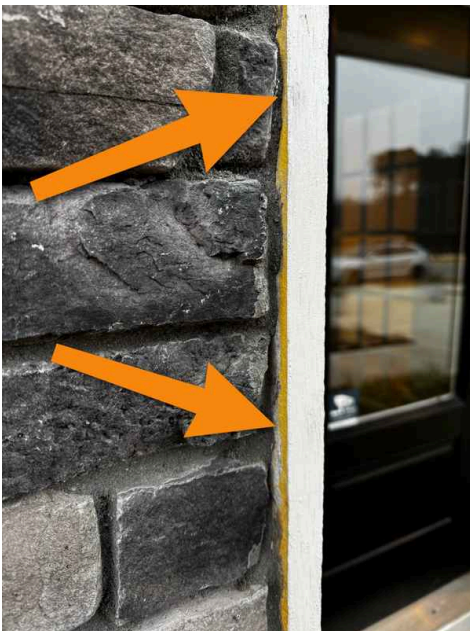
Similar findings were found here where there is no transition strip. Also, the trim is not painted which means it does not protected.

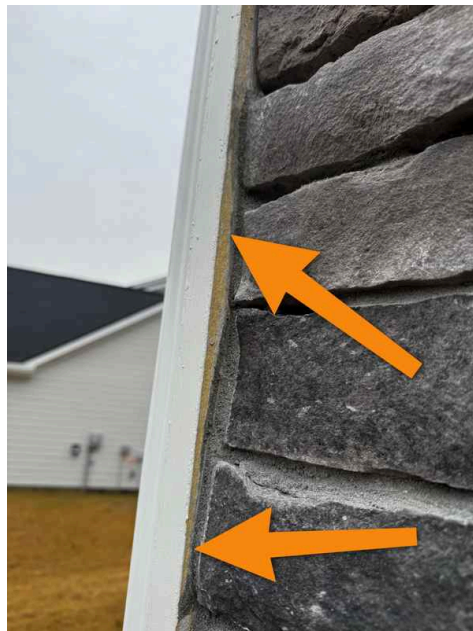
This unpainted trim is not projected by a transition strip and is not painted. This area is exposed to water each time it rains.

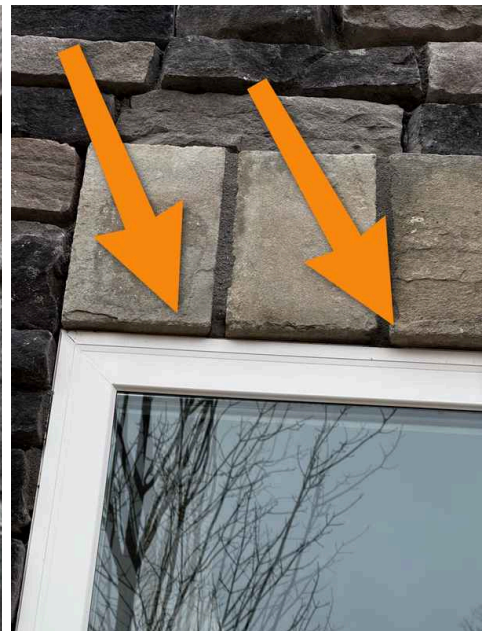
Additional photo of this finding, there is no weep system above the windows. The area above the windows and garage door are the most likely to become decayed.

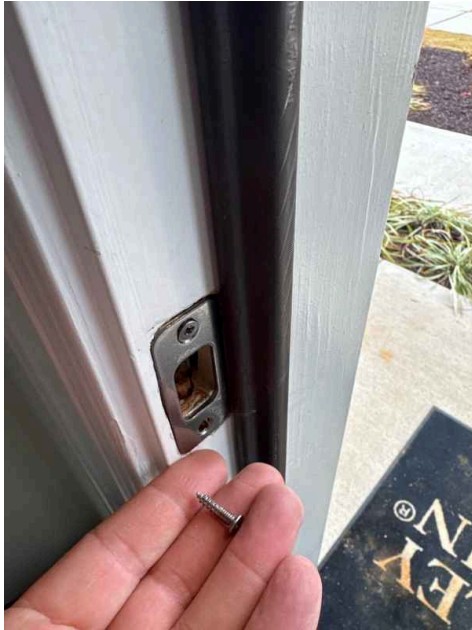
See description for this finding for the front door. These small three-quarter inch screws will not stop an intruder.

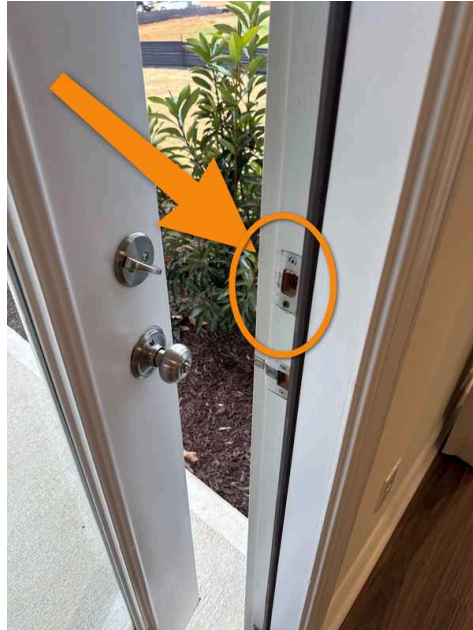
Similar findings were found here for the rear door.

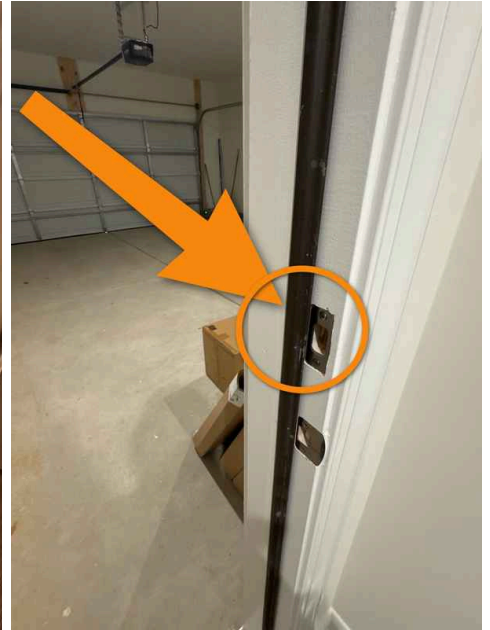
Similar findings were found here.

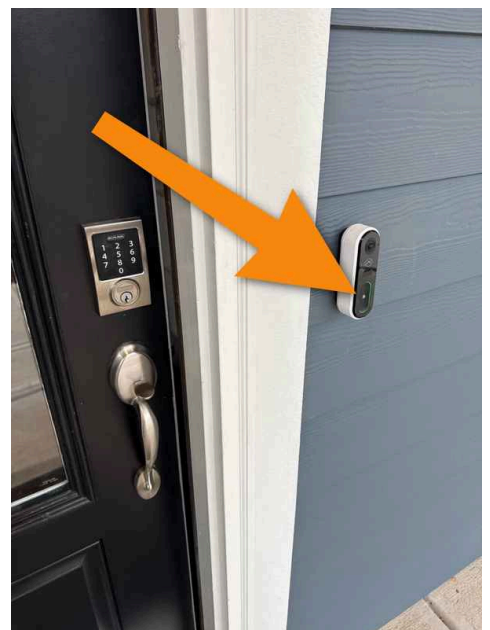
See description for this finding.

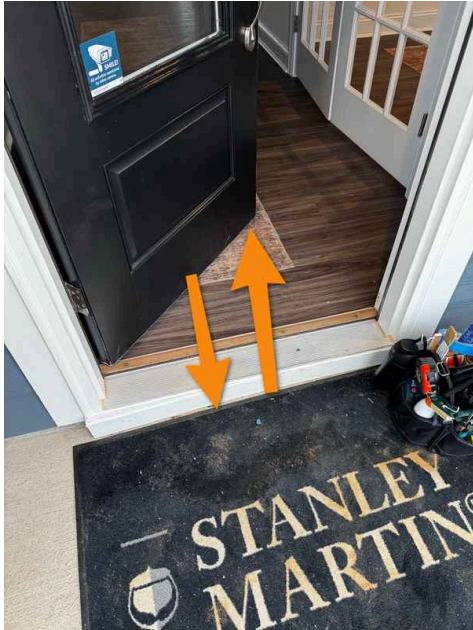
See description for this finding, the threshold makes a significant amount of noise. See following video.

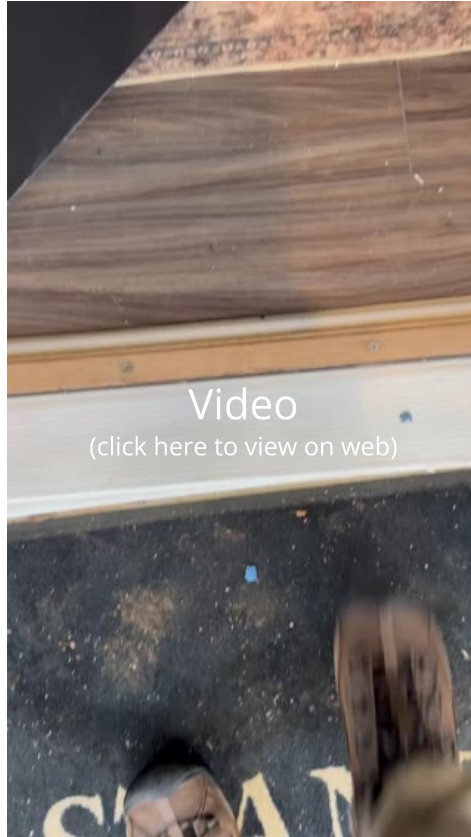
4.5.1 Vegetation, Grading, & Retaining Walls

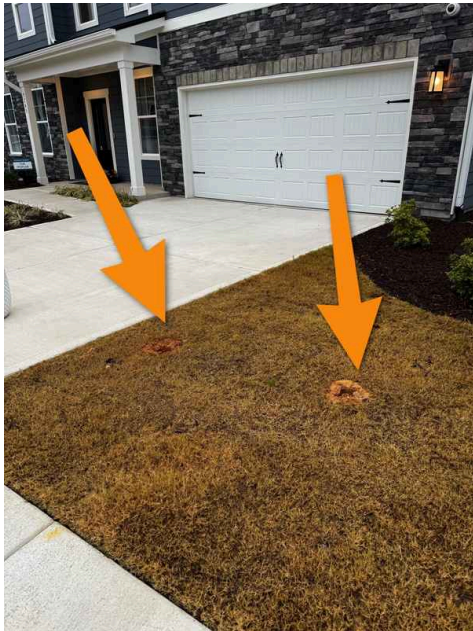
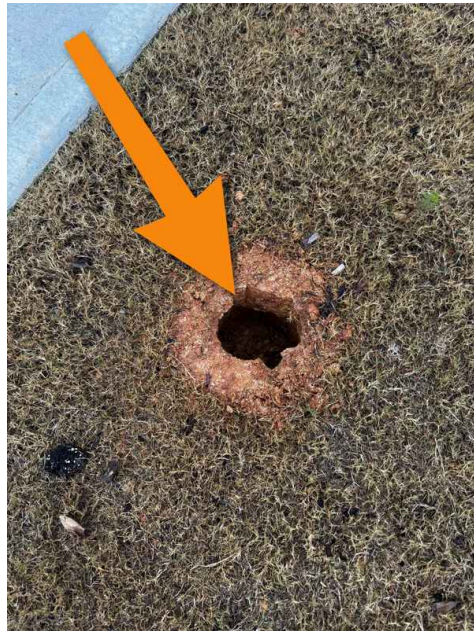
See description and following photos.

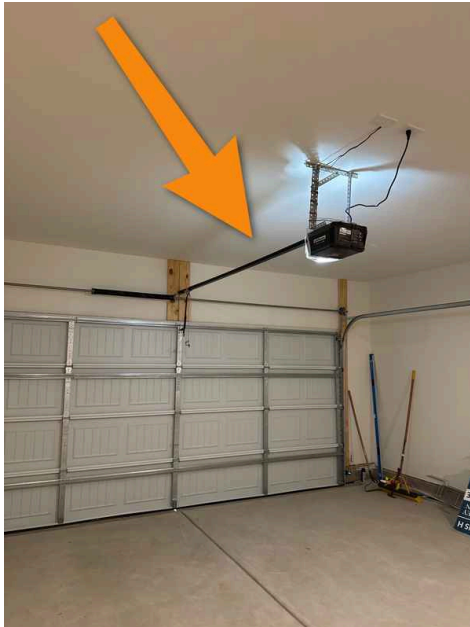
See description for this finding. The chain begins shaking when the door is lowered. See following video.

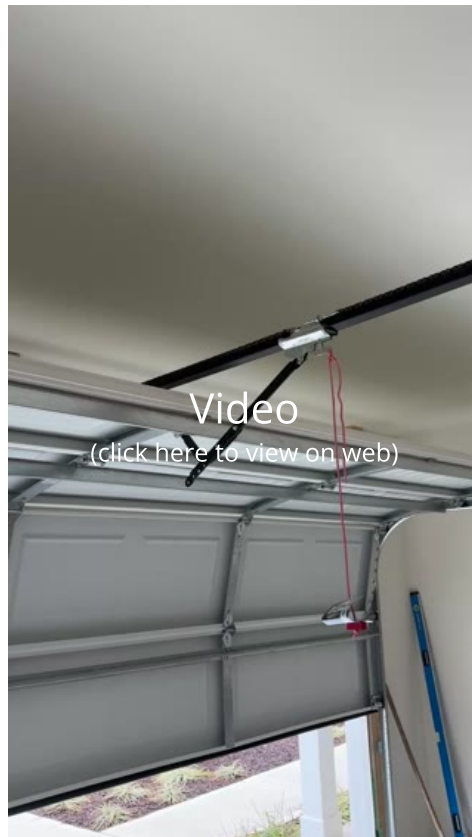
6.2.2 Garage Door & Opener

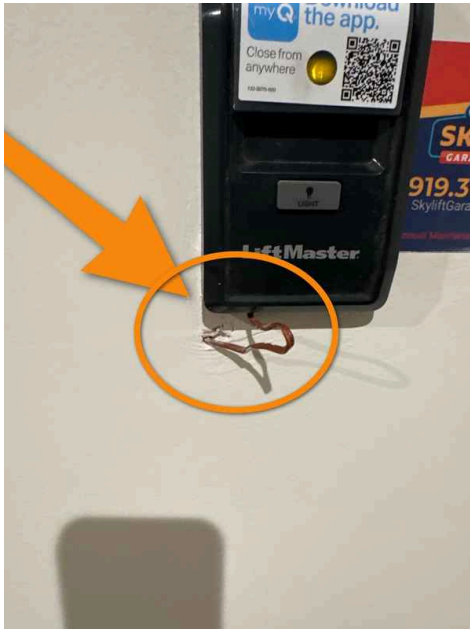
The wiring below the button is visible.

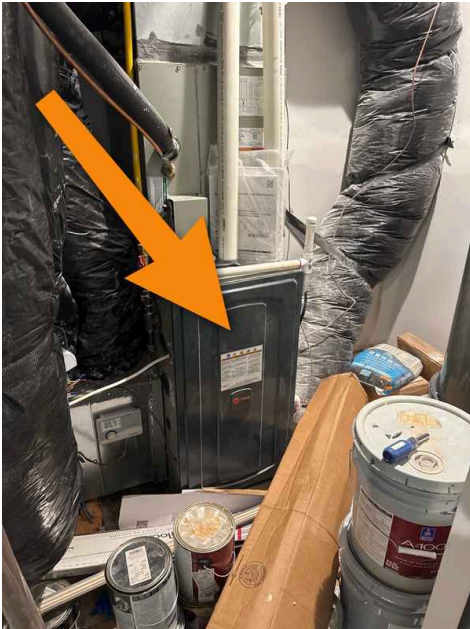
See description and following photo regarding the small gas leak here inside the furnace cabinet.

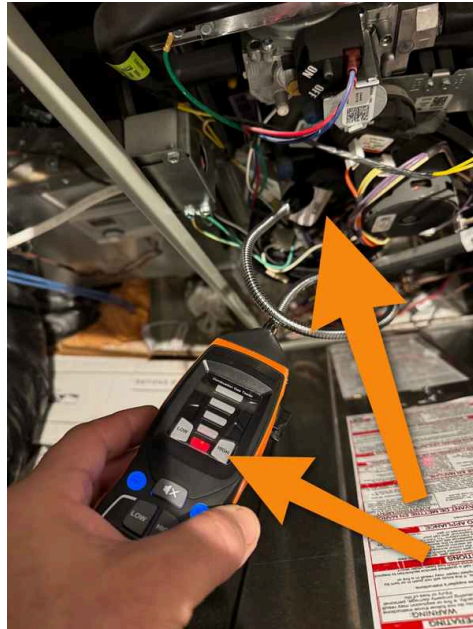
Additional photo of this finding.

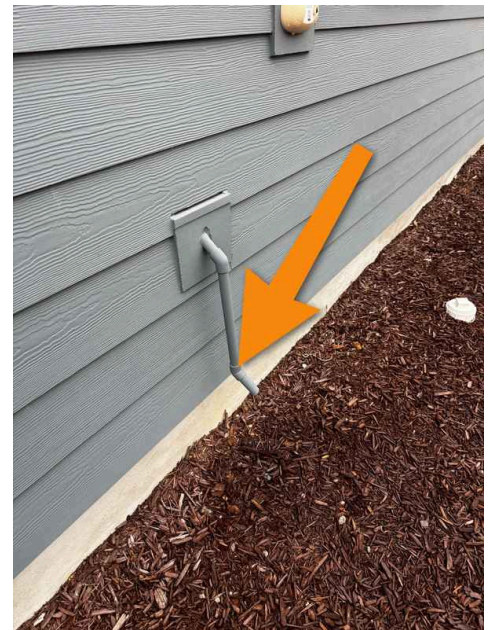
See description for this recommended upgrade.

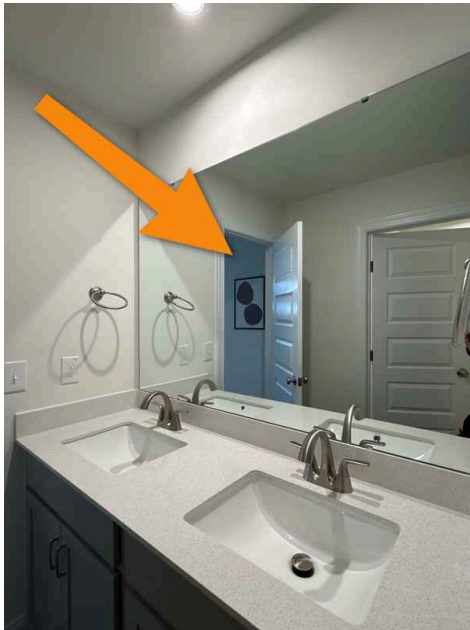
See description and following photo regarding the mirror and the jack and Jill bathroom.

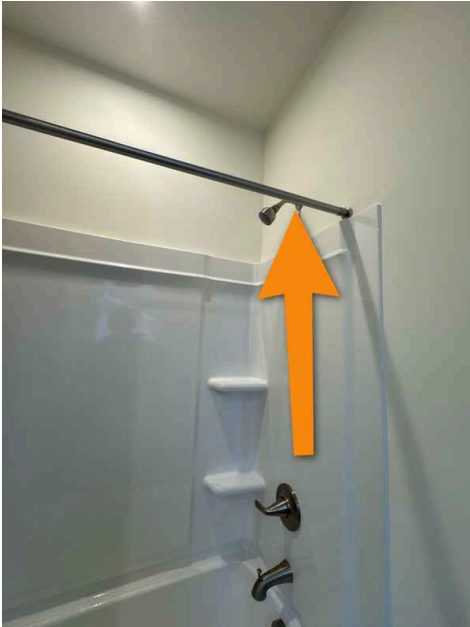
See description and following photo regarding the showerhead in the first floor bathroom.

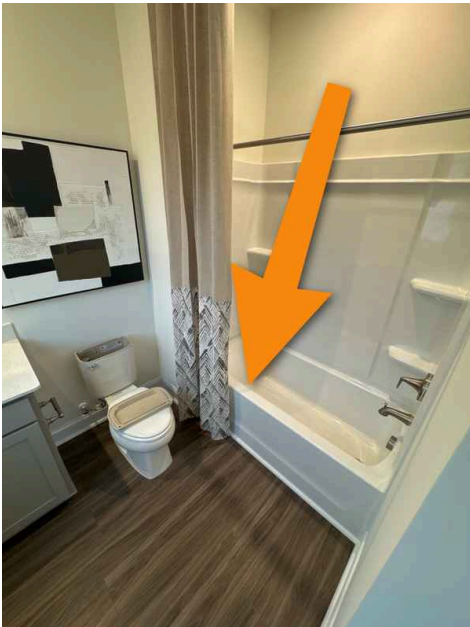
See description and following photos regarding the tub in the first floor full bath.

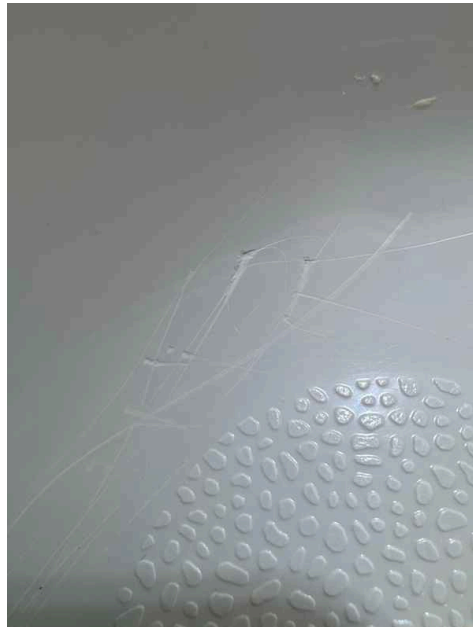
The damage in the tub is significant and could cause a tub to crack at a later time. Manufacturer evaluation is needed. This defect described in this section of the report is likely to void the manufacturer warranty. The buyer should consult with the manufacturer (not the installer) directly.

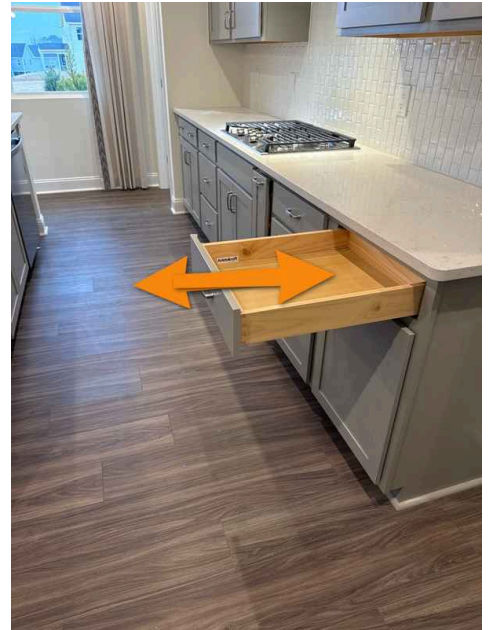
Contact a qualified professional.

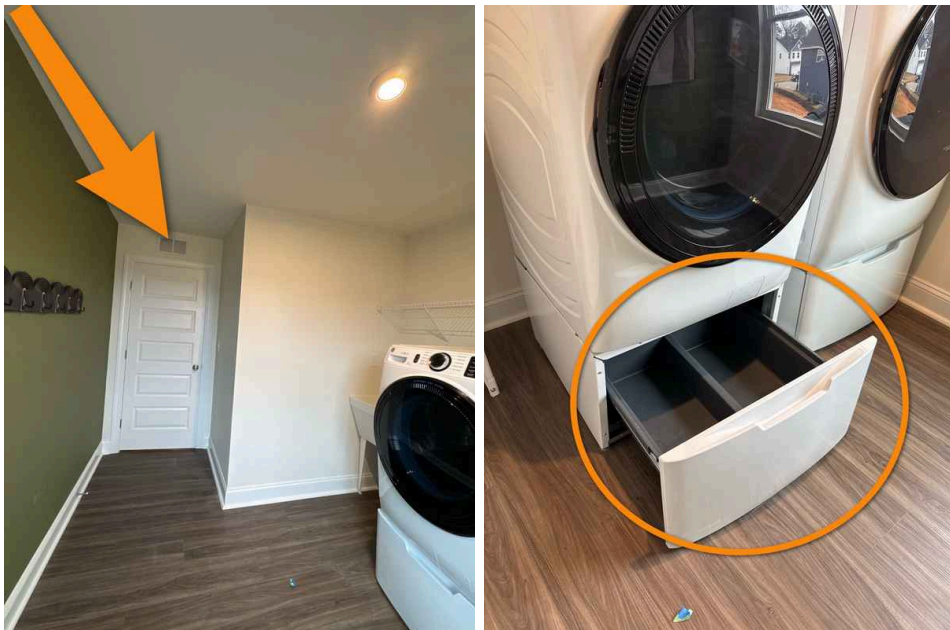
Today's modern construction requires installation of a constant vent/fresh air inlet to the laundry room. This vent is smaller than common. The original building specs/plans should be followed.

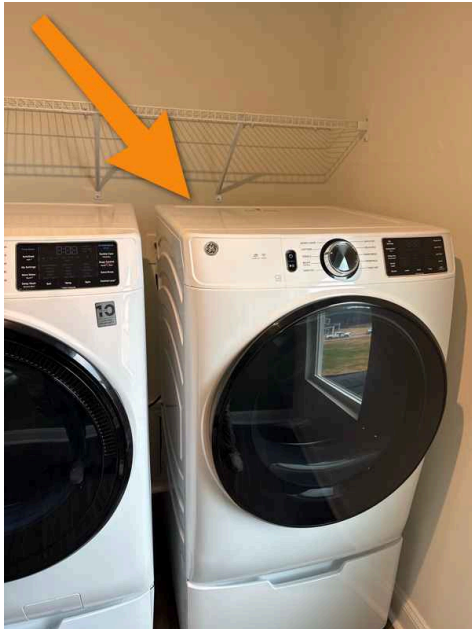
See description and following photos regarding the electrical connection for the dryer.

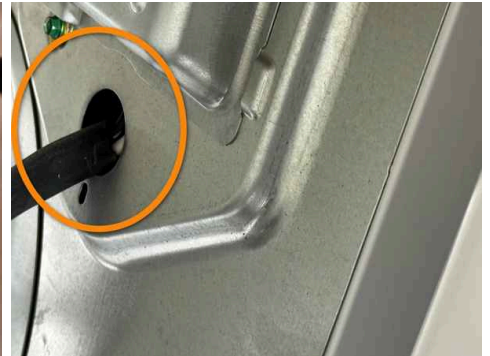
The metal sleeve that protects the wire from the sharp metal dryer cabinet is missing.

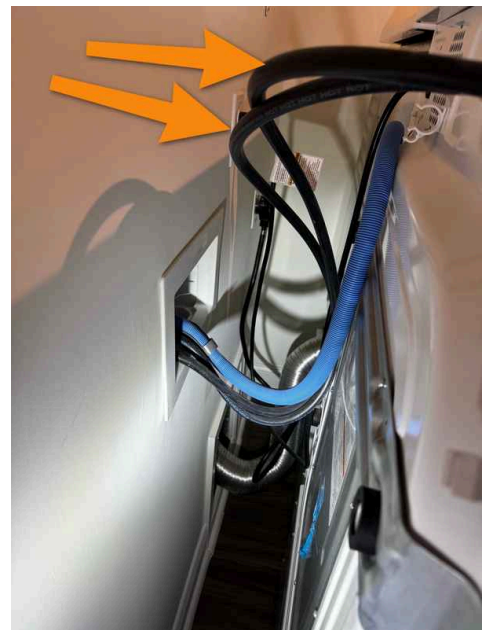
See description for this finding.

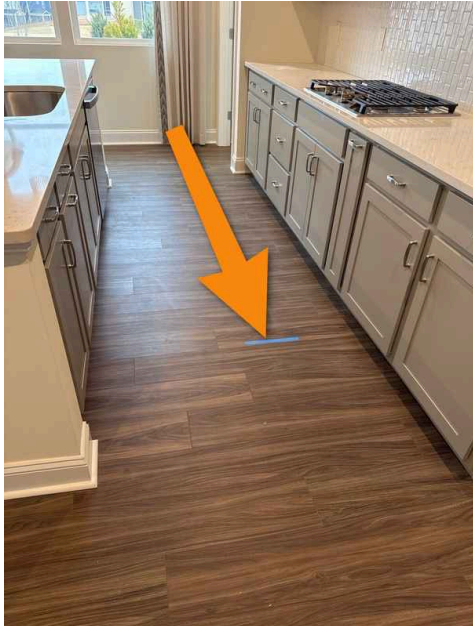
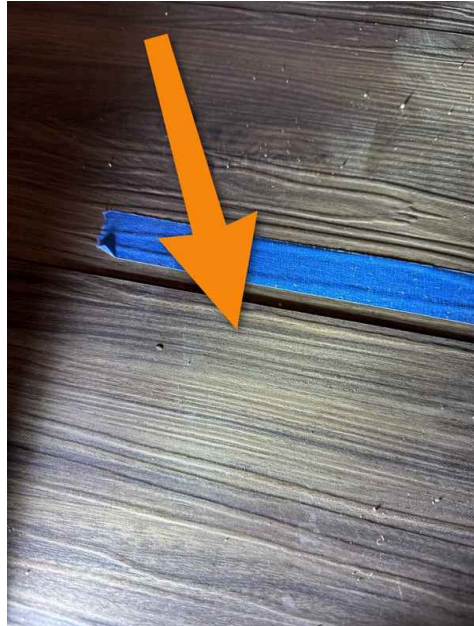
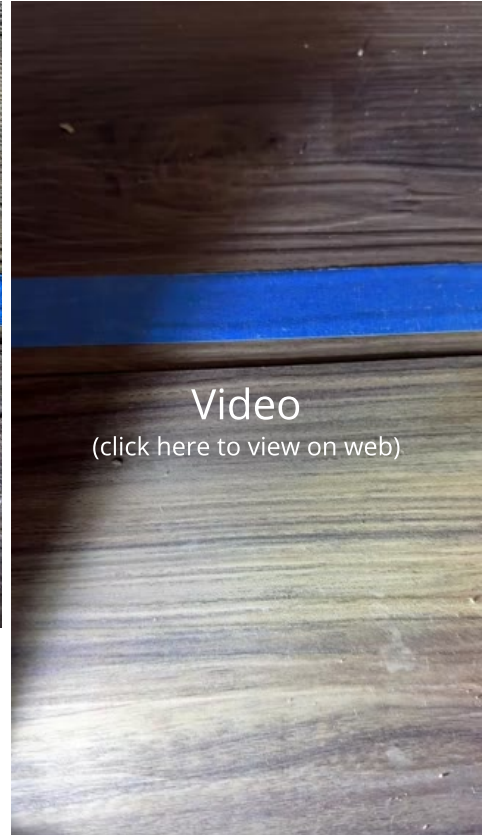
The flooring was repaired here. The two pieces move up and down separately more than what is common. This means this area of flooring is likely to become damaged.

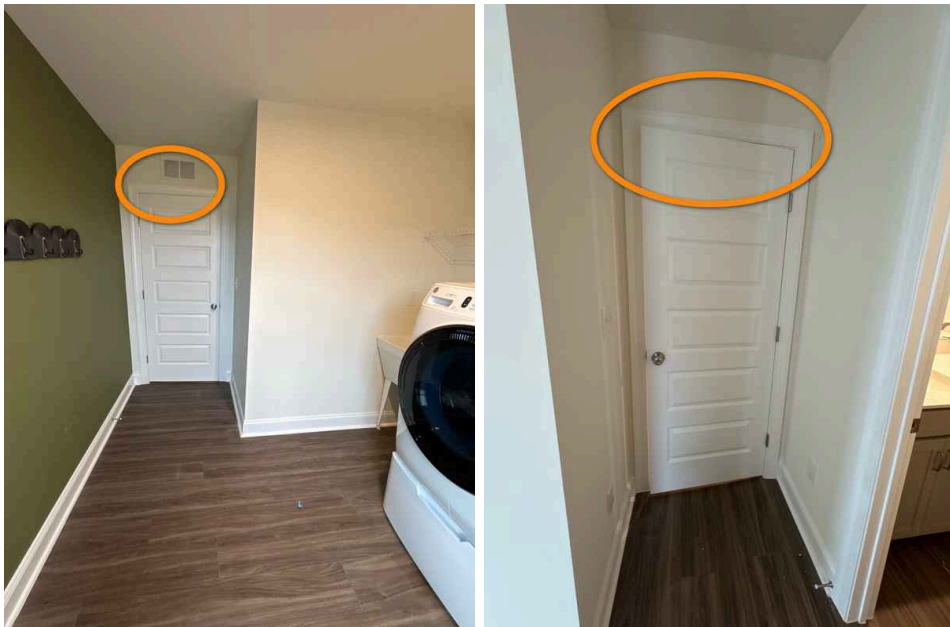
See description for this finding located in the laundry room. Also, the door cannot be closed for this reason.

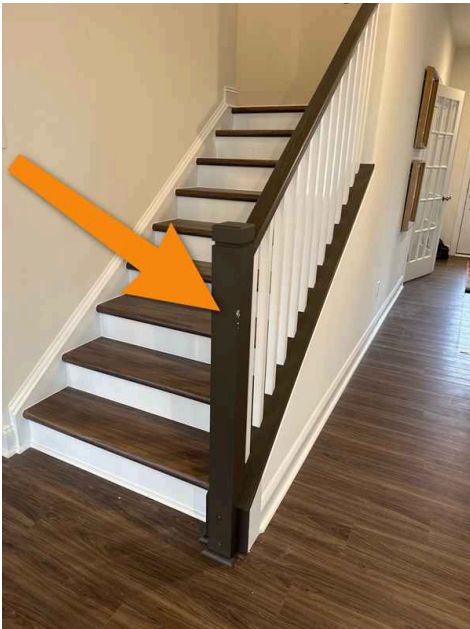
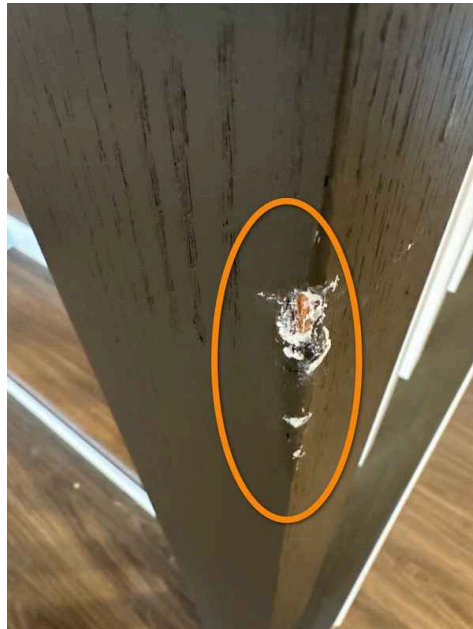
See description and following photos.

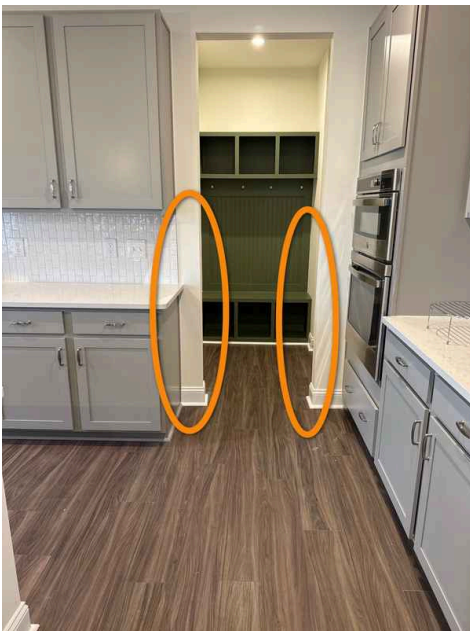
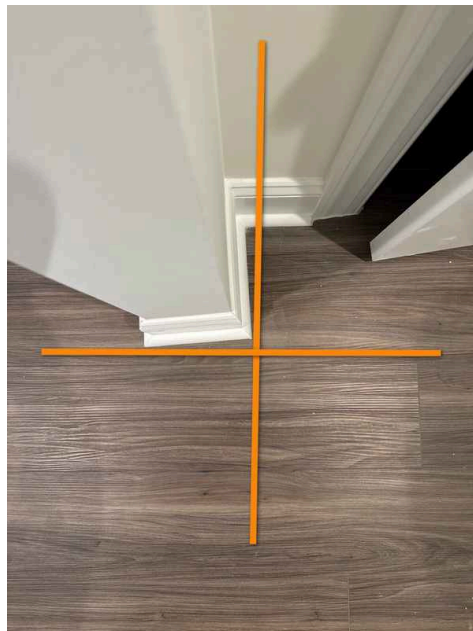
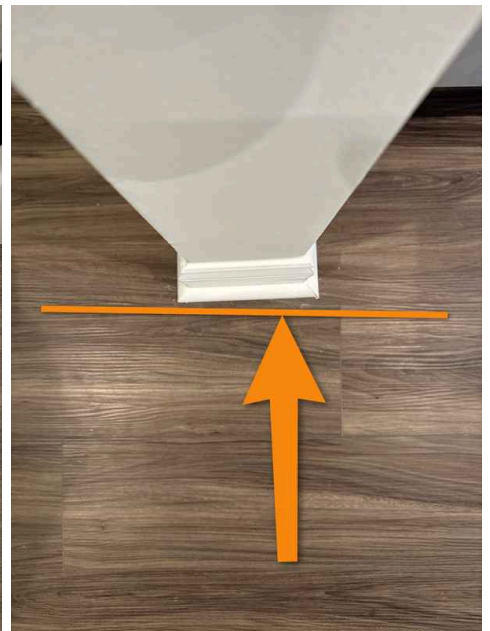
See description and following photos.

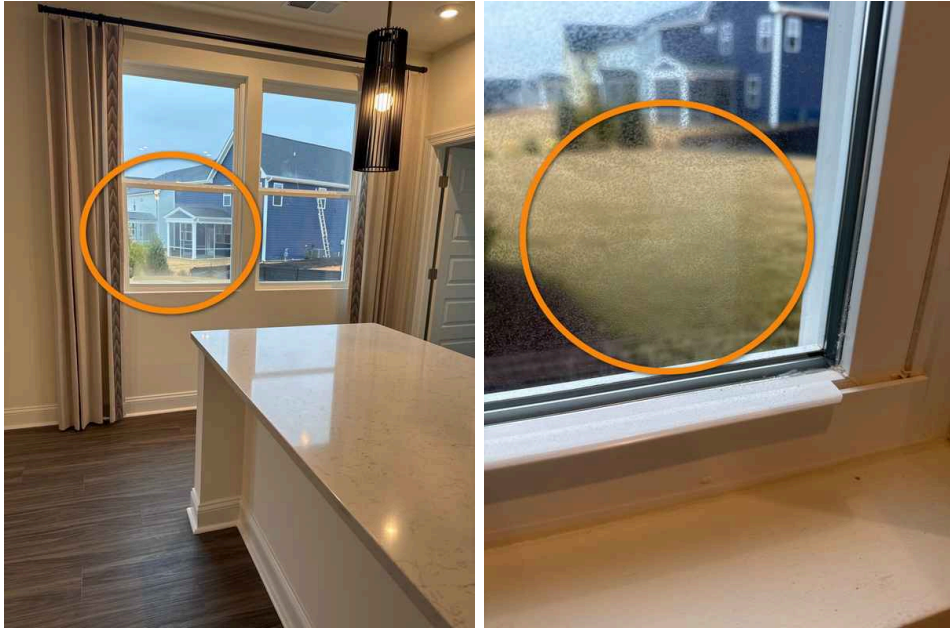
See description and following photos. Additional photo of this finding.

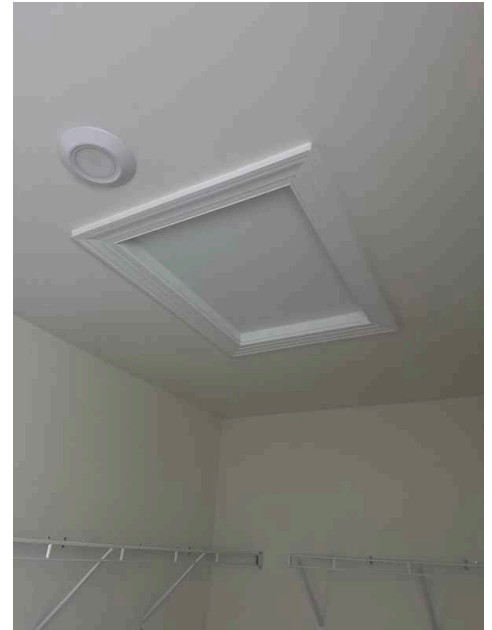
See description for this finding. The attic access is completely painted shut. Inspecting structure is important. The inspector will return no charge if the panel is removed in a timely manner.

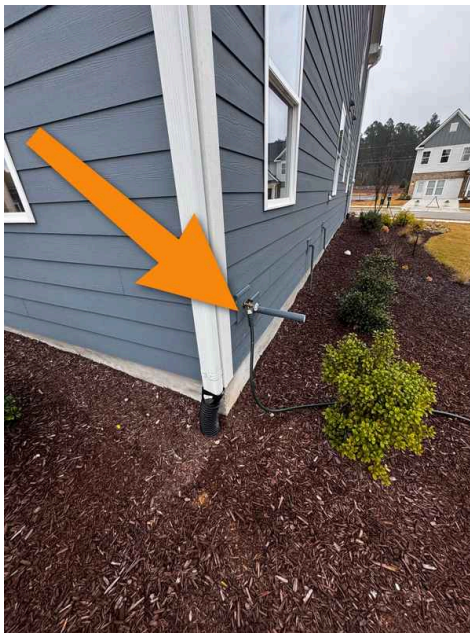
See description and following photo regarding this hose bib on the left rear corner of the home.

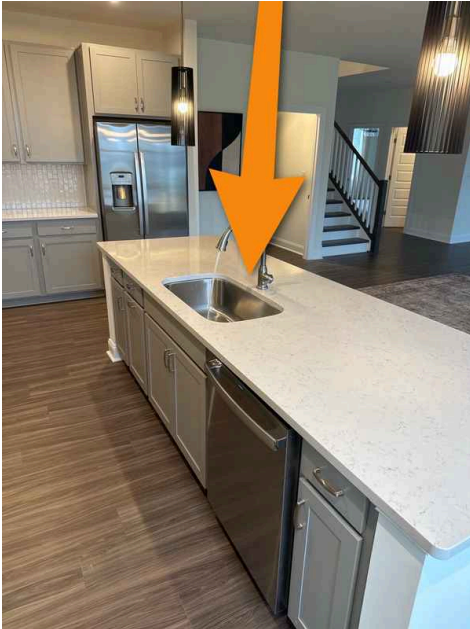
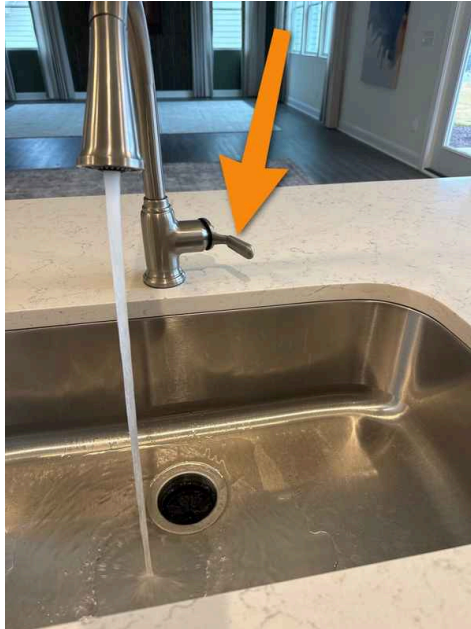
See description and following photos.

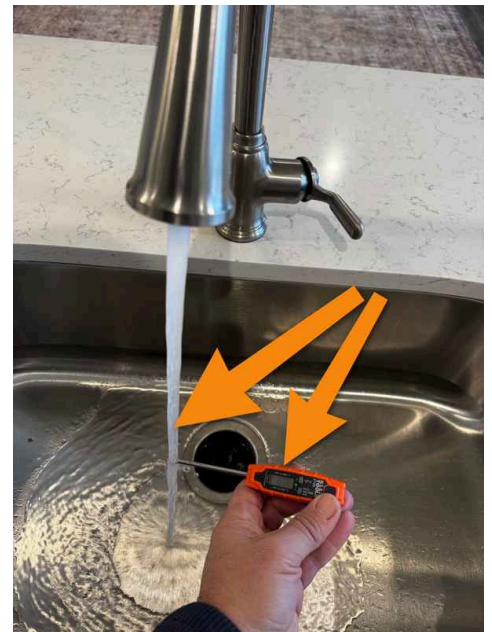
The highest temperature achieved was 105°.

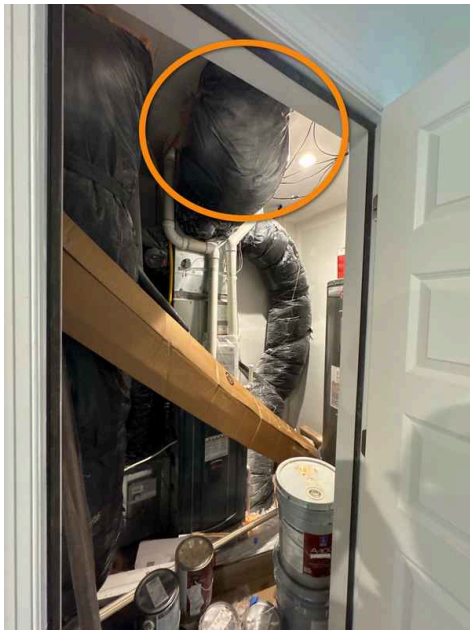
Insulation falls from the attic when the doors opened. This means the fire blocking between floors is missing.

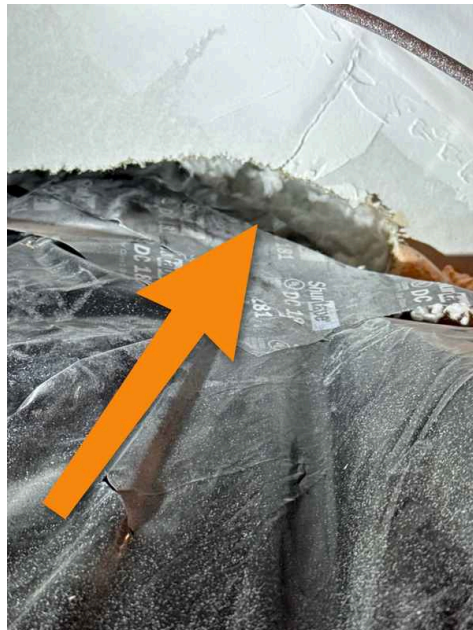
Additional photo of this finding looking up at the ceiling showing some of the gaps.

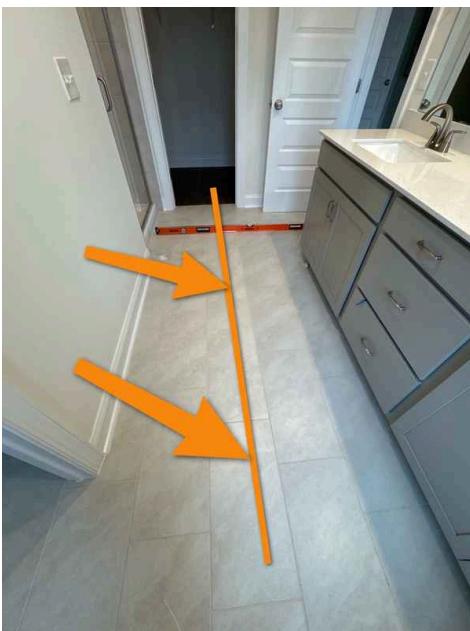
See description for this finding, this means the tile are more likely to come loose because the floor is not flat. See following video.

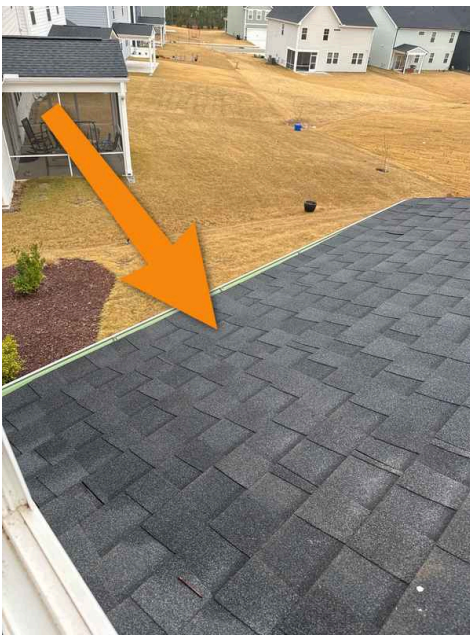
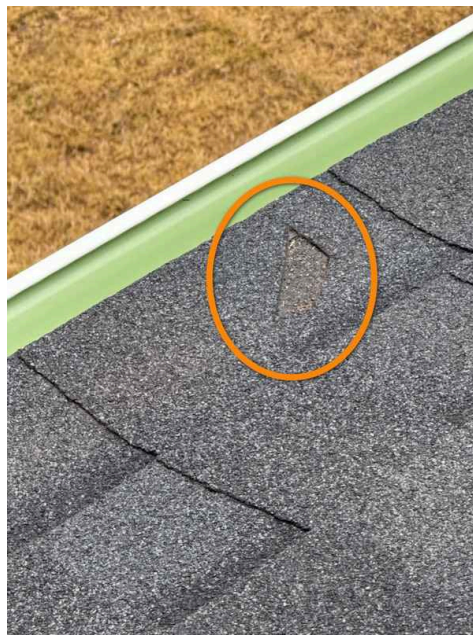
See description for this finding located above the rear porch.

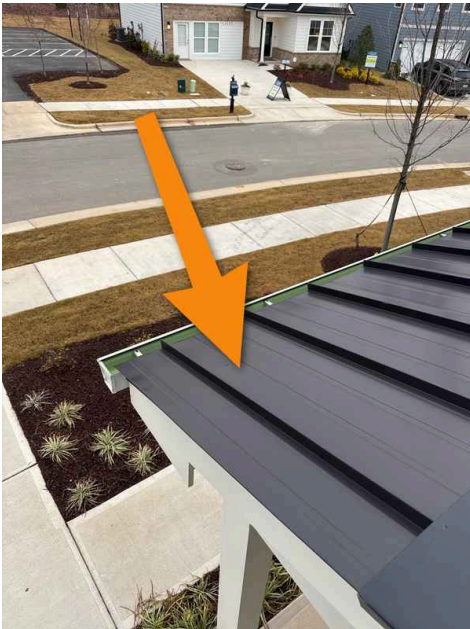
See description and following photo. The roofing is damaged from material such as a raised nail that was under the roofing..

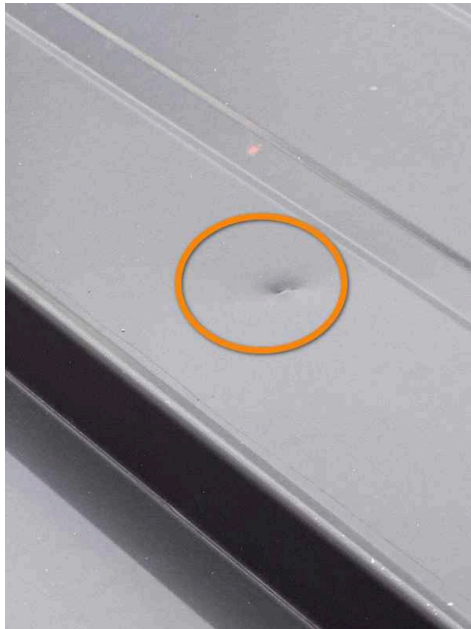
This raised nail may puncture the Roofing at any time.

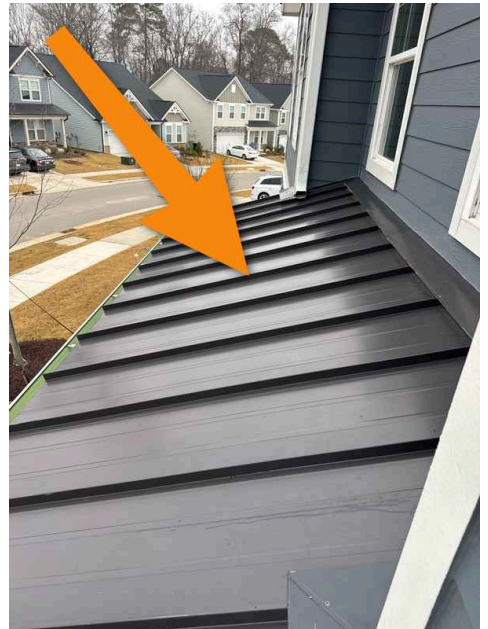
Similar findings were found here.

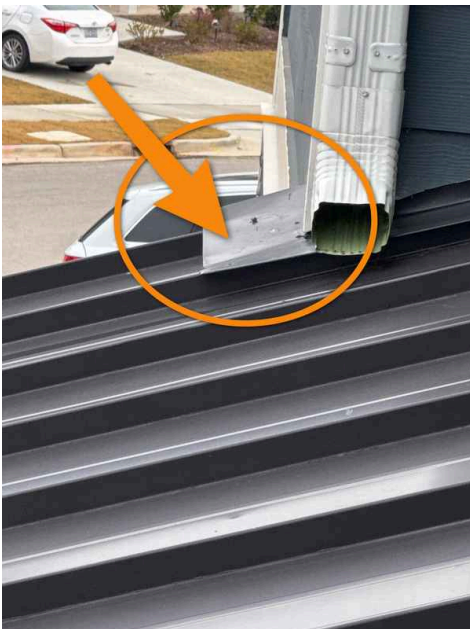
Also, the counter flashing on the left side of the porch is significantly damaged.

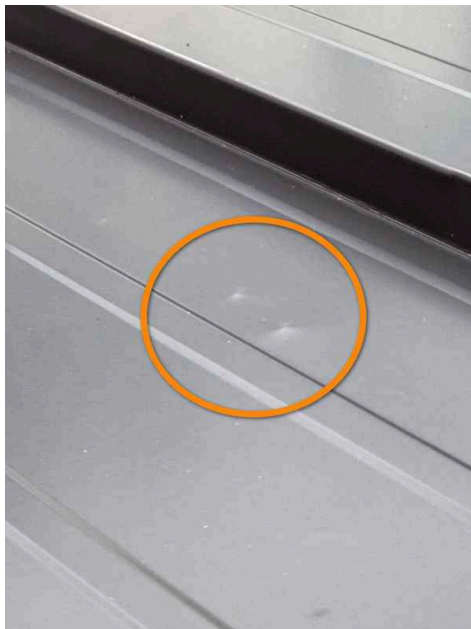
Additional photo of this finding. All areas of the this Roofing section should be assessed for the same finding.

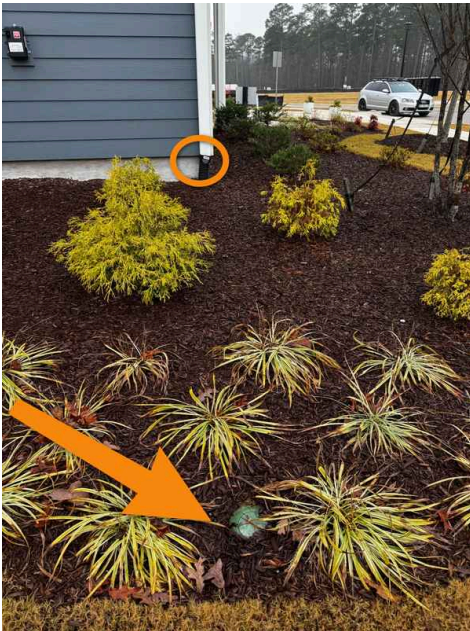
See description and following photos. Water overflows in the circled area by the home.

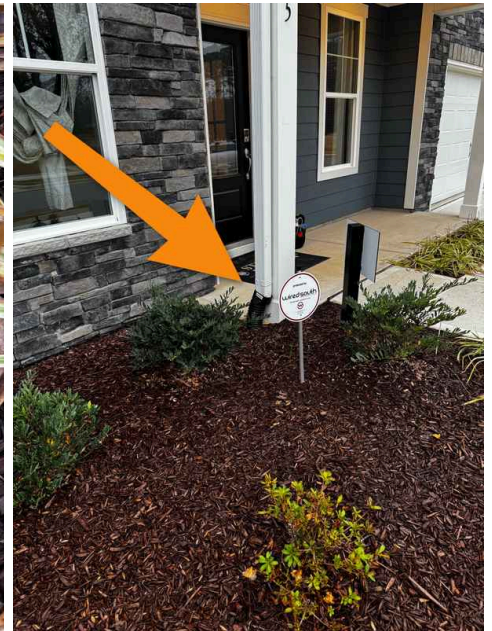
Similar findings were found here.

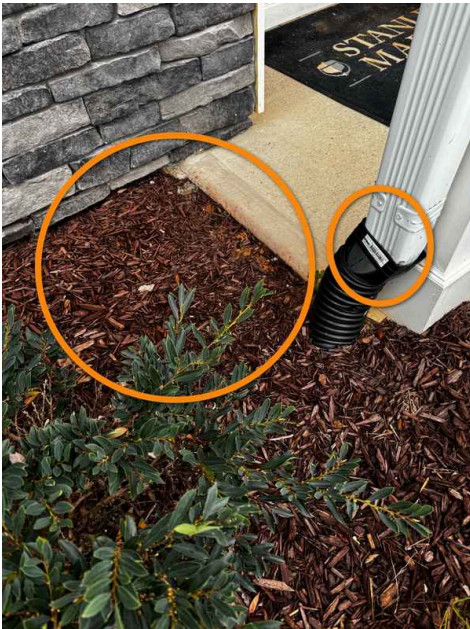
The mulch is being washed away because water overflows from the downspout.
