ELDREDGE HOME INSPECTION

RESIDENTIAL REPORT

1234 Main Street
Cary, NC 27513

01/24/2026 9:00AM

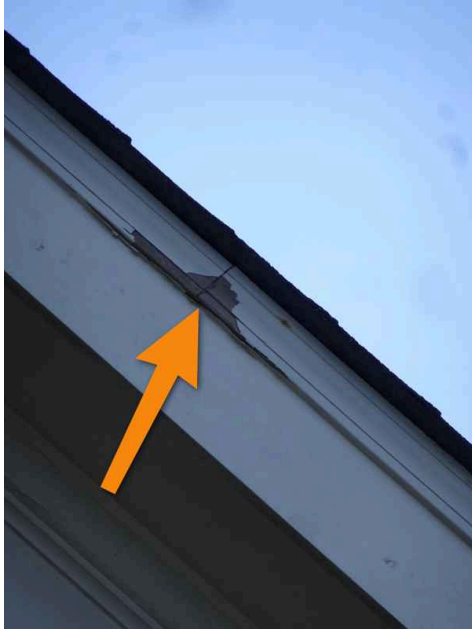
The trim and siding were found to be in need of painting and caulking around the home. Some wood replacement may be necessary when the painting is done by a professional painting company.

See description and following photos.

Contact a qualified professional.

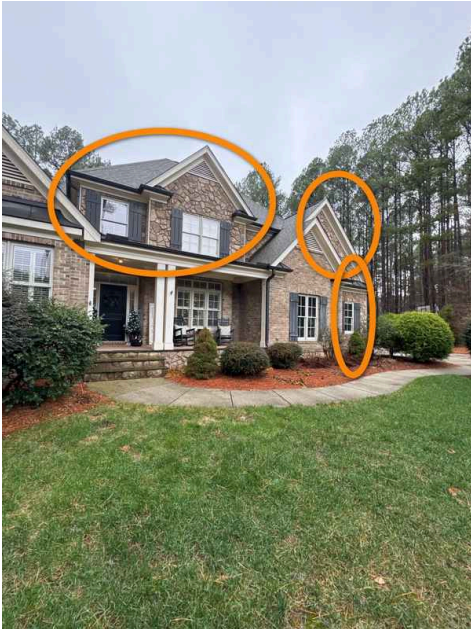
Adhered masonry stone/manufactured stone veneer cladding has been installed on this home. An inspection of the visible components suggests that the cladding system may not have been installed in such a way as to ensure that the cladding is a weather-resistant system that protects the wall assembly from excessive water penetration, condensation, and or water accumulation. At the time of inspection, the following concerns were noted and in need of further evaluation:

- A weep system was not observed either at the base of the framed walls or at the termination of the veneer.
- A weep system was not observed at transitional intersections with adjacent cladding materials and trim.
- Transitional flashing, drip screed, and sealant details were not observed for window and door openings.
- Standard clearances, transitional flashing, weep screed, and sealant details were not observed for at intersections with roof covering materials
- Standard clearance, flashing and sealant details were not observed at boxing areas, eaves and rakes.

- Clearances were not maintained between stone cladding and the ground and/or paved surfaces to prevent wicking and frost heave problems.
- Clearances were not maintained between stone cladding and roofing materials to allow for proper drainage and future roof repairs and/or replacement.

See description and following photos. Damage was found in the crawlspace caused by leakage from above the porch. This means hidden damage in the walls at each end of the porch is expected.

The installation of the stone cladding should be evaluated by a licensed general contractor and repaired as needed to correct any possible water penetration issues and verify that the stone cladding is installed to the specific installation requirements of the North Carolina State Building Code: Residential Code and /or the Masonry Veneer Manufacturer's Association (MVMA). Please note that because the water resistive barrier, metal lath, and base coat(s) of cement stucco are completely concealed behind the adhered masonry stone veneer cladding, they cannot be evaluated by a visual inspection.

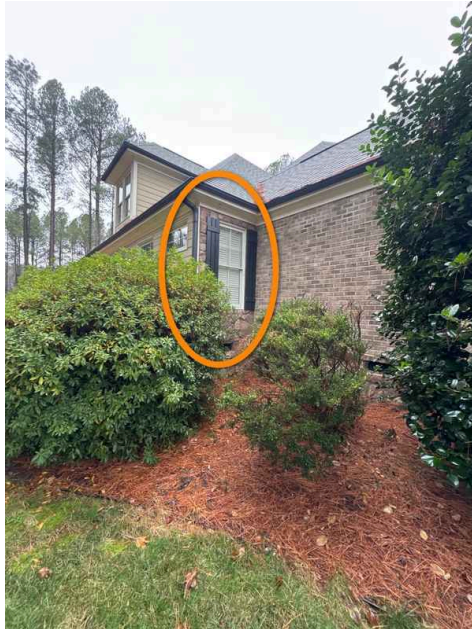
Similar findings were found here.

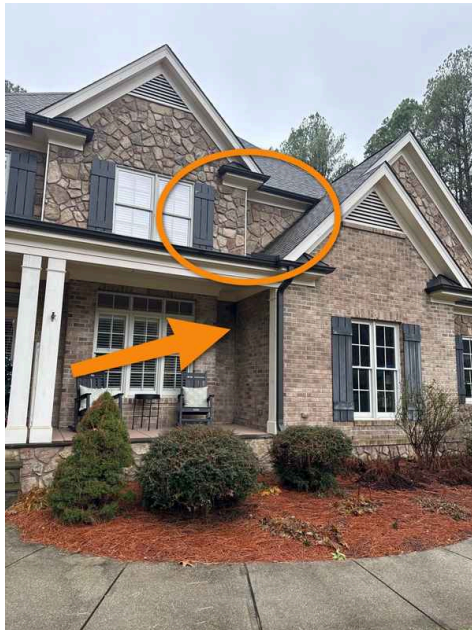
This area is leaking to the wall below.

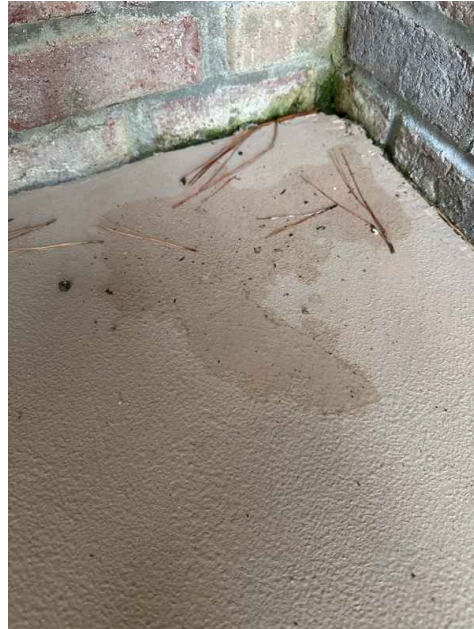
Additional photo of water on the porch from the leak.

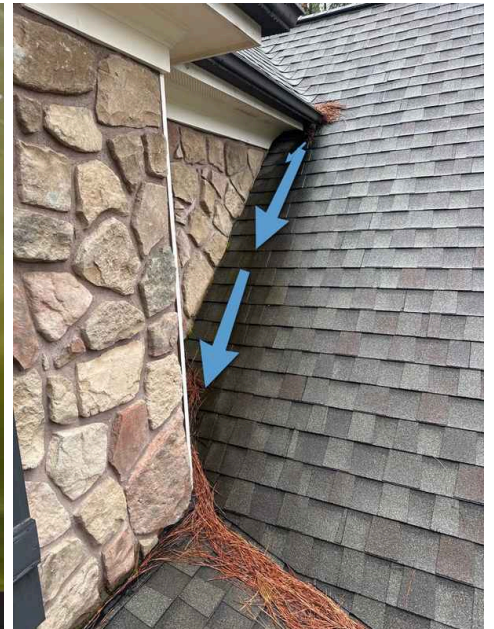
Too much water is directed against the stonework here. Hidden damage is expected.

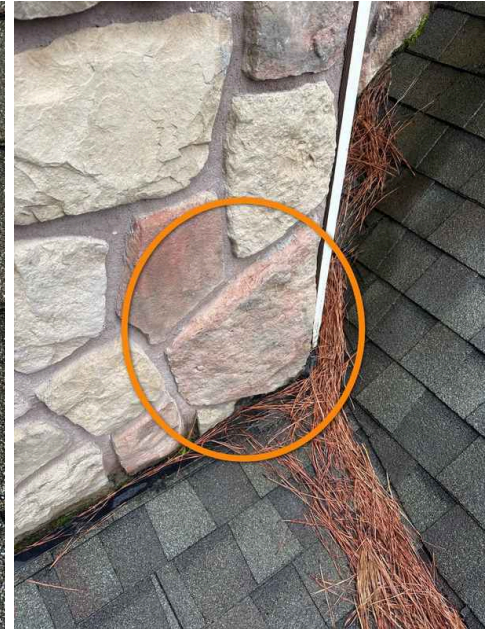
This stone is slightly loose which is typical of hidden damage.

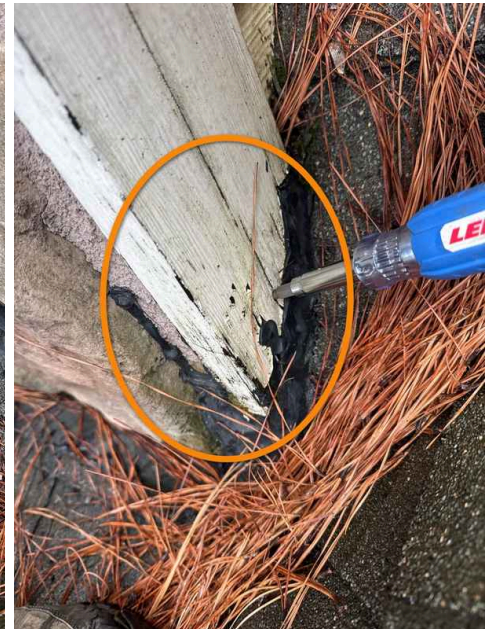
Additional photo of this finding showing the decay.

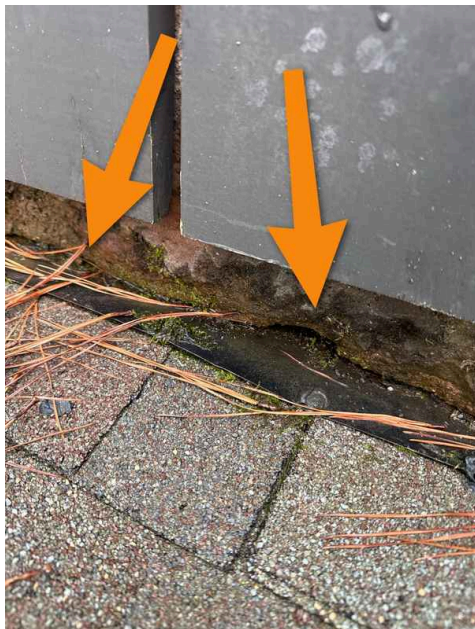
Moss buildup on the stonework indicate excessive moisture caused by improper installation.

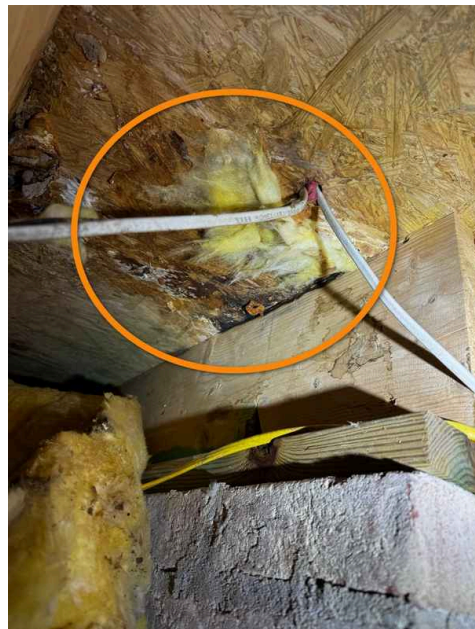
The subfloor is decayed here at the rear left corner of the front porch. This means that hidden damage is expected in the wall above this area.

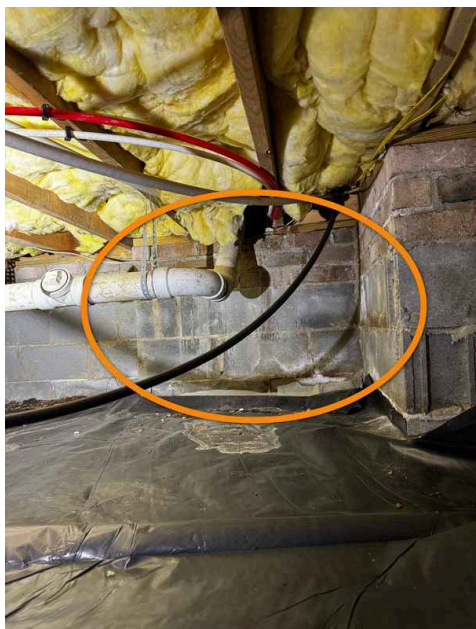
The foundation wall is wet here between the garage and front porch area. Significant amount of water flow down the wall from the roof above the porch. See following photos.

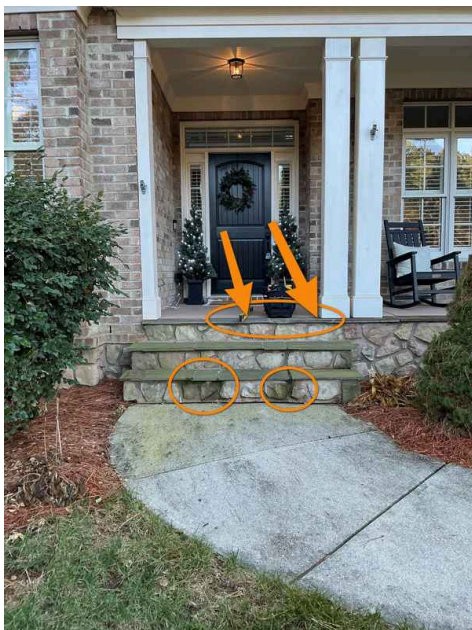
Location of the following finding. The two stones at the top are loose.

This evaluation should be completed by a licensed general contractor or specialist in the field described.

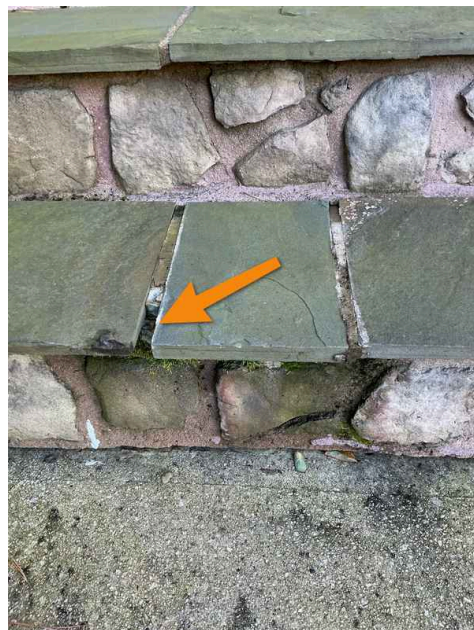
Mortar is missing inbetween the stone surface which allows the water to cause the steps to come loose.

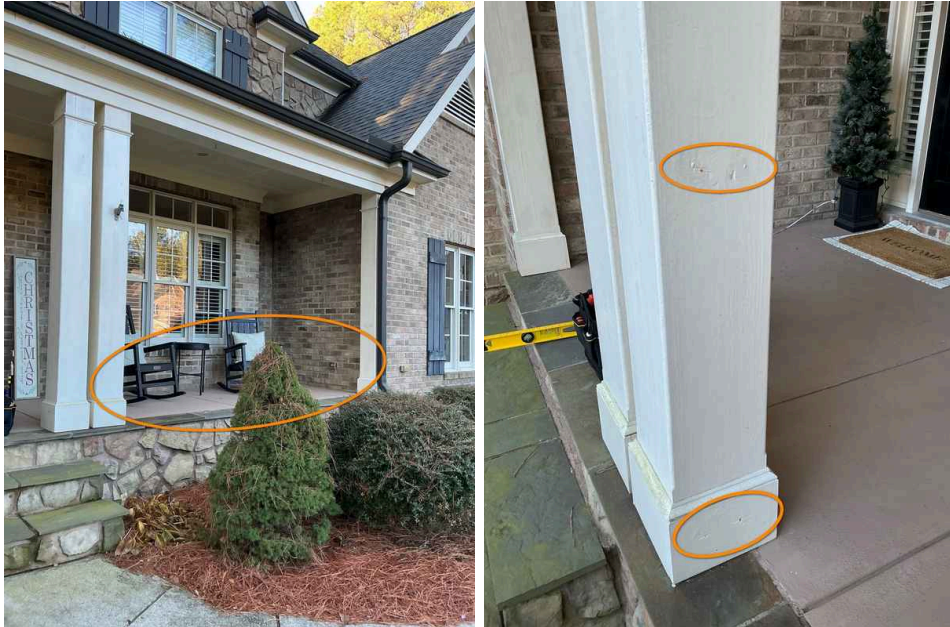
Located on the front porch, the railing is missing here.

Evidence of a previous railing was noted on the porch.

Contact a qualified professional.

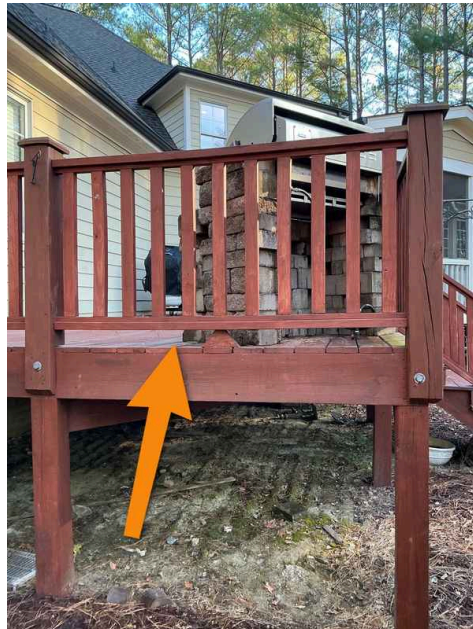
The deck structure was noted to be sagging slightly due to the excess weight of the stone Grill stand. See description for this finding.

A full evaluation and repair plan should be completed regarding this area of the home. These repairs should be completed and managed by a licensed general contractor.

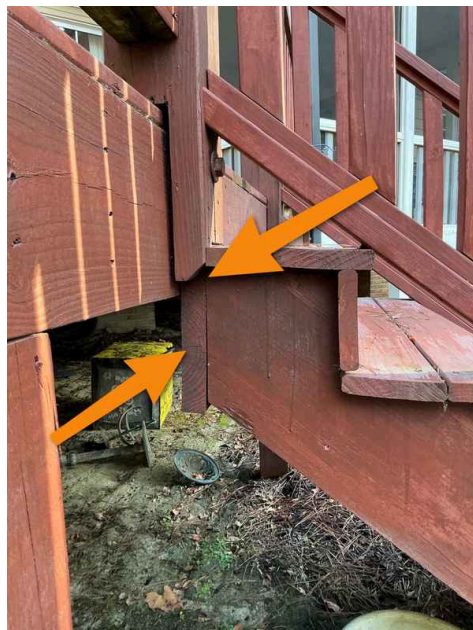
The deck stair stringers are tip loaded making them unsafe for future use.

A full evaluation and repair plan should be completed regarding this area of the home. These repairs should be completed and managed by a licensed general contractor.

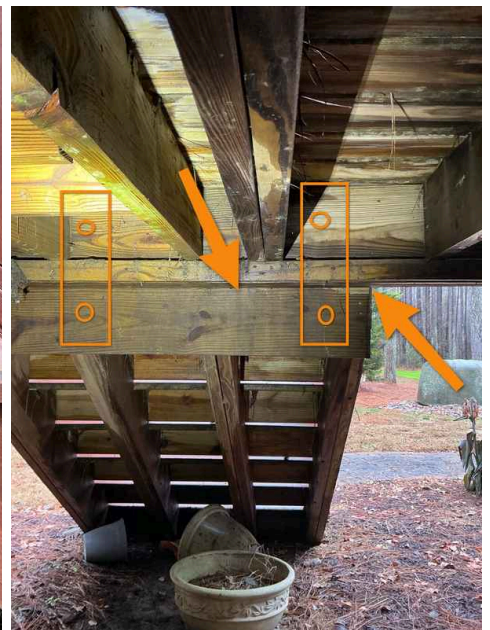
More lumber and bolting is necessary on the back of the stair stringers. See description and following photos.

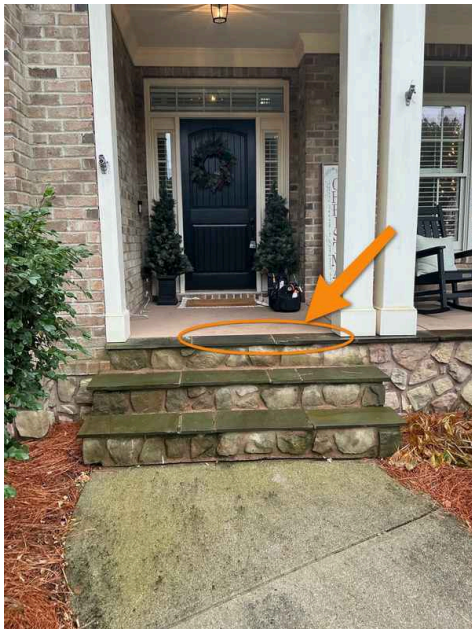
These two step stones are loose. See description and following video.

A full evaluation and repair plan should be completed regarding this area of the home. These repairs should be completed and managed by a licensed general contractor.

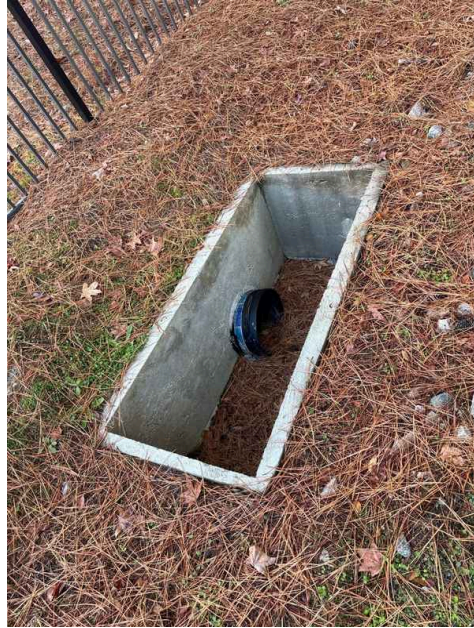
This presents a trip/fall hazard. See description for this finding.

A full evaluation and repair plan should be completed by a licensed general contract.

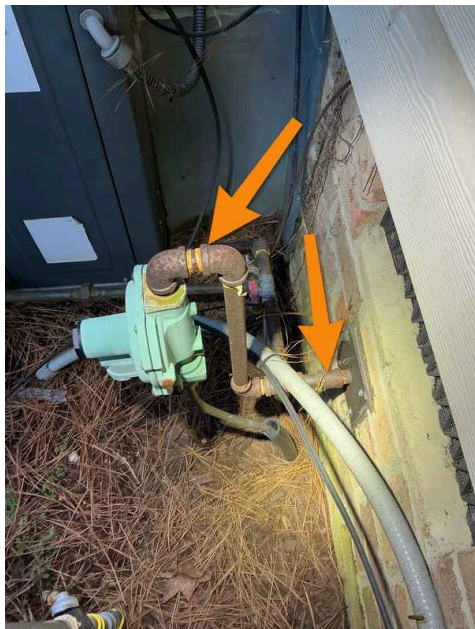
The gas line was noted to be corroded. Corrosion on a gas line is a serious concern that could result in leaks and or hazardous conditions. A plumbing or HVAC contractor should be consulted for a complete evaluation and repair of the gas line installation.

The gas line is rusty and corroded.

Contact a qualified professional.

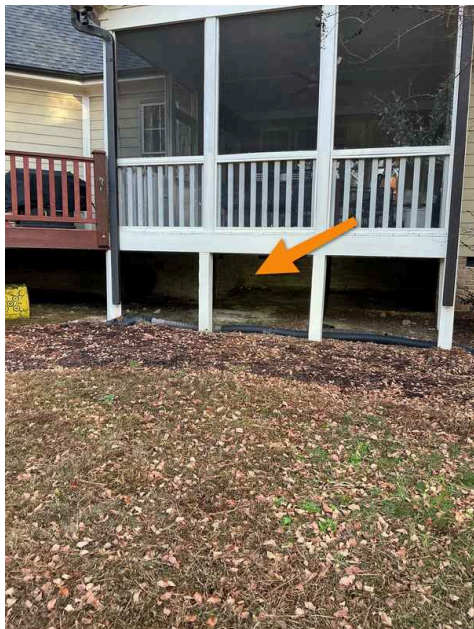
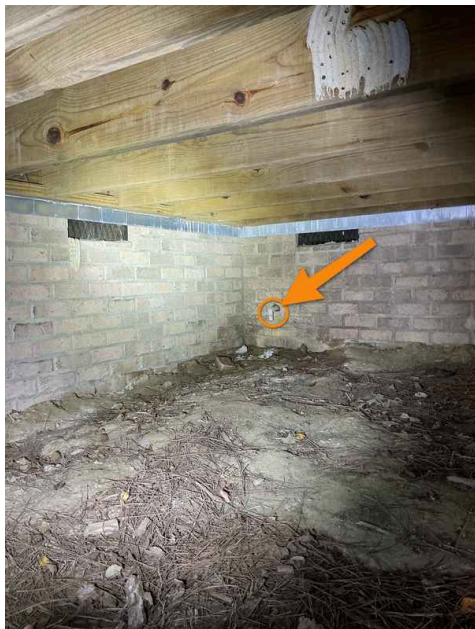
The condensate drain is too close to the foundation. The building code does not require this extension but water does often seep through the foundation from here. This can cause the soil to stay wet when the surrounding soil is dry. This wet soil expands causing a strain on the foundation system which can lead to cracking. A licensed HVAC Contractor should be consulted to extend this tubing to a proper design and length.

Location of the following finding under the rear deck.

Note: the tray used at the bottom of gutter downspouts is typically effectively utilized as a repair for this finding.

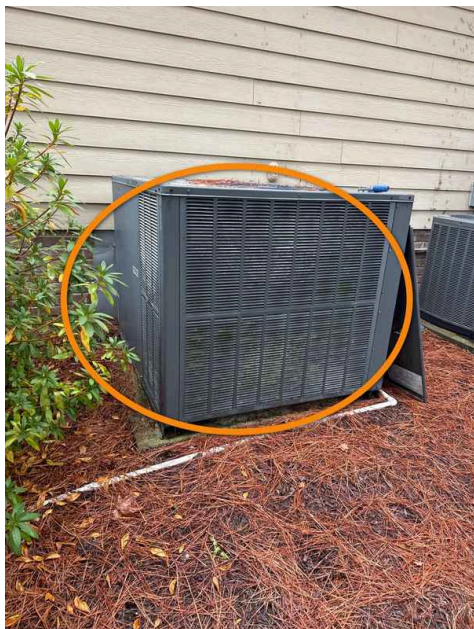
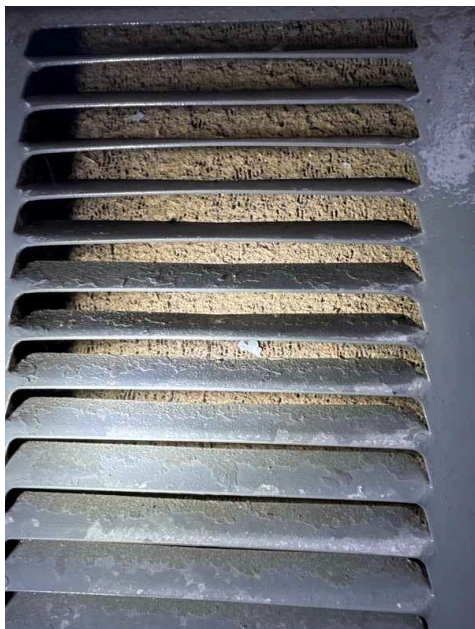
The coil for the HVAC unit is dirty. Dirty coils limit the air flow which can damage the compressor in time. A licensed HVAC technician should be consulted regarding the maintenance of the system.

The coil is significantly dirty.

Contact a qualified professional.

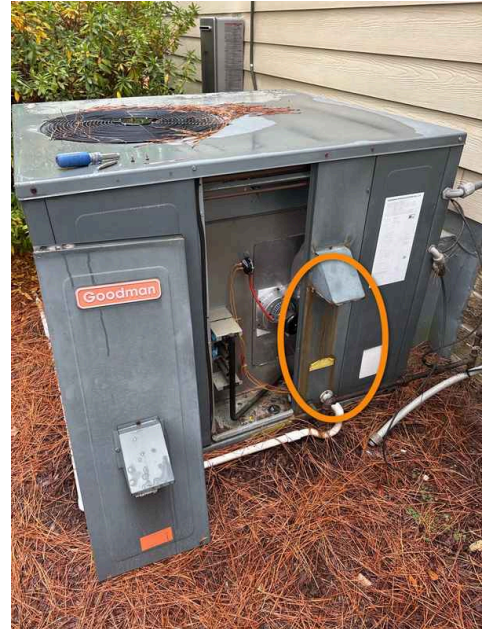
The heating side was functioning properly during the inspection. However, the unit does show signs of age. The weather is too cold to test the air conditioning. See description for this finding.

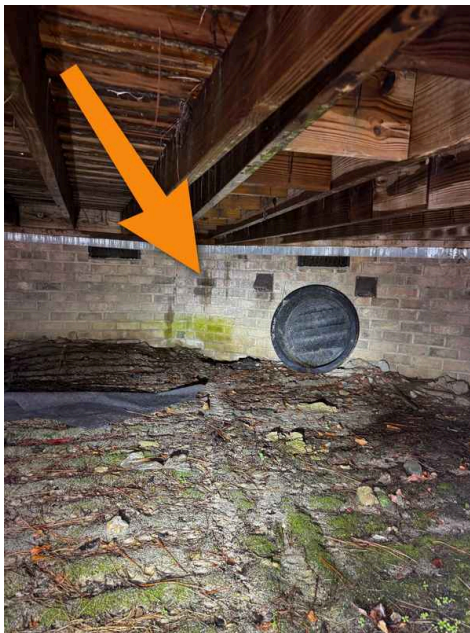
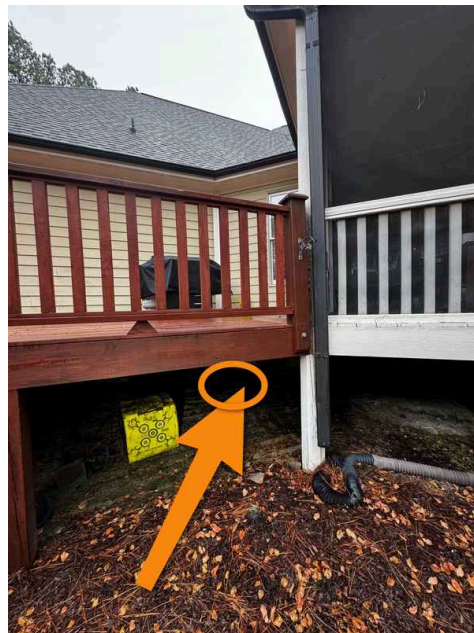
See description and following photos. The dryer vent releases hot humid air under the deck. This creates a humid environment for occupants using the deck. Relocation is recommended..

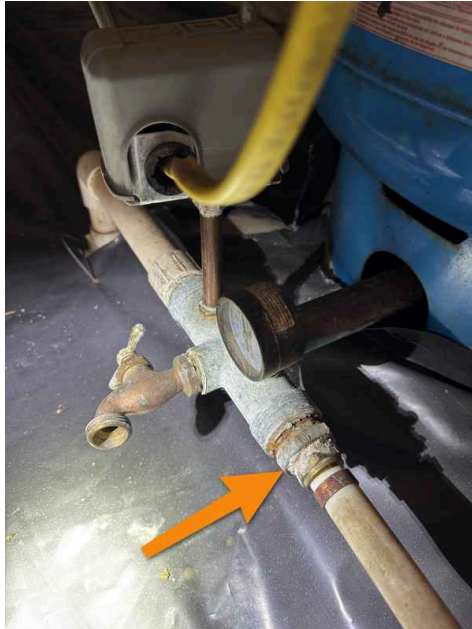
There are fittings that are corroded. Visible corrosion typically continues through the pipe fitting which will lead to breakage and large scale leaks. A licensed plumber should be consulted to evaluate all of the fittings and replace the fittings as needed. Also, note that the fittings inside the walls or under the slab cannot be seen for inspection. Also, when the main water valve is turned on and off the vibration in the pipes can cause more leaks.

This fitting is corroded.

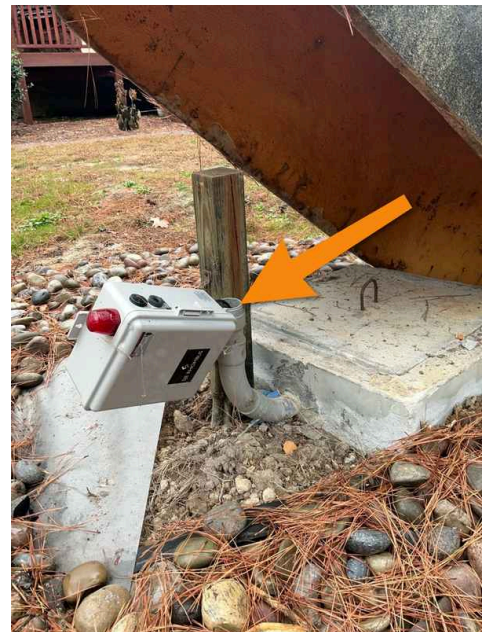
The septic control box is loose and falling off of the conduit. See description for this finding.

A licensed plumber should be consulted for a complete evaluation of this finding and repair to avoid leaks and property damage.

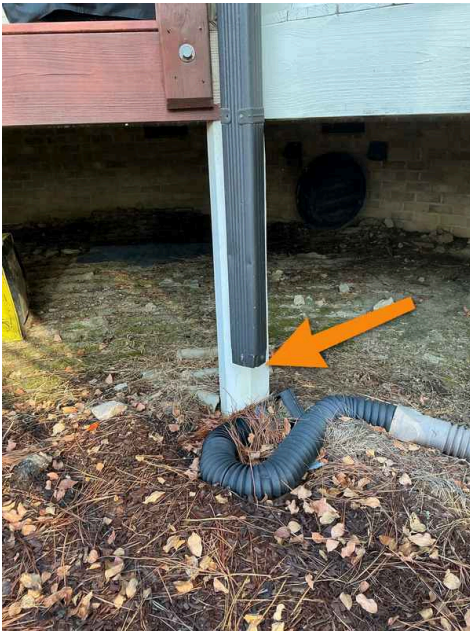
Gutters were damaged. This can result in excessive moisture in the soil at the foundation, which can lead to foundation/structural movement. Recommend a qualified contractor evaluate and repair.

The downspout elbow/extension is missing here.

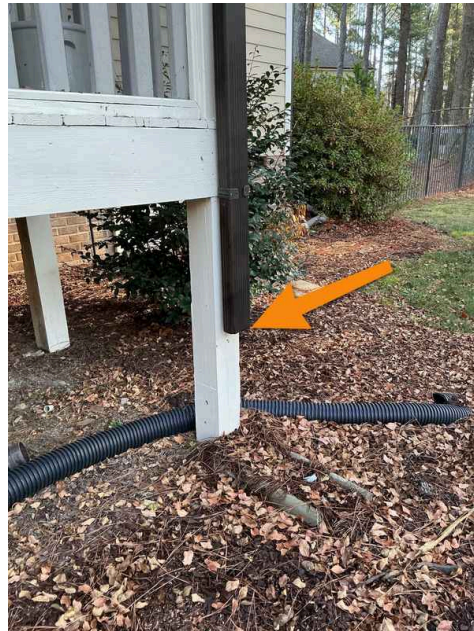
Similar findings were found here.

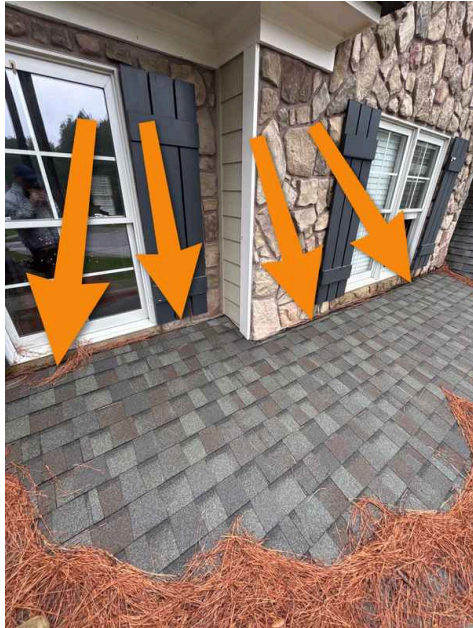
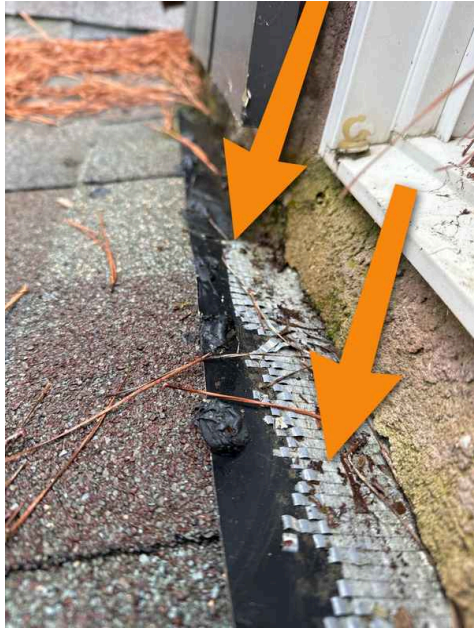
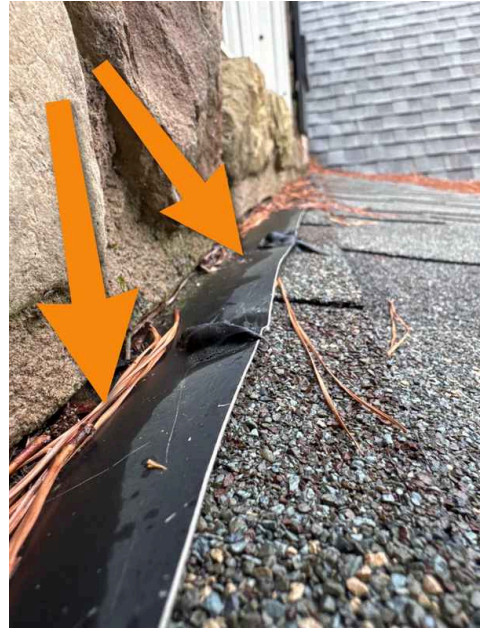
The flashing is loose/bent/missing up which will or has caused leaks within the roof. A roofing contractor should be consulted for a complete evaluation of the flashings system to make necessary repairs to ensure the weathertightness of the roof covering system.

The flashing across the front middle of the home is bent up at the end. This direct water toward the home.

Contact a qualified professional.
