ELDREDGE HOME INSPECTION

FULL HOME TEMP - NON IRB

1234 Main Street
Cary, NC 27513

01/24/2026 9:00AM

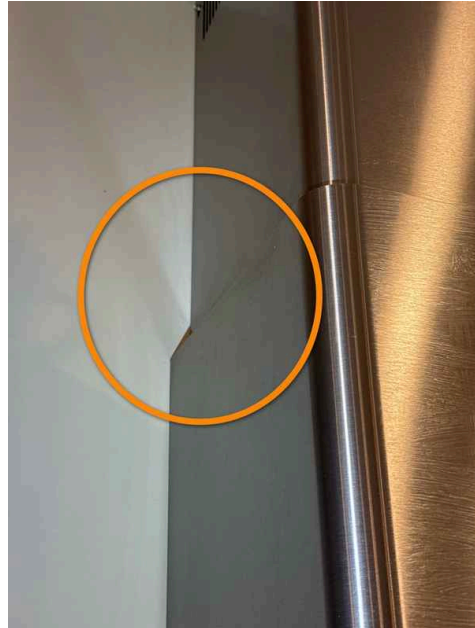
The cover for the duct is misaligned/not installed. Repairs should be made to straighten the duct cover by an appliance contractor.

Additional photo of this finding.

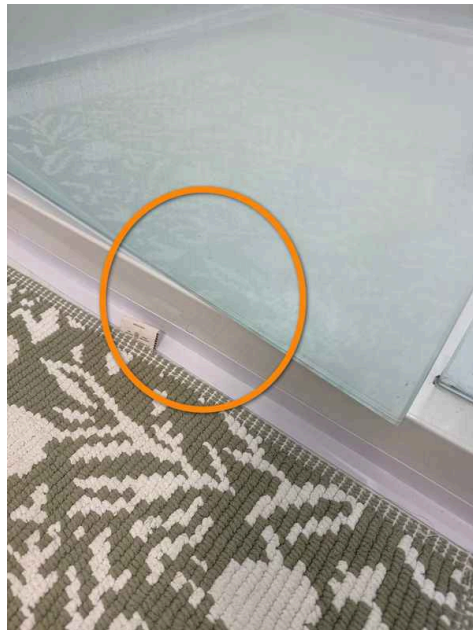
See description and following photos regarding the shower in the master.

The door is hinged to swing both ways which means the door should swing in both directions. The door cannot swing out because the door hits the threshold.

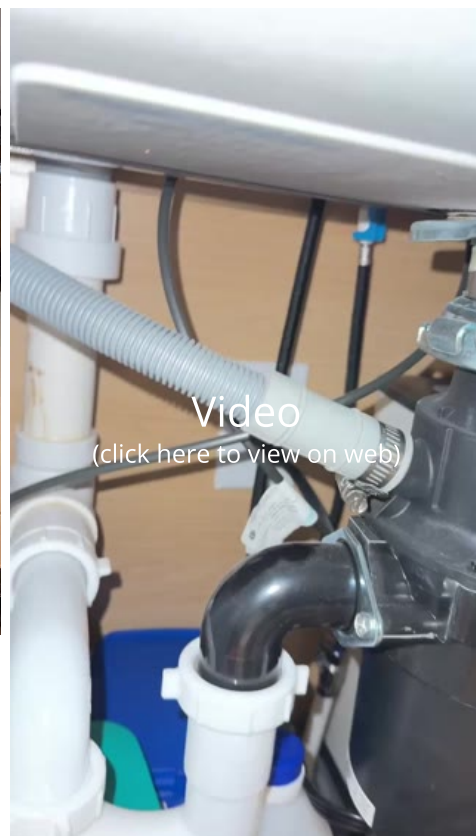
The plumbing lines for sink rattle when the water is turned on and off. The skin cause leaks.

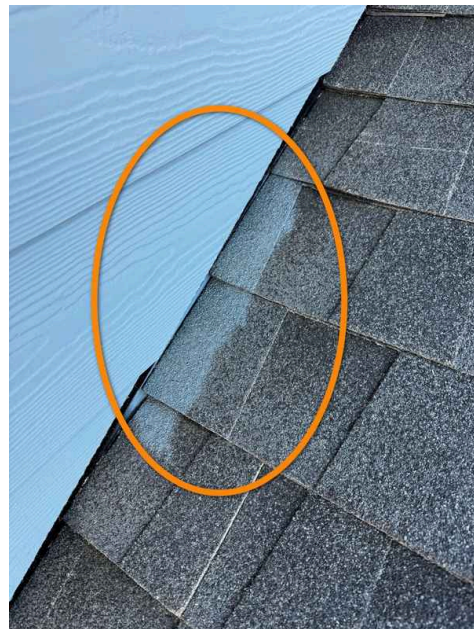
Additional photo of this finding.

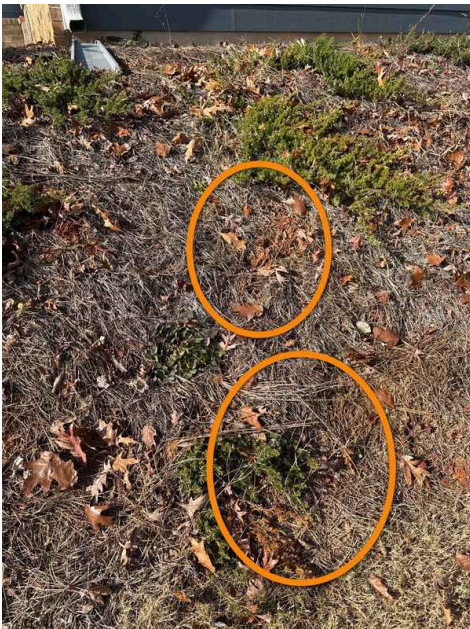
This downspout is causing erosion to the hill because there is no retaining wall.

Additional photo of this finding under the pine straw.
